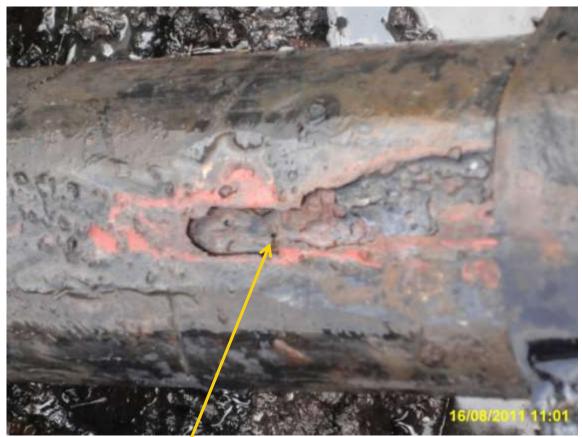
<u>Close-up:</u> Spill due to pinhole from inward dent on Cawthorne Channel Well 29T flowline at Mbiama. Picture taken during Joint Investigation of 16th August, 2011.
