THE SHELL PETROLEUM DEVELOPMENT COMPANY OF NIGERIA LIMITED.

JOINT INVESTIGATION REPORT FOR INCIDENT NO: 1231430 JIV report S/N: 00129

1. Spill incident Number: 1231430 2. Type of incident\* OIL SPILL  
 3. Name of Location 12" BENISEDE - ISAMPOU DELIVERY LINE  
 4. Name of nearest community FOUTORUGBEN 5. State: BAYELSA 6. LGA EKEREMOR  
 7. Type of Production facility/Installation OIL PIPELINE 8. Asset owner/District PIPELINES

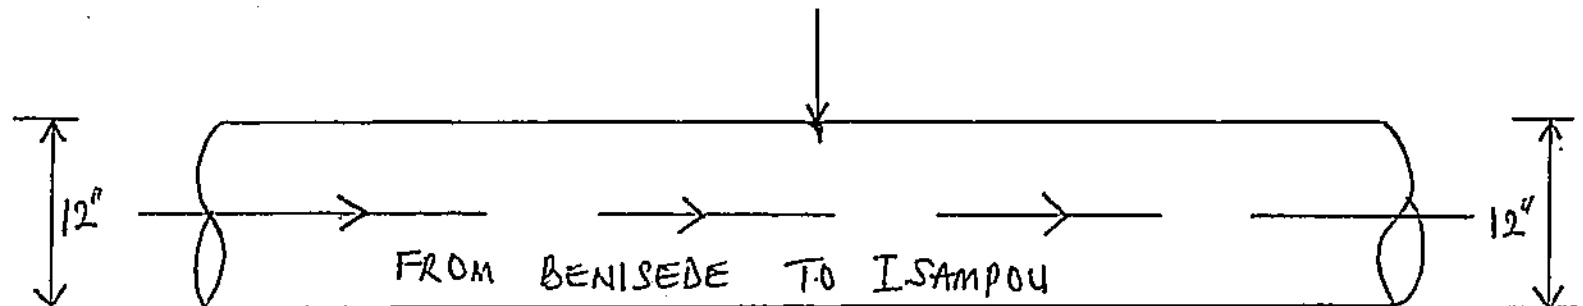
12" BENISEDE - ISAMPOU DELIVERY LINE AT FOUTORUGBENE

Additional observations around the spill point: - A TRENCH WAS OBSERVED AT THE INCIDENT POINT. UPON EXCAVATION, A WOODEN COFFER-DAM WAS SEEN AND AN OPEN HACK SAW CUT WAS OBSERVED ON THE PIPELINE. THE AFFECTED PART OF THE PIPELINE WAS ALSO OBSERVED TO BE DECOATED.

SECTION OF 12" BENISEDE - ISAMPOU DELIVERY LINE AT FOUTORUGBENE, SHOWING; OPEN HACK SAW CUT AT 12 O'CLOCK POSITION.

OPEN HACK SAW CUT AT 12 O'CLOCK POSITION

If yes to item 14, give brief description: CLAMPING OF THE AFFECTED POINT ON THE PIPELINE WAS CARRIED OUT.
