THE SHELL PETROLEUM DEVELOPMENT COMPANY OF NIGERIA LIMITED.

JOINT INVESTIGATION REPORT FOR INCIDENT NO: 1380641 JIV report S/N: 00878

1. Spill incident Number: 1380641 2. Type of incident* OIL SPILL
 3. Name of Location 4" OBELE - IBAA PIPELINE
 4. Name of nearest community IBAA (OMUEZE) State: RIVERS 6. LGA EMOHUA
 7. Type of Production facility/Installation OIL PIPELINE 8. Asset owner/District PIPELINE

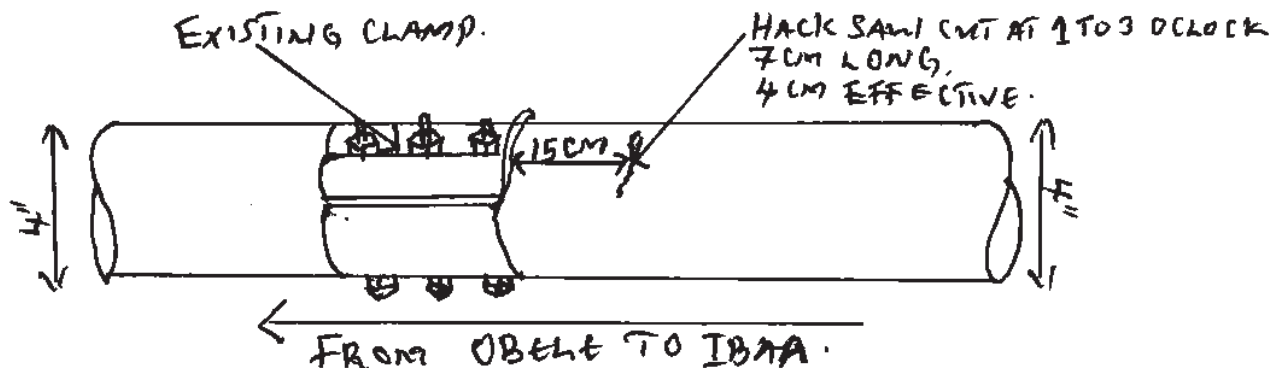
| <input type="checkbox"/> Drilled hole | <input checked="" type="checkbox"/> Hack saw cut | <input type="checkbox"/> Tear (_____). |

- ☒ Third party interference (Sabotage ☒; crude theft ☐; Line theft ☐; Accidental 3rd party damage ☐
☐ Operational ☐ Others (including Mystery spills) _____

SECTION OF 4" OBELE - IBAA PIPELINE AT IBAA (OMUTZE)
SHOWING POSITION OF HACK SAW CUT AT 1 TO 3 O'CLOCK POSITIONS.

RECOVERY ACTIVITIES ONGOING. REPAIR WORK WAS DONE BY CLAMPING.
