**THE SHELL PETROLEUM DEVELOPMENT COMPANY OF NIGERIA LIMITED.**

JOINT INVESTIGATION REPORT FOR INCIDENT NO: 1380914 JIV report S/N: 00838

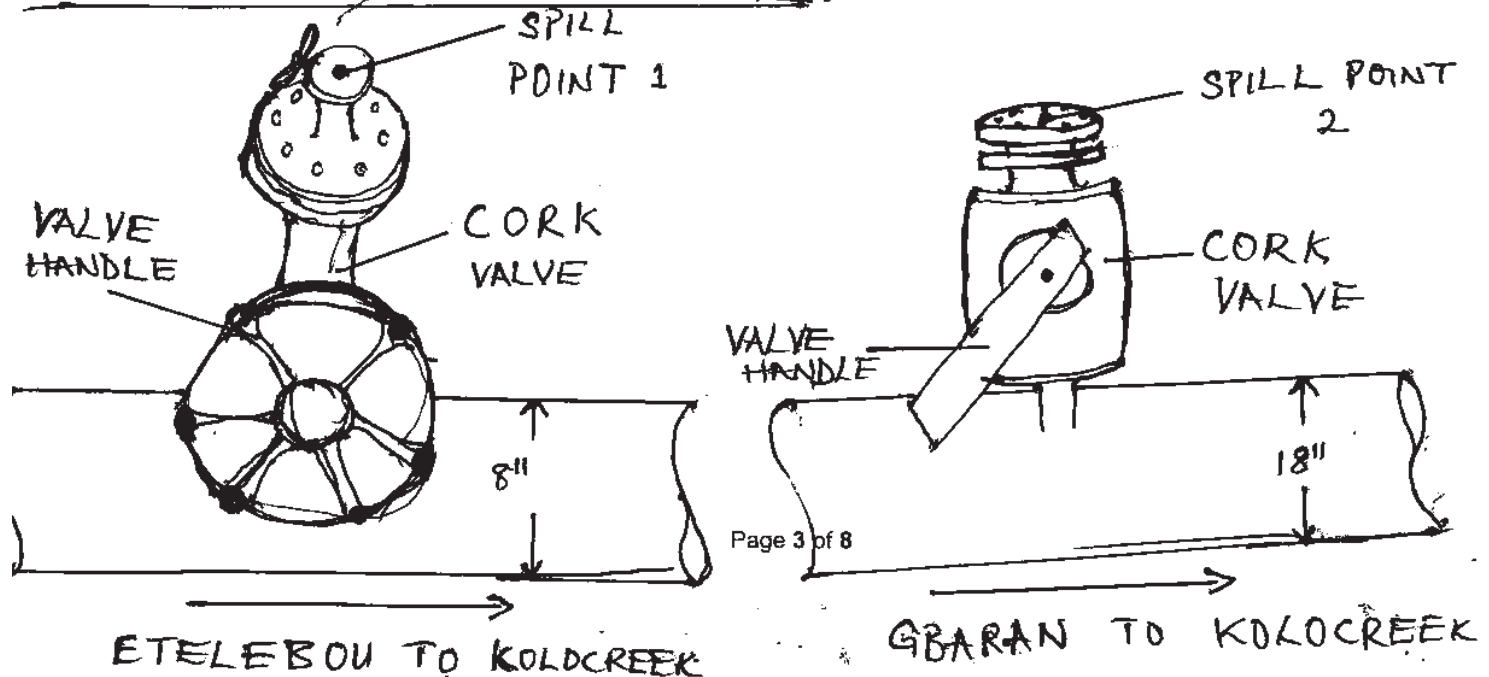
E. GRAPHIC DESCRIPTION OF LEAK POINT (while detail report of the leak point should be contained in the leak report, overview sketch of the site should be added as an appendix 1)

Additional observations around the spill point: THE TEAM OBSERVED THAT 2" CORK VALVE WAS REMOVED FROM 8" ETELOBU DELIVERY LINE AND 2" CORK VALVE GAUGE WAS ALSO REMOVED FROM 18" GBARAN-KOLOCREEK TRUNK LINE. THE JIV OBSERVED ALSO THAT THE BURGLARY PROOF AT THE PERIMETRE DRAIN WAS FRESHLY CUT.

| <input type="checkbox"/> Relief valve failure | <input checked="" type="checkbox"/> Others (specify) <u>REMOVAL OF CORK VALVE GAUGE</u> | |

- ☒ Third party interference (Sabotage ☒; crude theft ☐; Line theft ☐; Accidental 3<sup>rd</sup> party damage ☐  
☐ Operational ☐ Others (including Mystery spills) \_\_\_\_\_

CREEK MANIFOLD SHOWING TWO CORK VALVES, TAMPERED BY REMOVING THE CORK VALVE GUAGES. TWO SECTIONS OF KOLO

THE CORK VALVE WAS REPLACED
