JOINT INVESTIGATION REPORT

INCIDENT NO: 1413816 JIV report S/N: Nº 0000008

1. Spill incident Number: 1413816 2. Type of incident* OIL SPILL
3. Name of Location 28" Nkpoku - BOMU PIPELINE
4. Name of nearest community EJAMATI EBUBU 5. State: RIVER 6. LGA ELEME
7. Type of Production facility/Installation OIL PIPELINE
8. Asset owner/District SPDC / PIPELINE

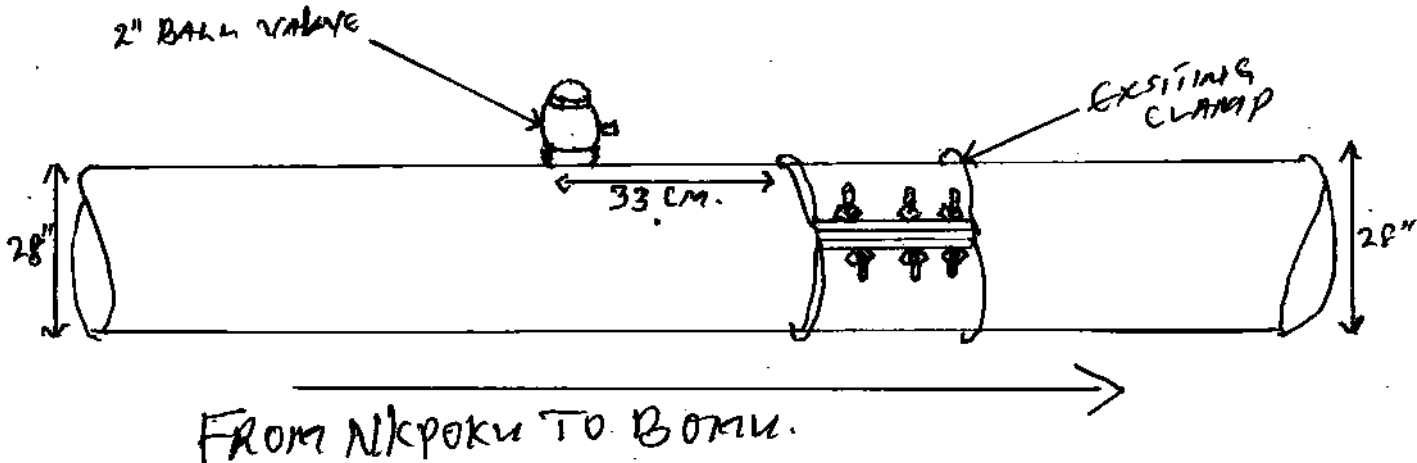
E. GRAPHIC DESCRIPTION OF LEAK POINT (while detail report of the leak point should be contained in the leak report, overview sketch of the site should be added as an appendix 1)

| <input checked="" type="checkbox"/> Failed Weld-on illegal hot tap valve | <input type="checkbox"/> Failed Clamp, | <input type="checkbox"/> Missing Pipeline/Flowline |
| <input checked="" type="checkbox"/> Crude oil theft (illegal bunkering) point, | <input type="checkbox"/> Saver-pit over flow | <input type="checkbox"/> Third party tampering with Clamp |

SECTION OF 28" NKPOKU - BOMU PIPELINE AT EJAMAH EBUBU SHOWING ONE NUMBER OF 2" CRUDE OIL THEFT POINT AT 12 O' CLOCK POSITION.

RECOVERY ACTIVITIES ONGOING. REPAIR WORK WAS DONE BY CLAMPING.
