# JOINT INVESTIGATION REPORT

INCIDENT NO: 1428935 JIV report S/N: Nº 000006

1. Spill incident Number: 1428935 2. Type of incident\* OIL SPILL  
3. Name of Location OBIGBO WELL 10 T WELLHEAD  
4. Name of nearest community UMUDINOR 5. State: RIVERS 6. LGA OYIGBO  
7. Type of Production facility/Installation WELL HEAD  
8. Asset owner/District THE SHELL PETROLEUM DEVELOPMENT COMPANY OF NIGERIA LIMITED / LAND 1

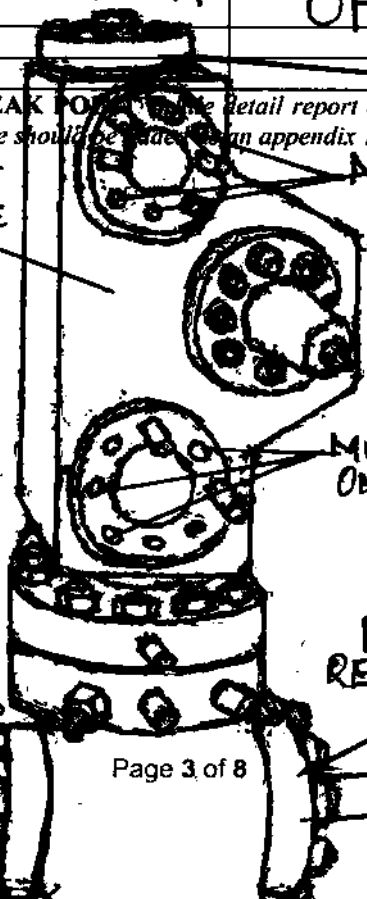
OBIGBO WELL 10T CHRISTMAS TREE

Additional observations around the spill point: THE JOINT INVESTIGATION TEAM ON ARRIVAL AT SITE OBSERVED THAT TWO (2) NO. GAS LIFT VALVES ON THE OBIGBO WELL 10 T WELL HEAD HAD BEEN REMOVED BY UNKNOWN PERSONS WITH ONE OF THEM TO WHICH A GAS LIFT VALVE WAS INITIALLY CONNECTED BEING THE LEAK POINT. ALSO, MISSING BOLTS AND NUTS WERE OBSERVED ON THE MASTER AND SURVEY VALVES

OBSERVED MISSING BOLTS AND NUTS ON SURVEY VALVE

OBSERVED MISSING BOLTS AND NUTS ON MASTER VALVE

INITIAL POSITION OF GAS LIFT VALVE REMOVED BY UNKNOWN PERSON(S) (LEAK POINT)

SECTION OF OBIGBO WELL 10T WELL HEAD AT UMUDINOR SHOWING LEAK POINT (MISSING GAS LIFT VALVE REMOVED BY UNKNOWN PERSON(S)).

INITIAL POSITION OF SECOND GAS LIFT VALVE REMOVED BY UNKNOWN PERSON(S) (BLINDED BY SPDC ASSET OWNER AS AT TIME OF JIV).
