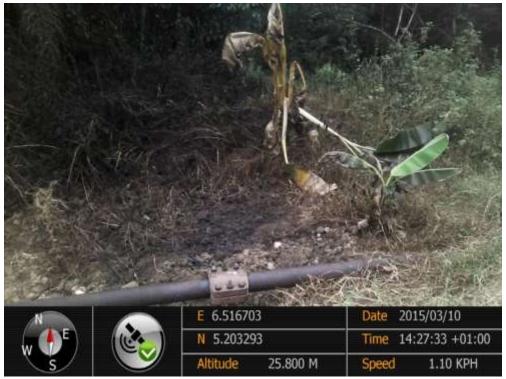
<u>Overview:</u> Part of spill impact on Adibawa Well10S Flowline Right of Way at Edagberi/Betterland. Picture was taken during Joint Investigation of 10<sup>th</sup> March 2015.

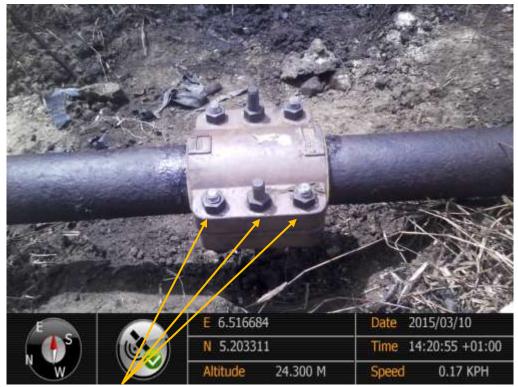
<u>Close-up:</u> Tampered nuts on Adibawa Well10S Flowline at Edagberi/Betterland. Picture was taken during Joint Investigation of 10<sup>th</sup> March 2015.
