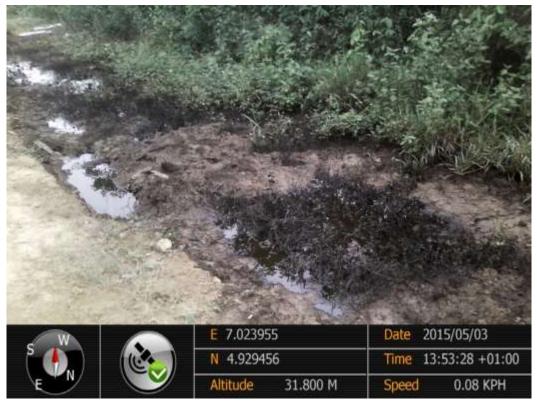
Overview: Part of spill impact on Agbada 2 Well34S Flowline Right of Way at Omuohia. Picture was taken during Joint Investigation of 3<sup>rd</sup> May 2015.

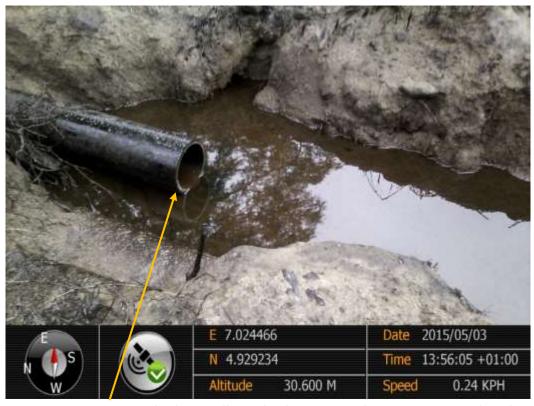
<u>Close-up:</u> Cut section on Agbada 2 Well34S Flowline at Omuohia. Picture was taken during Joint Investigation of 3<sup>rd</sup> May 2015.
