JOINT INVESTIGATION REPORT

INCIDENT NO: 1574386 JIV report S/N: Nº 0000397

1. Spill incident Number: 1574386 2. Type of incident* OIL SPILL
3. Name of Location 6" SEIBOU BULKLINE - 2
4. Name of nearest community AZAGBENE 5. State: BAYELSA 6. LGA EKEREMOR
7. Type of Production facility/Installation FLOWLINE
8. Asset owner/District THE SHELL PETROLEUM DEVELOPMENT COMPANY OF NIGERIA LIMITED / SWAMP WEST

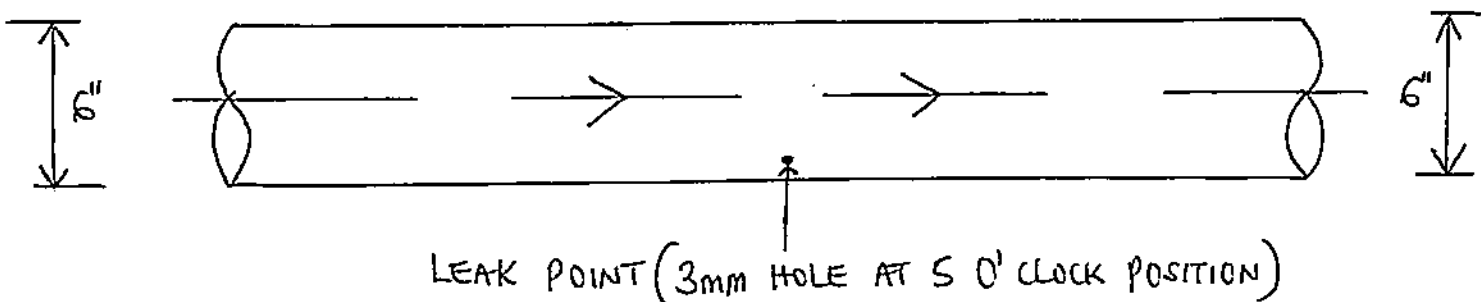
Additional observations around the spill point: INCIDENT CAUSE WAS CONFIRMED AS EQUIPMENT FAILURE BY THE JOINT INVESTIGATION TEAM, BASED ON THE OBSERVATION OF A 3mm HOLE AT 5 O'CLOCK POSITION ON THE 6" SEIBOU BULKLINE - 2 AT AZAGBENE AXIS.

SECTION OF 6" SEIBOU BULKLINE - 2 AT AZAGIBENE AXIS, SHOWING POSITION OF LEAK (3mm HOLE AT 5 O' CLOCK POSITION)

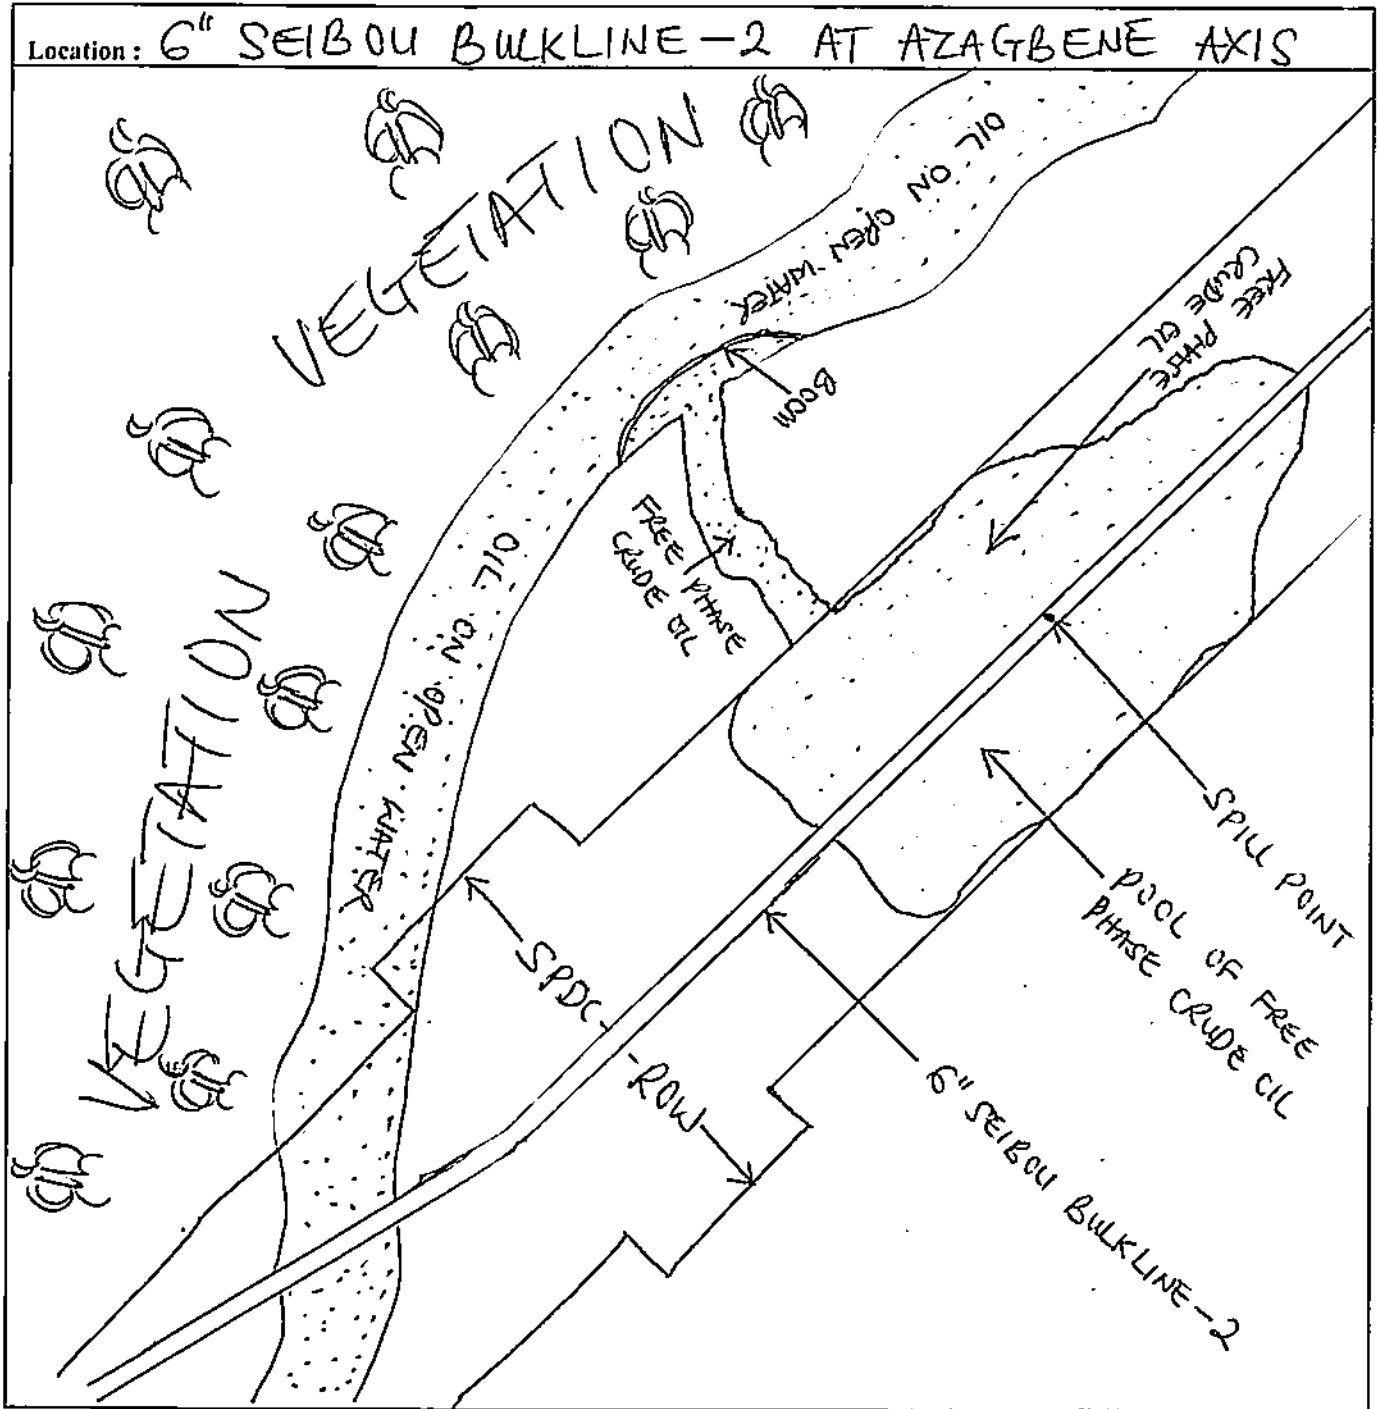
f. Appendix I: Overview sketch of the site

INC.NO:1574386			
	6" SEIBOU BULKLINE-2 @ AZAGBENE			
	WGS 84			
PTS	EASTINGS	NORTHING	REMARKS	
305	5.87637	4.86571	LEAK POINT	
311	5.87559	4.86646	FREE PHASE OIL ON WATER	
310	5.87574	4.86638	FREE PHASE OIL ON WATER	
3090	5.87624	4.865992	FREE PHASE OIL ON WATER	
308	5.876465	4.865785	FREE PHASE OIL ON WATER	
315	5.87676	4.86551	FREE PHASE OIL ON WATER	
314	5.87683	4.86562	FREE PHASE OIL ON WATER	
313	5.876784	4.865489	FREE PHASE OIL ON WATER	
3160	5.876915	4.865356	FREE PHASE OIL ON WATER	
3170	5.877193	4.865092	FREE PHASE OIL ON WATER	
317	5.87707	4.86495	FREE PHASE OIL ON WATER	
316	5.87685	4.86527	FREE PHASE OIL ON WATER	
3120	5.87664	4.865426	FREE PHASE OIL ON WATER	
312	5.8766	4.86548	FREE PHASE OIL ON WATER	
307	5.8764	4.86561	FREE PHASE OIL ON WATER	
306	5.87631	4.86567	FREE PHASE OIL ON WATER	
309	5.87616	4.86594	FREE PHASE OIL ON WATER	
356	5.87083	4.86707	OIL ON WATER	
353	5.87344	4.86593	OIL ON WATER
