<u>Overview:</u> Part of spill and Fire impact on Mininta Well 003L and Well 003S Communication Box at Elele Alimini. Picture was taken during Joint Investigation of 24th June 2016.

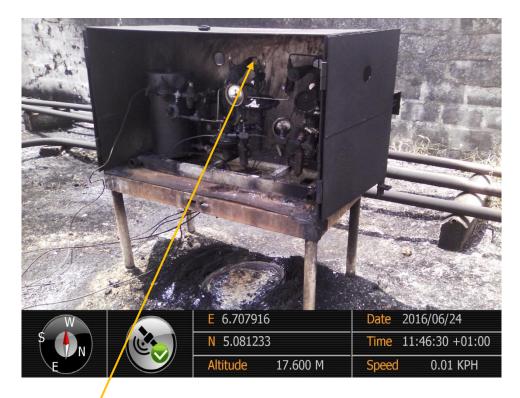
<u>Close-up</u>: Section of cut stainless tube and fire impact on Mininta Well 003L and Well 003S Communication Box at Elele Alimini. Picture was taken during Joint Investigation of 24th June 2016.
