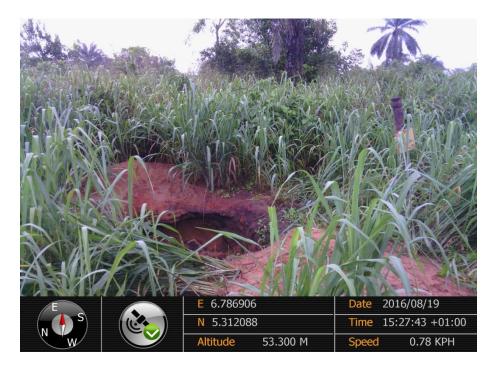
<u>Overview:</u> Part of spill impact on 18" Assa-Rumuekpe Pipeline at Ochia. Picture was taken during Joint Investigation of 19<sup>th</sup> August 2016.

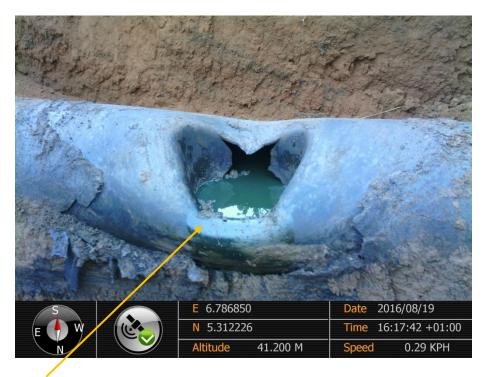
<u>Close-up:</u> Tear/inward dent on 18" Assa-Rumuekpe Pipeline at Ochia. Picture was taken during Joint Investigation of 19<sup>th</sup> August 2016.
