# JOINT INVESTIGATION REPORT

INCIDENT NO: 1834766 JIV report S/N: Nº 0000266

1. Spill incident Number: 1834766 2. Type of incident\* OIL SPILL  
3. Name of Location 12" IMO RIVER 2 - OGALE PIPELINE  
4. Name of nearest community OWAZA 5. State: ABIA 6. LGA UKWA - WEST  
7. Type of Production facility/Installation OIL PIPELINE  
8. Asset owner/District THE SHELL PETROLEUM DEVELOPMENT COMPANY OF NIGERIA LIMITED / PIPELINE

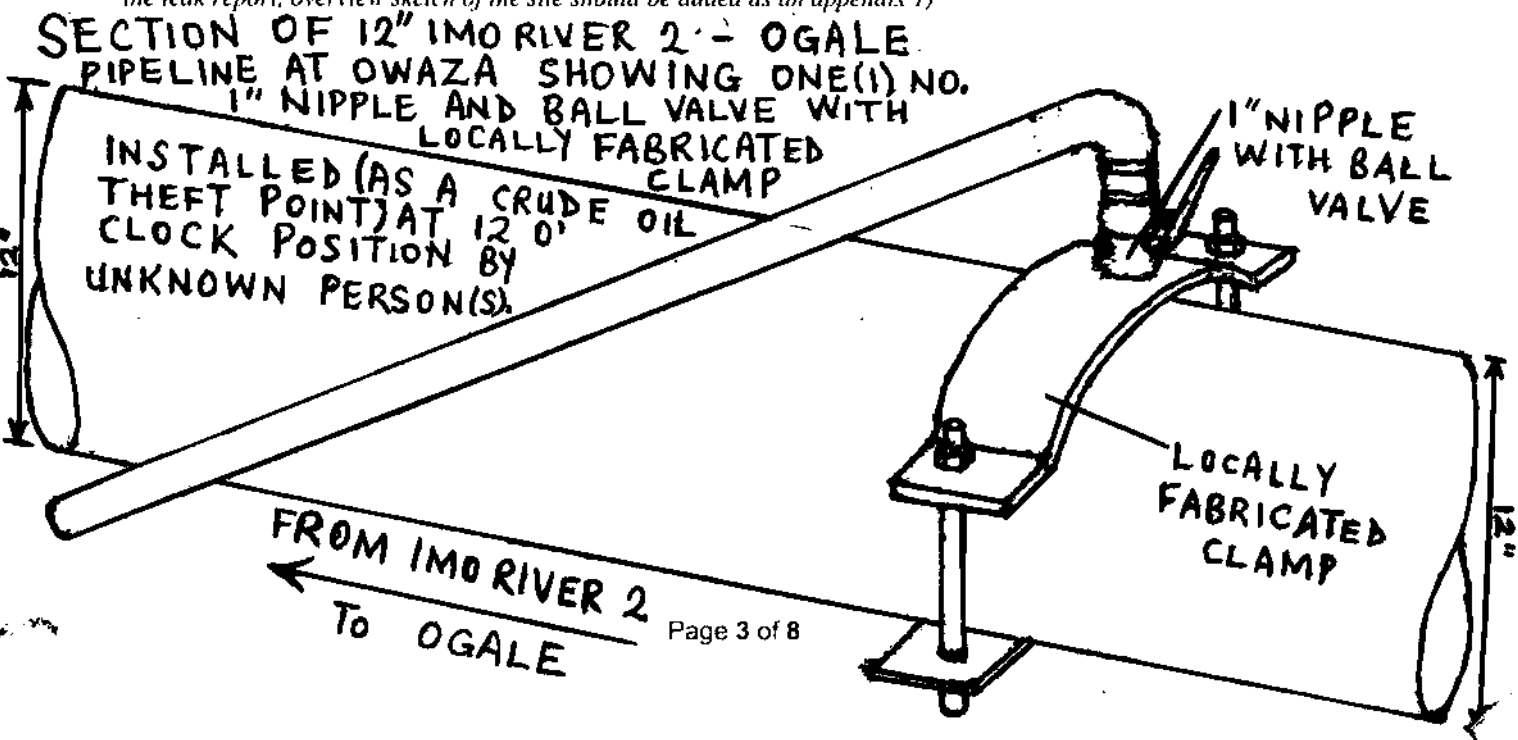
**E. GRAPHIC DESCRIPTION OF LEAK POINT** (while detail report of the leak point should be contained in the leak report, overview sketch of the site should be added as an appendix 1)

Additional observations around the spill point: THE SPILL POINT WAS OBSERVED WITHIN THE VICINITY OF A TARRER ACCESS ROAD.

| <input checked="" type="checkbox"/> Crude oil theft (illegal bunkering) point, | <input type="checkbox"/> Saver-pit over flow | <input type="checkbox"/> Third party tampering with Clamp |

RECOVERY OF FREE-PHASE OIL WAS DONE AND REPAIR WAS CARRIED OUT ON THE AFFECTED PIPELINE SECTION BY CLAMPING.

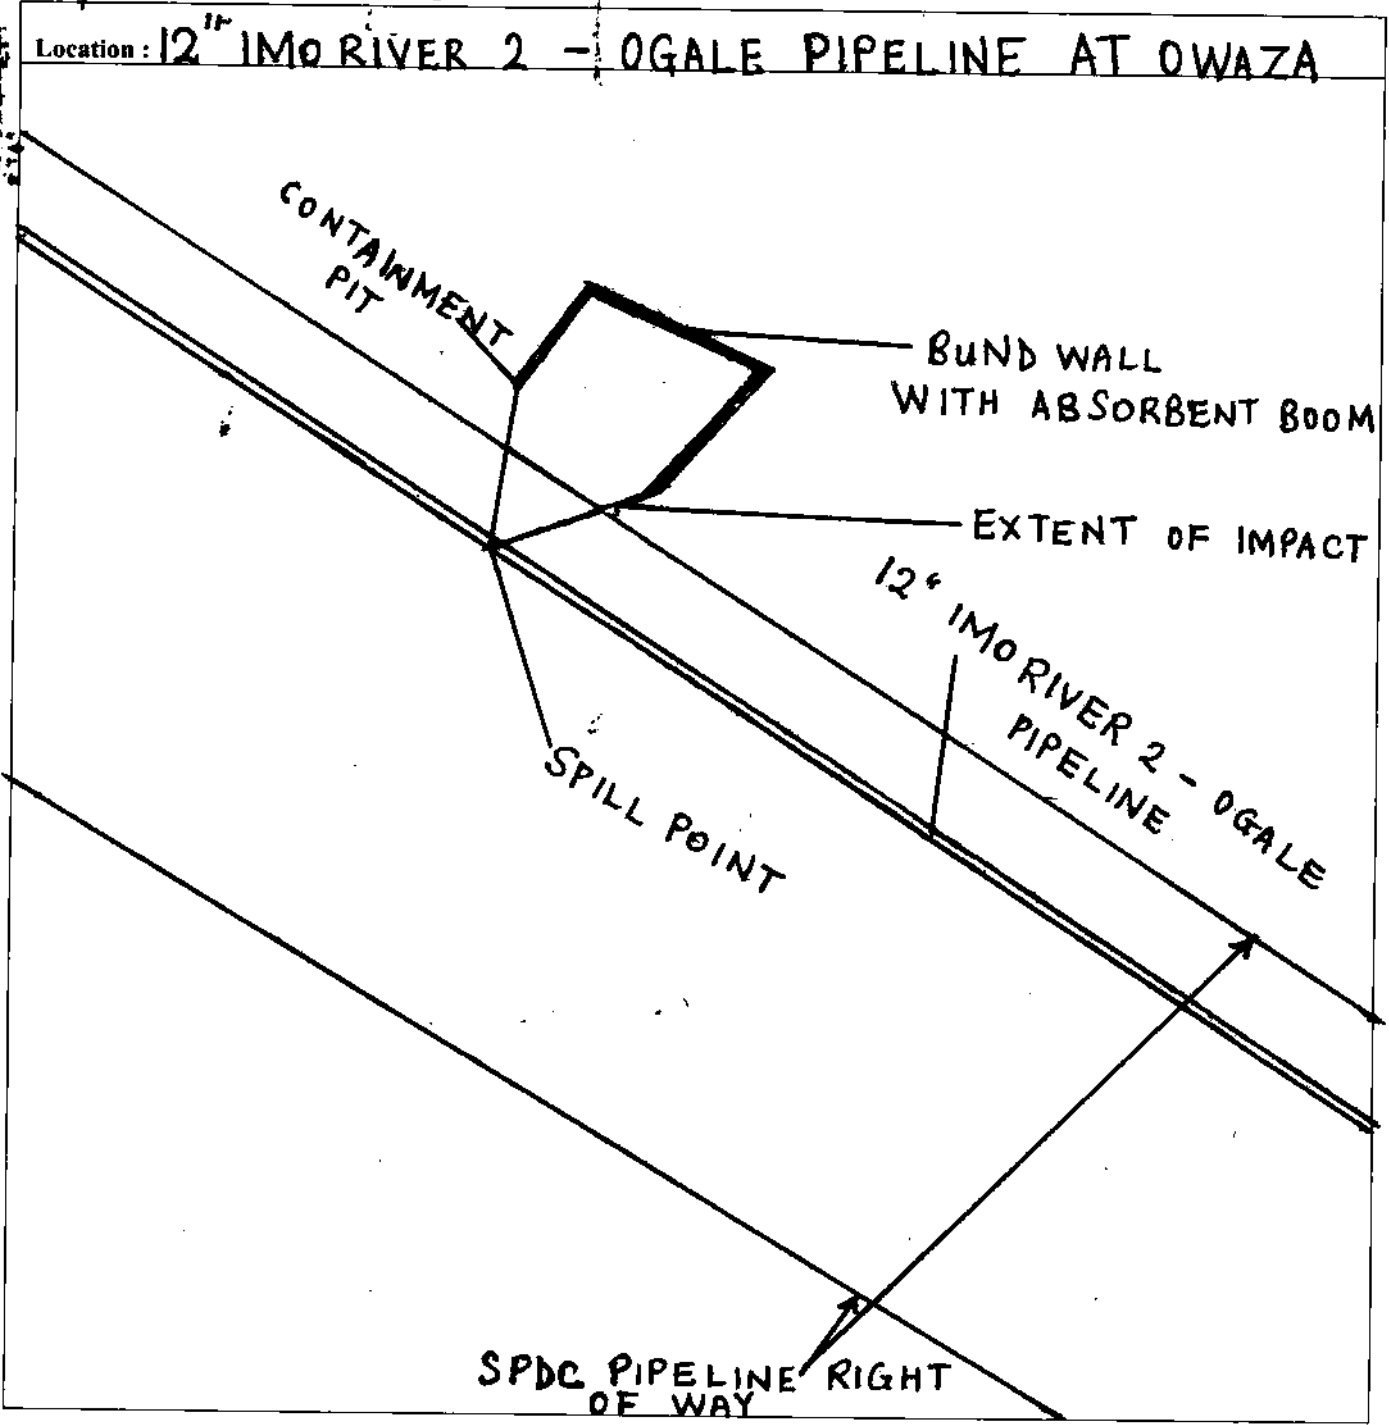
f. Appendix 1: Overview sketch of the site

- Total calculated area of impact 0.0076HA
- Impact within R.O.W YES
- Impact outside R.O.W YES
