# JOINT INVESTIGATION REPORT

INCIDENT NO: 1833450 JIV report S/N: Nº 0000313

1. Spill incident Number: 1833450 2. Type of incident\* OIL SPILL  
3. Name of Location 20" OTUMARA - ESCRAVOS PIPELINE  
4. Name of nearest community UGBOEGUNGUN 5. State: DELTA 6. LGA WARRI SOUTH-WEST  
7. Type of Production facility/Installation OIL PIPELINE  
8. Asset owner/District THE SHELL PETROLEUM DEVELOPMENT COMPANY OF

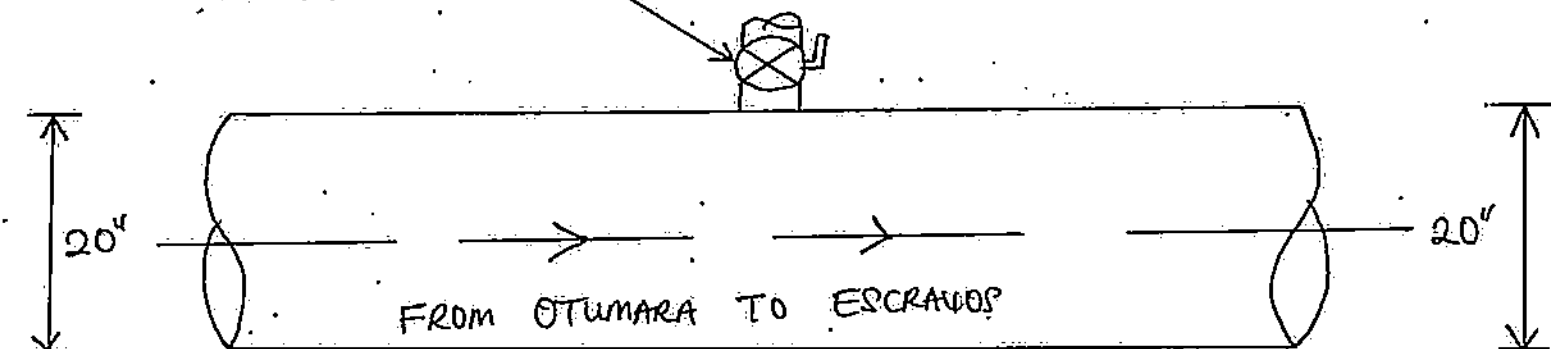
ON EXCAVATION, THE JOINT INVESTIGATION TEAM OBSERVED A 3" FAILED VALVE ILLEGALLY ATTACHED TO THE 20" OTUMARA - ESCRAVOS PIPELINE AT 12 O'CLOCK POSITION.

SECTION OF 20" OTUMARA - ESCRAVOS PIPELINE AT UGBOERUNGUN SHOWING 3" FAILED VALVE ILLEGALLY ATTACHED AT 12 O' CLOCK POSITION

3" FAILED VALVE ILLEGALLY ATTACHED AT 12 O' CLOCK POSITION
