JOINT INVESTIGATION REPORT

INCIDENT NO: 1844467 JIV report S/N:

1. Spill incident Number: 1844467 2. Type of incident* OIL SPILL
3. Name of Location: 4" OTUMARA WELL - 29 L/S FLOWLINES
4. Name of nearest community UGBOEGUNGUN State: DELTA 6. LG WARRI SOUTH-WEST
7. Type of Production facility/Installation FLOWLINES
8. Asset owner/District THE SHELL PETROLEUM DEVELOPMENT COMPANY OF

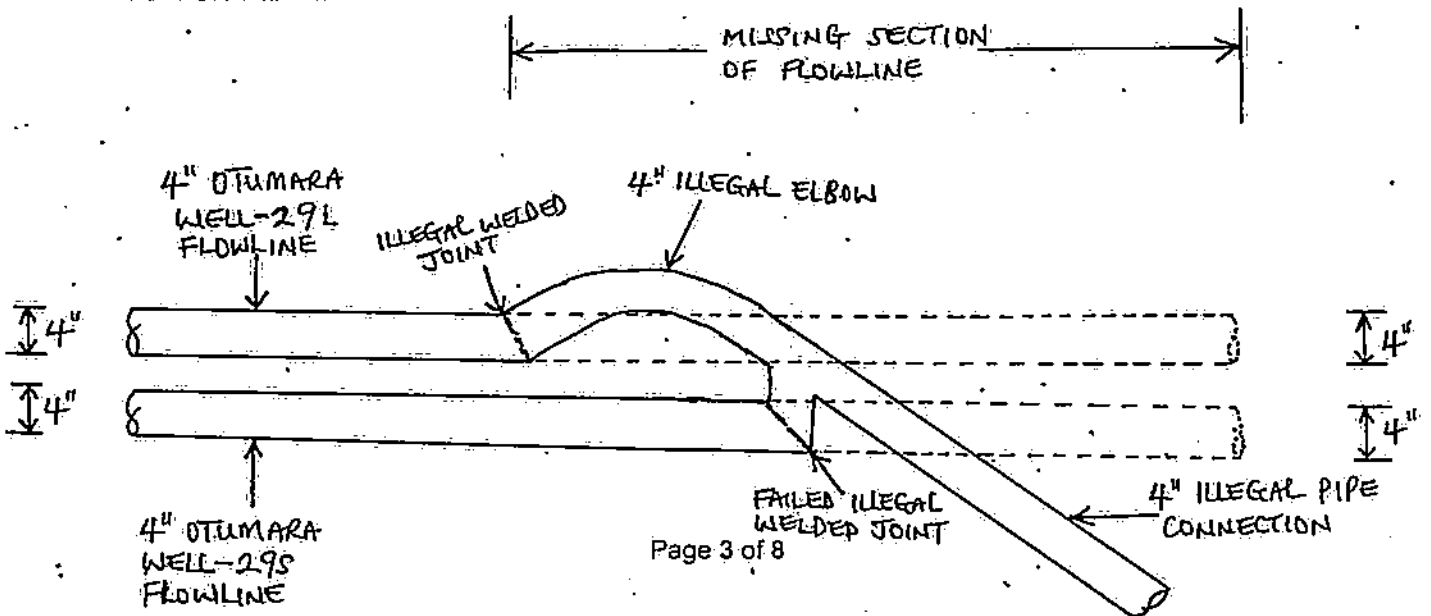
Additional observations around the spill point: ON EXCAVATION THE JOINT INVESTIGATION TEAM OBSERVED MISSING LENGTHS OF 4" OTUMARA WELL - 29 L/S FLOWLINES REMOVED BY UNKNOWN PERSONS, WITH A 4" ILLEGAL ELBOW AND PIPE CONNECTION AT ONE OF THE TWO CUT ENDS OF BOTH FLOWLINES (L & S), FOR CRUDE OIL BUNKERING ACTIVITIES.

SECTION OF 4" OTUMARA WELL - 29L/S FLOWLINES AT UGBOEGUNGUN AXIS SHOWING POSITIONS OF MISSING FLOWLINES AND 4" ILLEGAL PIPE CONNECTION
