# JOINT INVESTIGATION REPORT

INCIDENT NO: 1844460 JIV report S/N: No: 0000311

1. Spill incident Number: 1844460 2. Type of incident\* OIL SPILL  
3. Name of Location BENISEDE WELL - 16T WELLHEAD  
4. Name of nearest community OJOBO 5. State: BAYELSA 6. LGA EKEREMOR  
7. Type of Production facility/Installation WELLHEAD  
8. Asset owner/District THE SHELL PETROLEUM DEVELOPMENT COMPANY OF

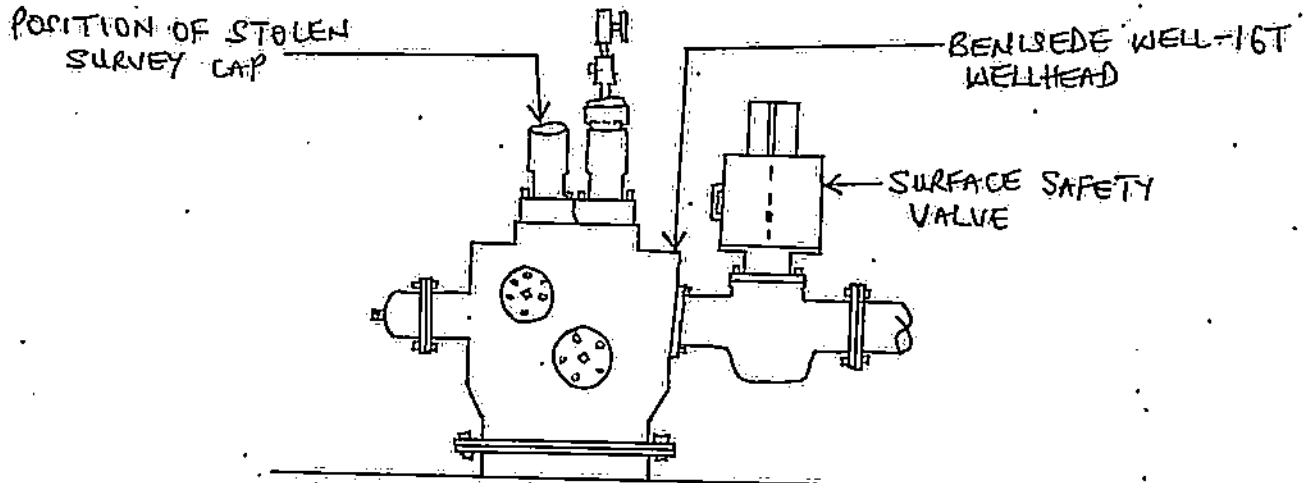
Additional observations around the spill point: ON ASSESSMENT, THE JOINT INVESTIGATION TEAM OBSERVED THAT THE SURVEY CAP ON THE NON-FLOWING STRING OF BENISEDE WELL - 16T WELLHEAD HAS BEEN REMOVED BY UNKNOWN PERSONS.

| <input checked="" type="checkbox"/> Others (specify) <u>THEFT OF WELLHEAD SURVEY CAP</u> | | |

SECTION OF BENISEDE WELL - 1ST WELLHEAD AT OJOBO AXIS. SHOWING POSITION OF STOLEN SURVEY CAP
