# JOINT INVESTIGATION REPORT

INCIDENT NO: 1873270 JIV report S/N: Nº 000294

1. Spill incident Number: 1873270 2. Type of incident\* OIL SPILL  
3. Name of Location 8" ETELEBON - KOLOCREEK PIPELINE  
4. Name of nearest community OPOLO 5. State: BAYELSA 6. LGA TENAGOA  
7. Type of Production facility/Installation OIL PIPELINE  
8. Asset owner/District SPDC / PIPELINE

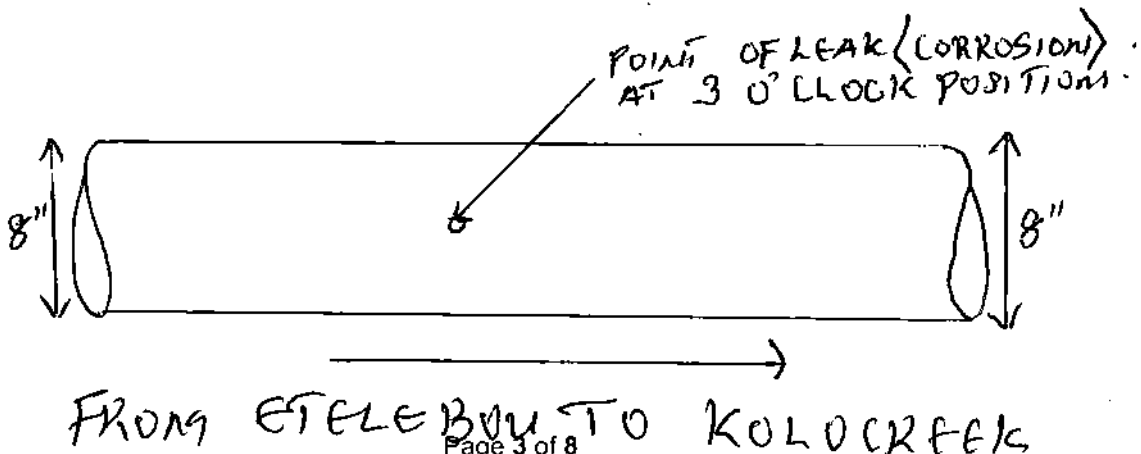
Additional observations around the spill point:  
ON ARRIVAL OF JOINT INVESTIGATION TEAM, THE SPILL SITE WAS FLOODED WITH CRUDE OIL IMPACT SEEN ON WATER.

| <input checked="" type="checkbox"/> Others(specify) <u>CORROSION (PIN HOLE)</u> | | |

SECTION OF 8" ETELEBON - KOLOCREEK PIPELINE AT OPOLO SHOWING POINT OF CORROSION/ LEAK POSITION

REPAIR WORK WAS DONE BY CLAMPING.
