JOINT INVESTIGATION REPORT

INCIDENT NO: 1881413 JIV report S/N: Nº 0000299

1. Spill incident Number: 1881413 2. Type of incident* OIL SPILL
3. Name of Location 12" IMO RIVERZ- OGAE PIPELINE
4. Name of nearest community IGIRIKWU ONAZA 5. State: ABIA 6. LGA UKWA-WEST
7. Type of Production facility/Installation OIL PIPELINE
8. Asset owner/District SPDC / PIPELINE

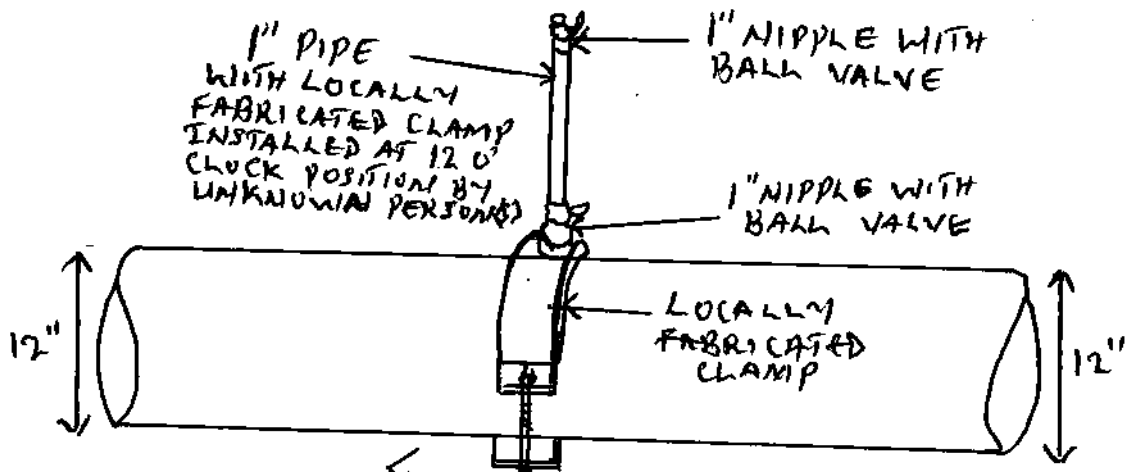
THE SPILL POINT WAS OBSERVED WITHIN THE VICINITY OF A TARRED ROAD. SAND BAGS WERE ALSO OBSERVED.

SECTION OF 12" IMO RIVER 2 - OGALE PIPELINE AT IGIRIUKWU DWAZA SHOWING CRUDE OIL THEFT POINT AT 12 O'CLOCK POSITION.

OIL SPILL RECOVERY AND REPAIR ACTIVITIES ARE
ON GOING.

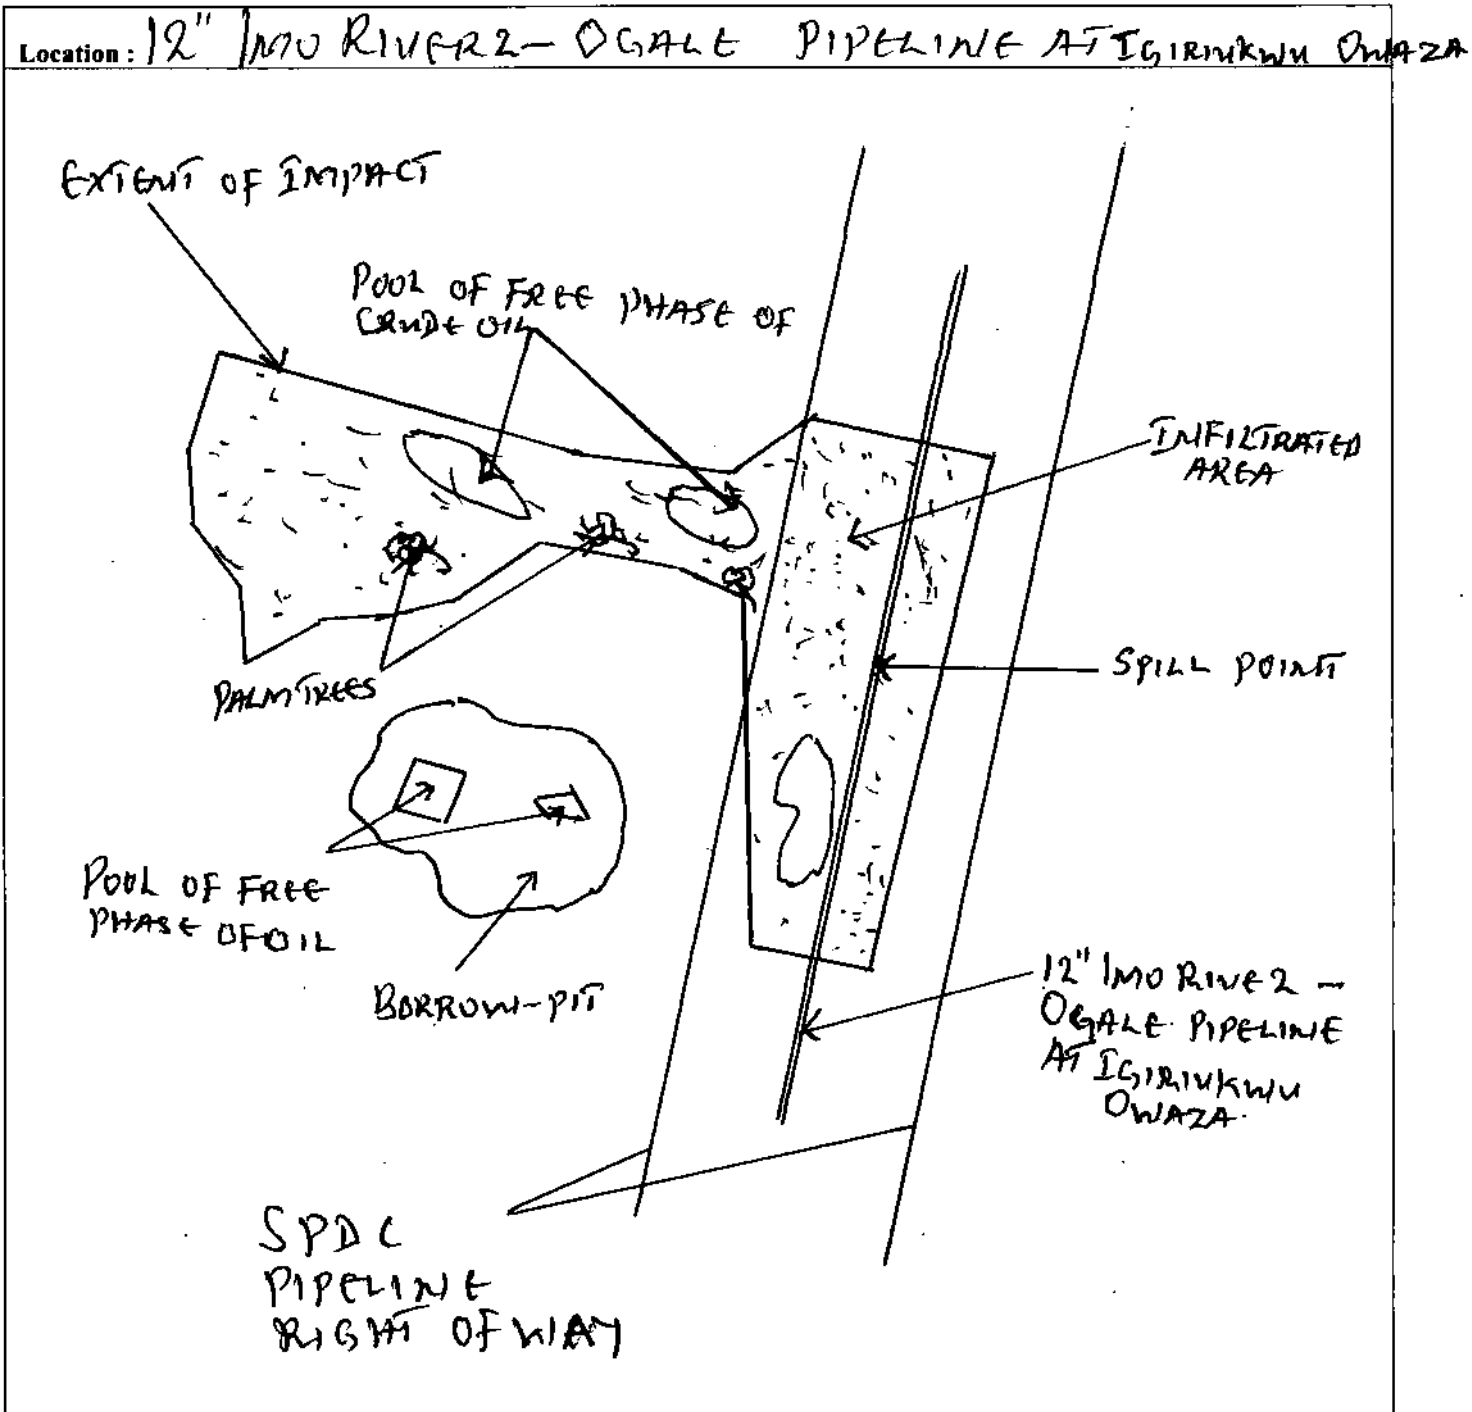
f. Appendix 1: Overview sketch of the site

- Total calculated area of impact 0.09Ha
- Impact within R.O.W YES
- Impact outside R.O.W YES
