JOINT INVESTIGATION REPORT

INCIDENT NO: 1872249 JIV report S/N: NO 0000318

1. Spill incident Number: 1872249 2. Type of incident* OIL SPILL
3. Name of Location 20" OTUMARA - ESCRAVOS PIPELINE
4. Name of nearest community UGBDEGUNGUN 5. State: DELTA 6. LGA WARRI SOUTH-WEST
7. Type of Production facility/Installation: OIL PIPELINE
8. Asset owner/District THE SHELL PETROLEUM DEVELOPMENT COMPANY OF

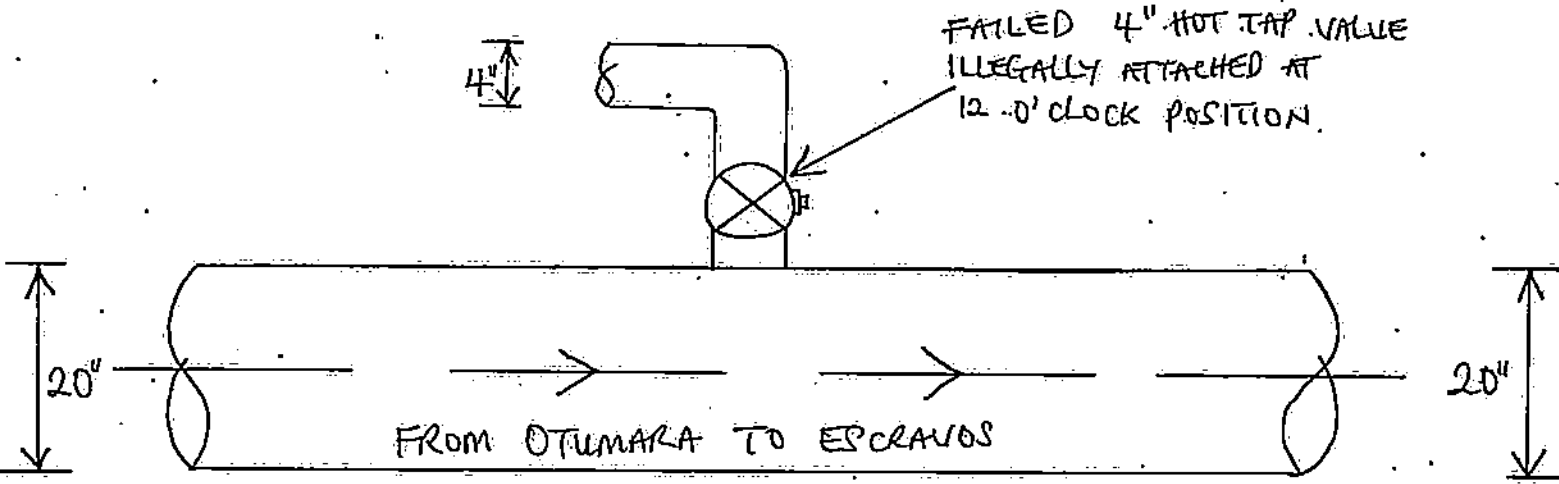
E. GRAPHIC DESCRIPTION OF LEAK POINT (while detail report of the leak point should be contained in the leak report, overview sketch of the site should be added as an appendix 1)

Additional observations around the spill point: ON EXCAVATION, THE JOINT INVESTIGATION TEAM OBSERVED A FAILED 4" HOT TAP VALVE, ILLEGALLY ATTACHED TO THE 20" OTUMARA - ESCRAVOS PIPELINE AT 12 O' CLOCK POSITION. THE LEAK WAS OBSERVED TO HAVE STOPPED AT THE TIME OF JIV.

SECTION OF 20" OTUMARA - ESCRAVOS PIPELINE AT UGBODEGUNGUN SHOWING; A FAILED 4" HOT TAP VALVE ATTACHED AT 12 O'CLOCK POSITION.
