JOINT INVESTIGATION REPORT

INCIDENT NO: 1876963 JIV report S/N: No: 0000322

1. Spill incident Number: 1876963 2. Type of incident* OIL SPILL
3. Name of Location 20" OTUMARA - ESCRAVOS PIPELINE
4. Name of nearest community UGBOEGUNGUN State: DELTA 6. LGA WARRI SOUTH-WEST
7. Type of Production facility/Installation OIL PIPELINE
8. Asset owner/District THE SHELL PETROLEUM DEVELOPMENT COMPANY OF NIGERIA LIMITED / PIPELINES

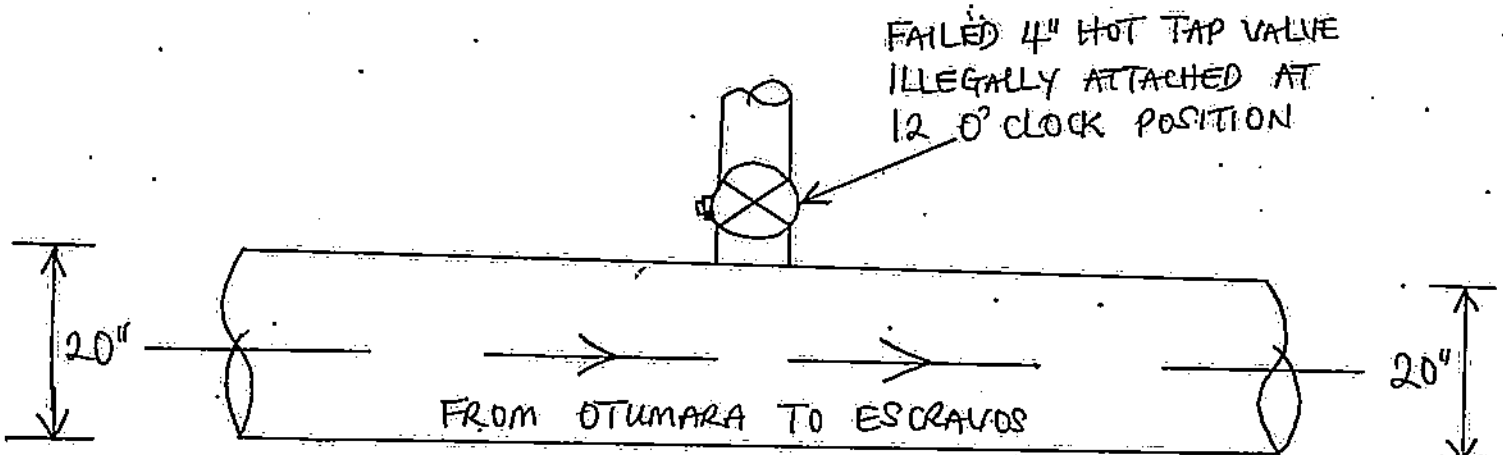
ON EXCAVATION, THE JOINT INVESTIGATION TEAM OBSERVED A FAILED 4" HOT TAP VALVE, ILLEGALLY ATTACHED TO THE 20" OTUMARA-ESCAVOS PIPELINE AT 12 O' CLOCK POSITION.

SECTION OF 20" OTUMARA-ESCRAVOS PIPELINE AT UGBOEGUNGUN SHOWING; FAILED 4" HOT TAP VALVE AT 12 O' CLOCK POSITION
