JOINT INVESTIGATION REPORT

INCIDENT NO: 1871090 JIV report S/N: Nº 0000335

1. Spill incident Number: 1871090 2. Type of incident* OIL SPILL
3. Name of Location 20" KOLOCREEK - RUMUEKPE PIPELINE
4. Name of nearest community ODAU 5. State: RIVERS 6. LGA ABUA/ODUA
7. Type of Production facility/Installation OIL PIPELINE
8. Asset owner/District THE SHELL PETROLEUM DEVELOPMENT COMPANY OF NIGERIA LTD
/ PIPELINE

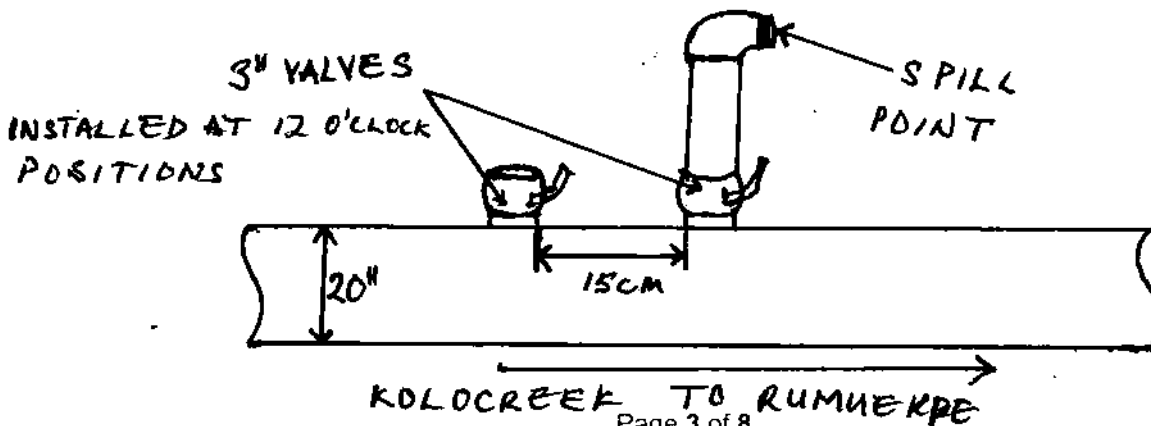
Additional observations around the spill point: THE JOINT INVESTIGATION TEAM SAW 2 NOS 3" VALVES INSTALLED 15CM APART AT 12 O'CLOCK POSITIONS.

| <input checked="" type="checkbox"/> Crude oil theft (illegal bunkering) point, | <input type="checkbox"/> Saver-pit over flow | <input type="checkbox"/> Third party tampering with Clamp |

A SECTION OF 20" KOLOCREEK - RUMUEKPE PIPELINE AT ODAU SHOWING 2x 3" VALVE CRUDE THEFT POINT INSTALLED 15CM APART AT 12 O'CLOCK POSITIONS BY UNKNOWN PERSONS.

TEMPORARY REPAIR BY SCREW PLUGGING
