JOINT INVESTIGATION REPORT

INCIDENT NO: 1864496 JIV report S/N: Nº 0000287

1. Spill incident Number: 1864496 2. Type of incident* OIL SPILL
3. Name of Location 12" IMDRIVER - OSALE PIPELINE
4. Name of nearest community OKOHIA - ASA AIZUAKU 5. State: ABIA 6. LGA UKWA WEST
7. Type of Production facility/Installation OIL PIPELINE
8. Asset owner/District THE SHELL PETROLEUM DEVELOPMENT COMPANY OF NIGERIA LTD
(SPDC)

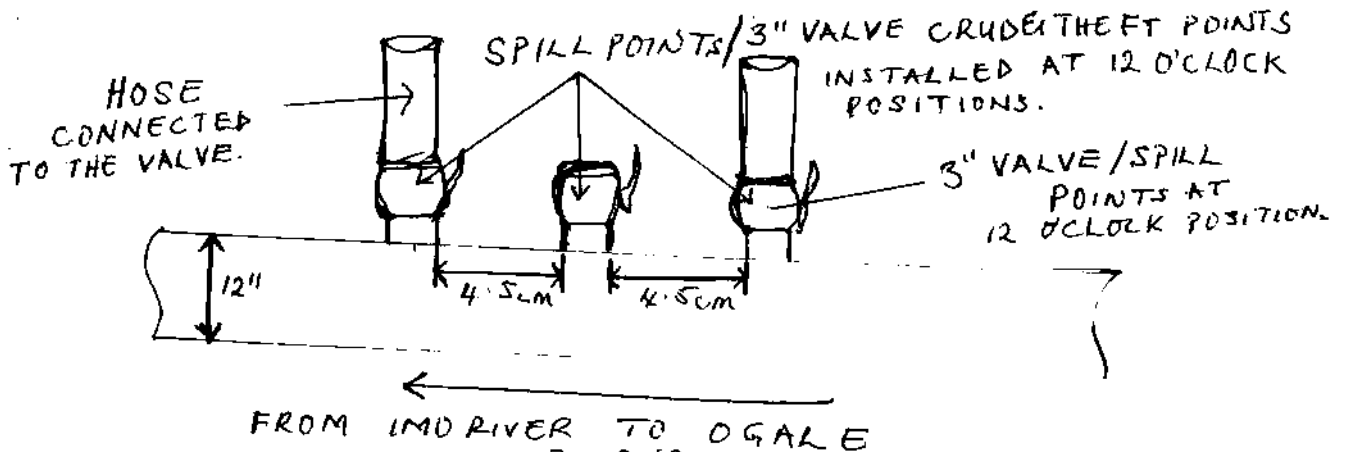
Additional observations around the spill point: THE JOINT INVESTIGATION TEAM SAW CRUDE OIL THEFT POINTS CONNECTED TO THE PIPELINE AT 12 O'CLOCK POSITIONS

| <input checked="" type="checkbox"/> Crude oil theft (illegal bunkering) point, | <input type="checkbox"/> Saver-pit over flow | <input type="checkbox"/> Third party tampering with Clamp |

the leak report, overview sketch of the site should be added as an appendix 1) A SECTION OF 12" (MDRIVER - OGALE PIPELINE AT OKOHIA-ASA SHOWING 3 (NO) 3" CRUDE THEFT POINT VALVES INSTALLED AT 12 O'CLOCK POSITIONS BY UNKNOWN PERSONS.

REPAIR BY CLAMPING
