# JOINT INVESTIGATION REPORT

INCIDENT NO: 1816063 JIV report S/N: Nº 0000254

1. Spill incident Number: 1816063 2. Type of incident\* OIL SPILL  
3. Name of Location 12" IMO RIVER - OGALE PIPELINE  
4. Name of nearest community KOM-KOM 5. State: RIVERS 6. LGA OYIGBO  
7. Type of Production facility/Installation OIL PIPELINE  
8. Asset owner/District THE SHELL PETROLEUM DEVELOPMENT COMPANY OF NIGERIA LIMITED / PIPELINE

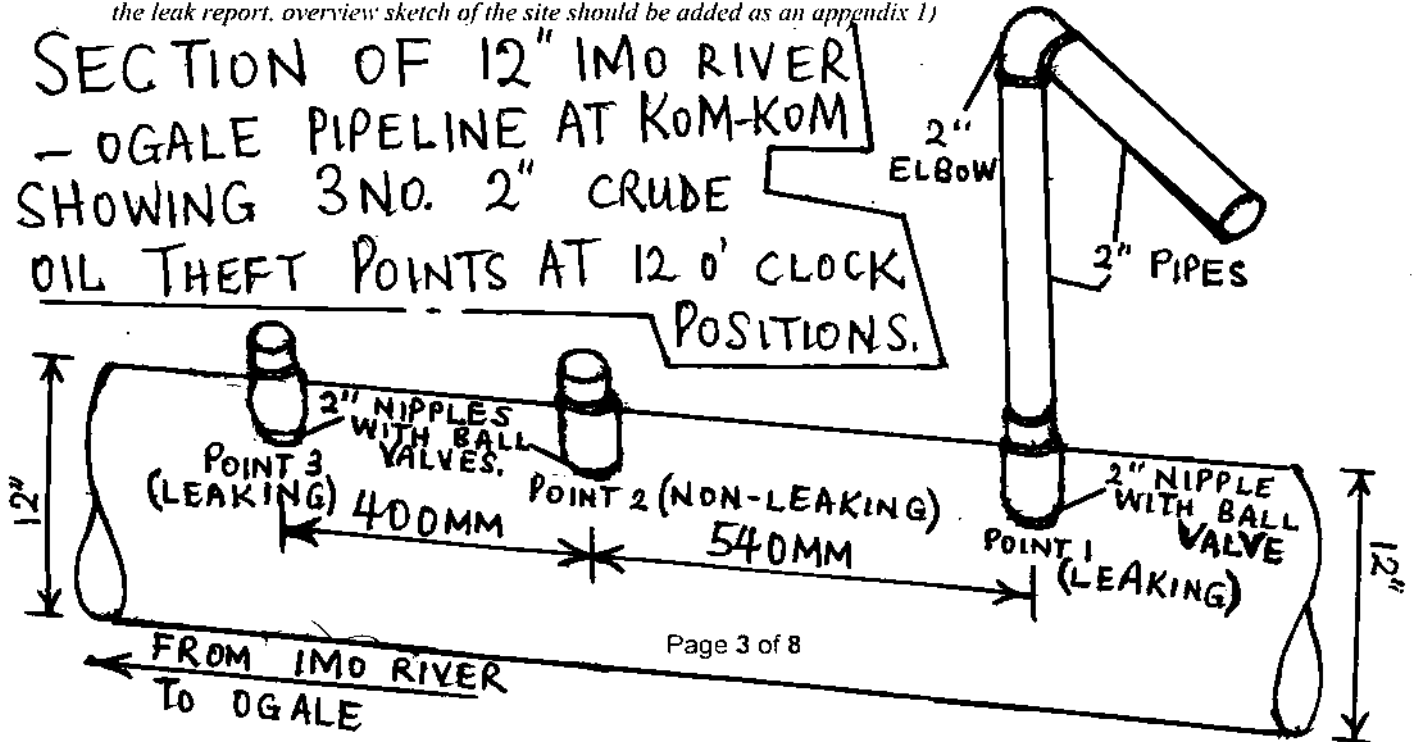
Additional observations around the spill point: A SECTION OF THE PIPELINE POLYKENE TAPE COATING (SURROUNDING THE OBSERVED CRUDE OIL THEFT POINTS) WAS OBSERVED TO HAVE BEEN REMOVED BY UNKNOWN PERSON(S).

| <input checked="" type="checkbox"/> Crude oil theft (illegal bunkering) point, | <input type="checkbox"/> Saver-pit over flow | <input type="checkbox"/> Third party tampering with Clamp |

SECTION OF 12" IMO RIVER  
- OGALE PIPELINE AT KOM-KOM  
SHOWING 3 NO. 2" CRUDE  
OIL THEFT POINTS AT 12 O' CLOCK  
POSITIONS.

**RECOVERY OF FREE-PHASE OIL WAS DONE AND REPAIR WAS CARRIED OUT ON THE AFFECTED PIPELINE SECTION BY CLAMPING**
