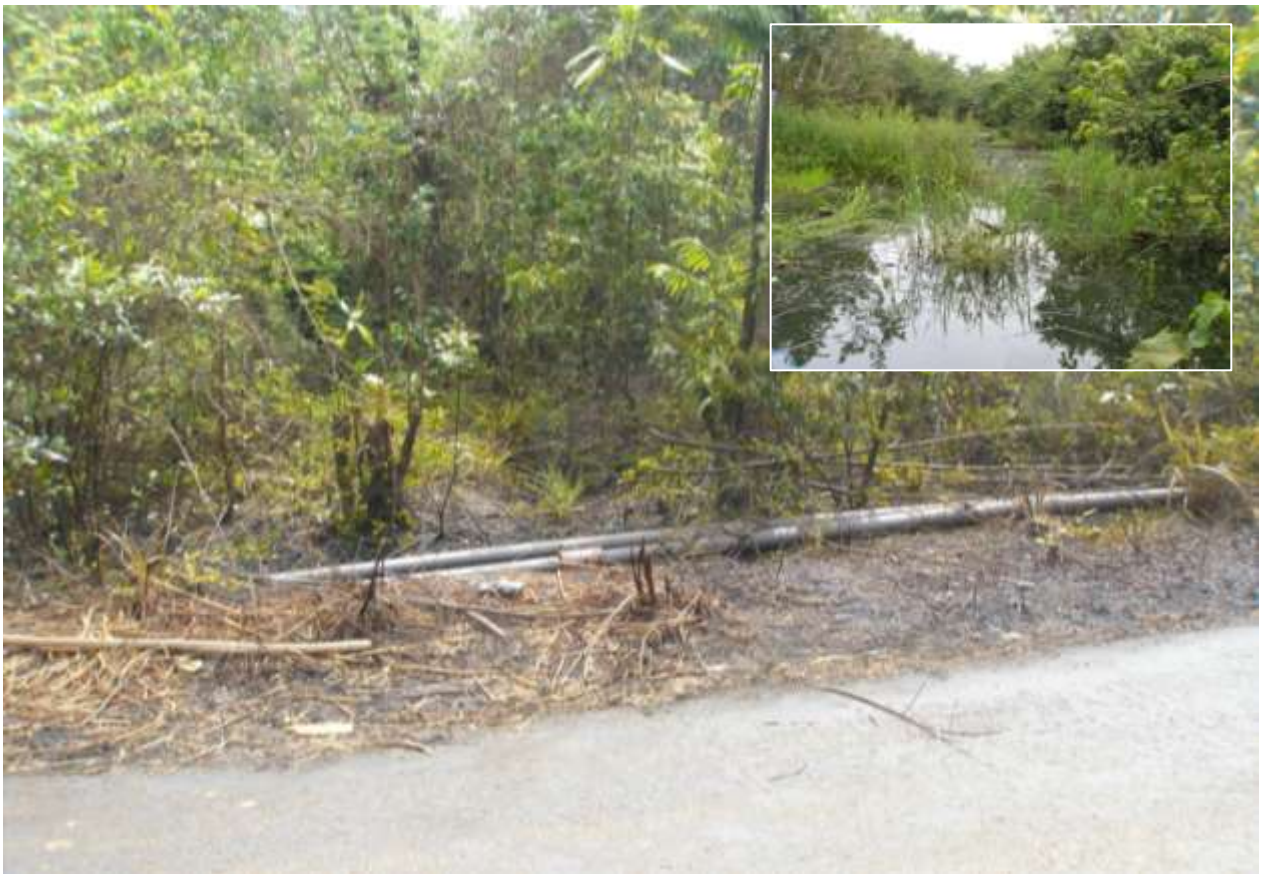
Overview: Extent of the spill incident impact on Adibawa North-East Well 4L pipeline route at Biseni. Insert shows pit with large volume of oil, 12m from spill point.

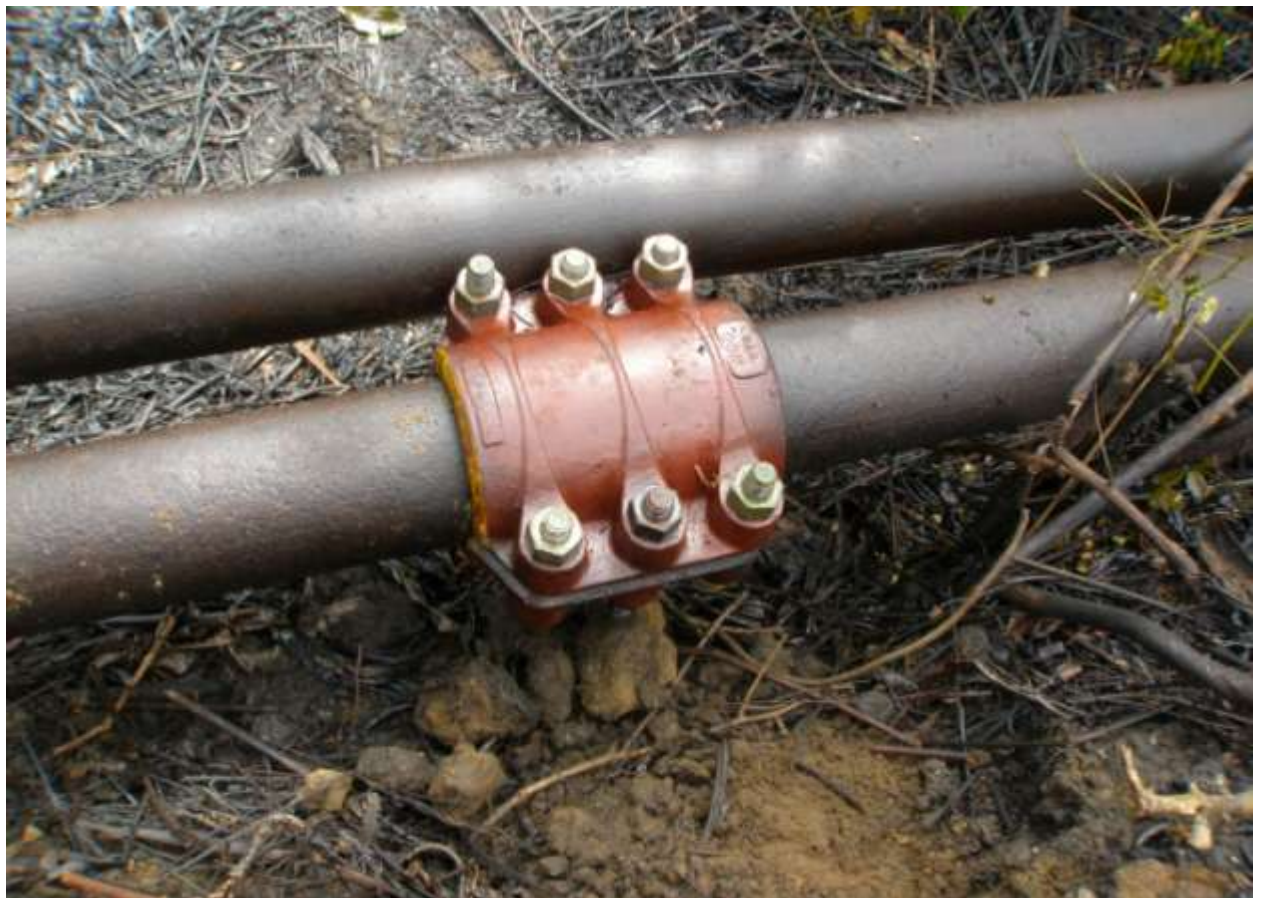
Close-up: Spill due to tampering with clamp nuts and bolts on Adibawa North-East Well 4L pipeline route at Biseni. Pictures taken during JIV of 11th April, 2011.
