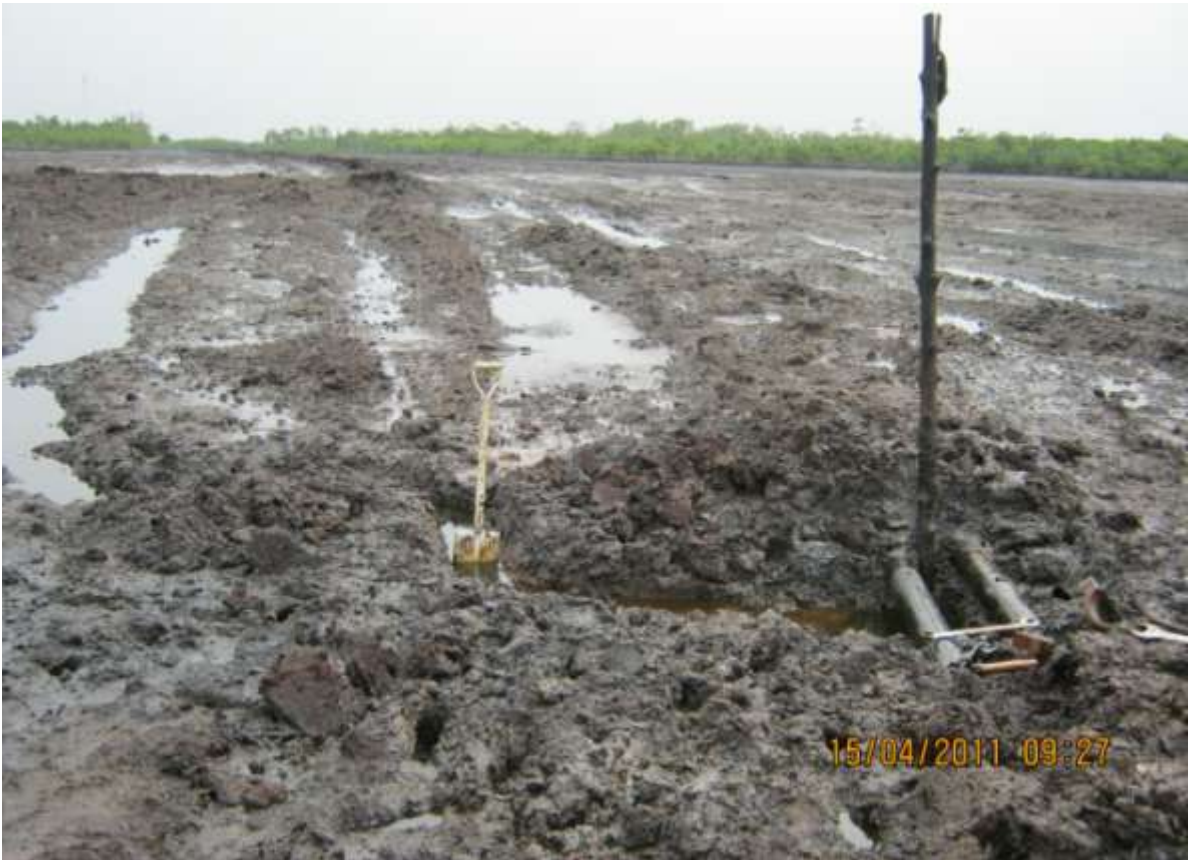
Overview: Spill incident site at low tide at Akaso Well 3L Flowline route. Picture was taken during JIV of 15th April, 2011

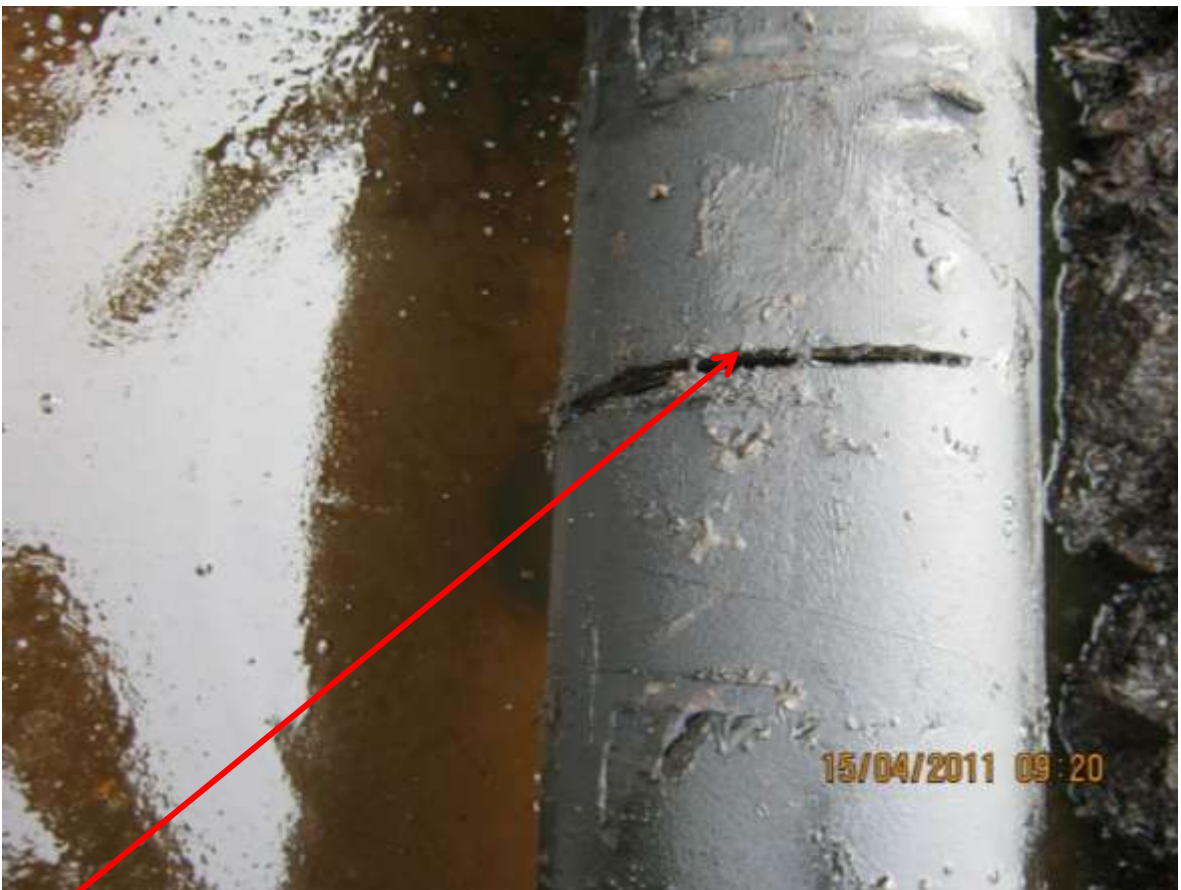
Close-up: Hacksaw cut on Akaso Well 3L Flowline route in Akaso. Picture was taken during JIV of 15th April, 2011
