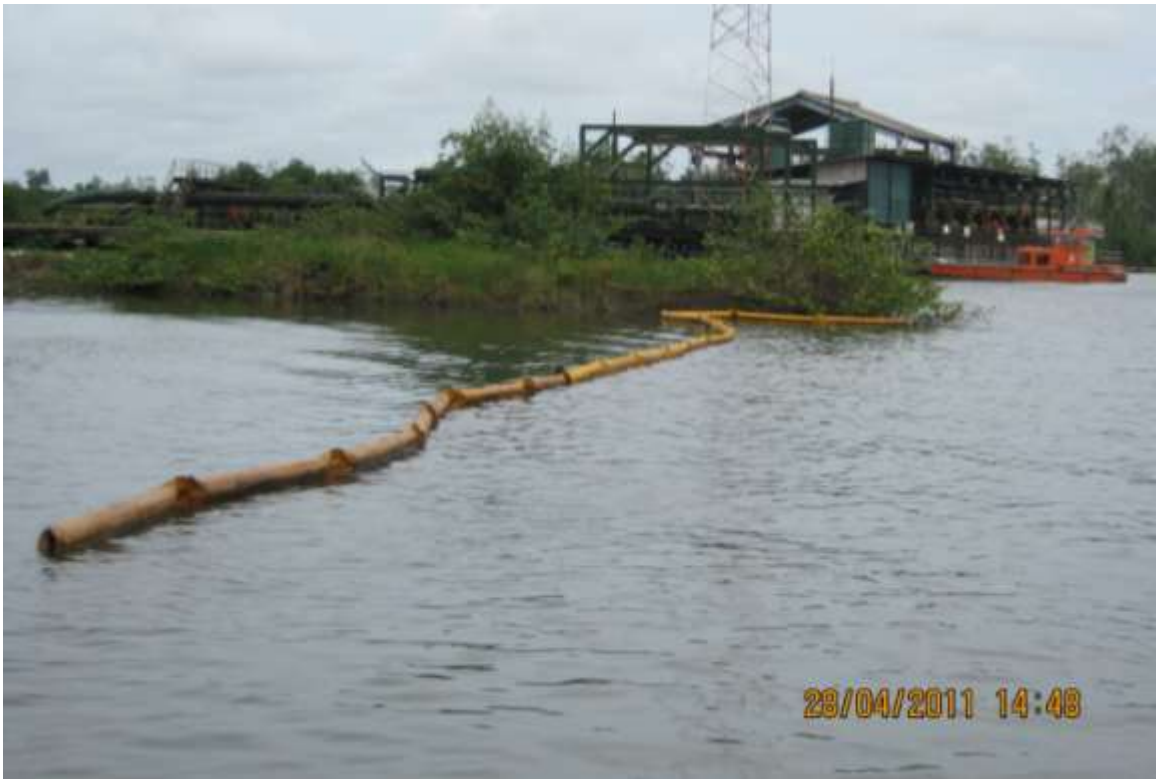
Overview: Partially removed Oil Boom placed around work area as a precautionary measure during replacement of the failed valve at Nembe creek 2 flow station.

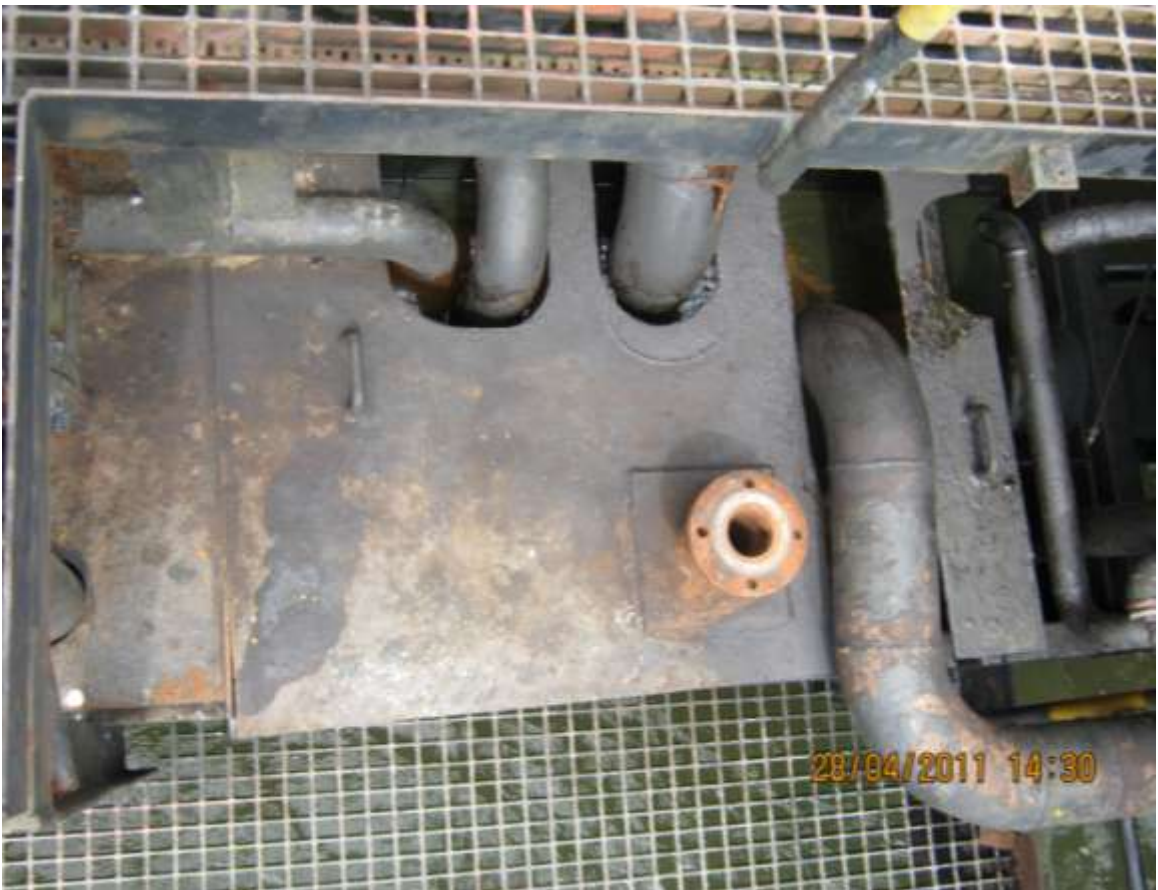
Close-up: Saver-pit source of over flow at Nembe creek 2 flow station in Nembe . Picture was taken during JIV of 28<sup>th</sup> April, 2011

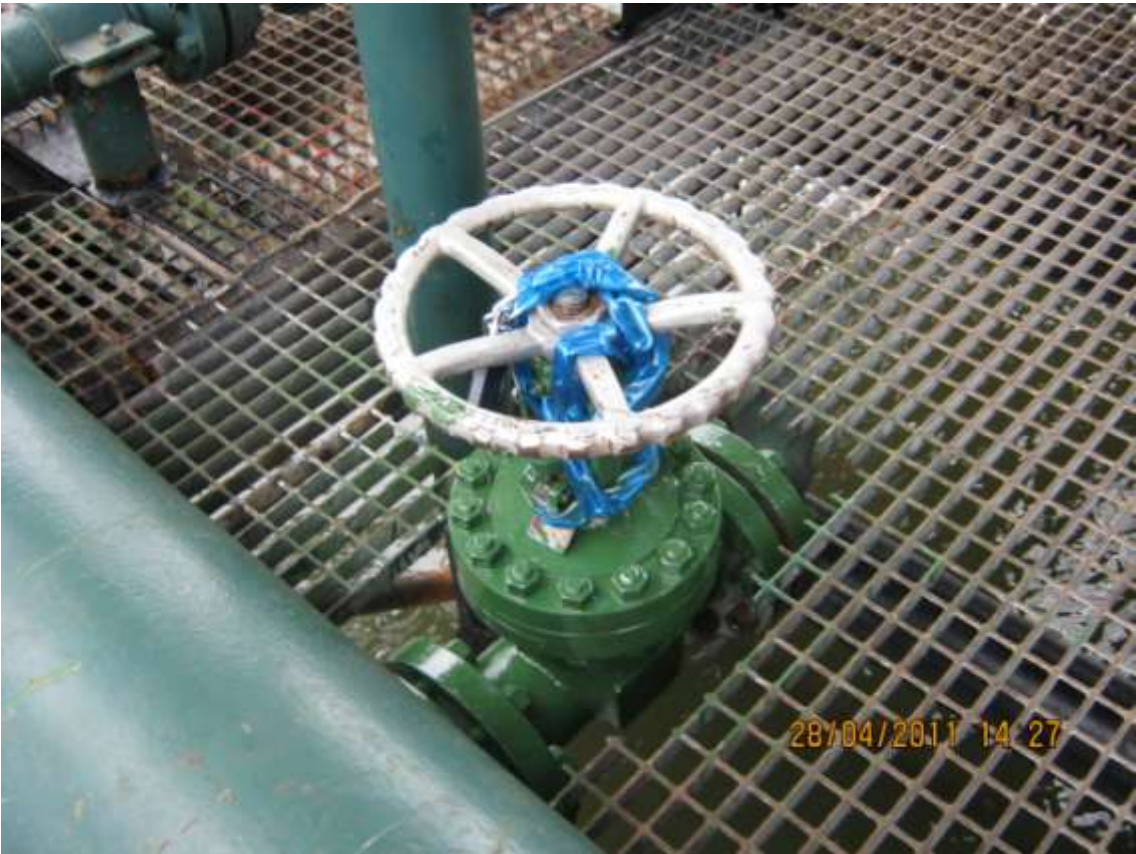
Overview: New valve replacing failed valve at Nembe creek 2 flow station. Picture was taken during JIV of 28<sup>th</sup> April, 2011
