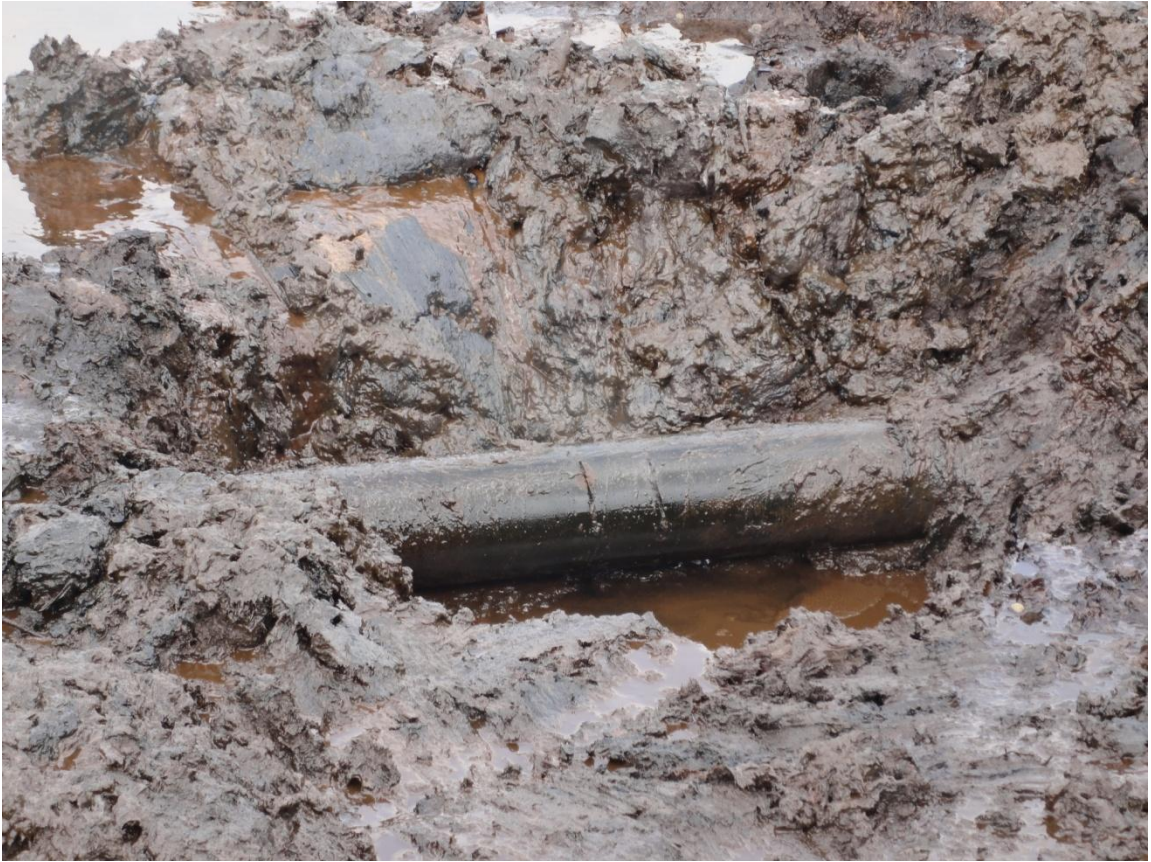
Overview: Hacksaw cuts visible on Well 13L flowline at Akaso. Picture was taken during JIV of 4<sup>th</sup> May, 2011
