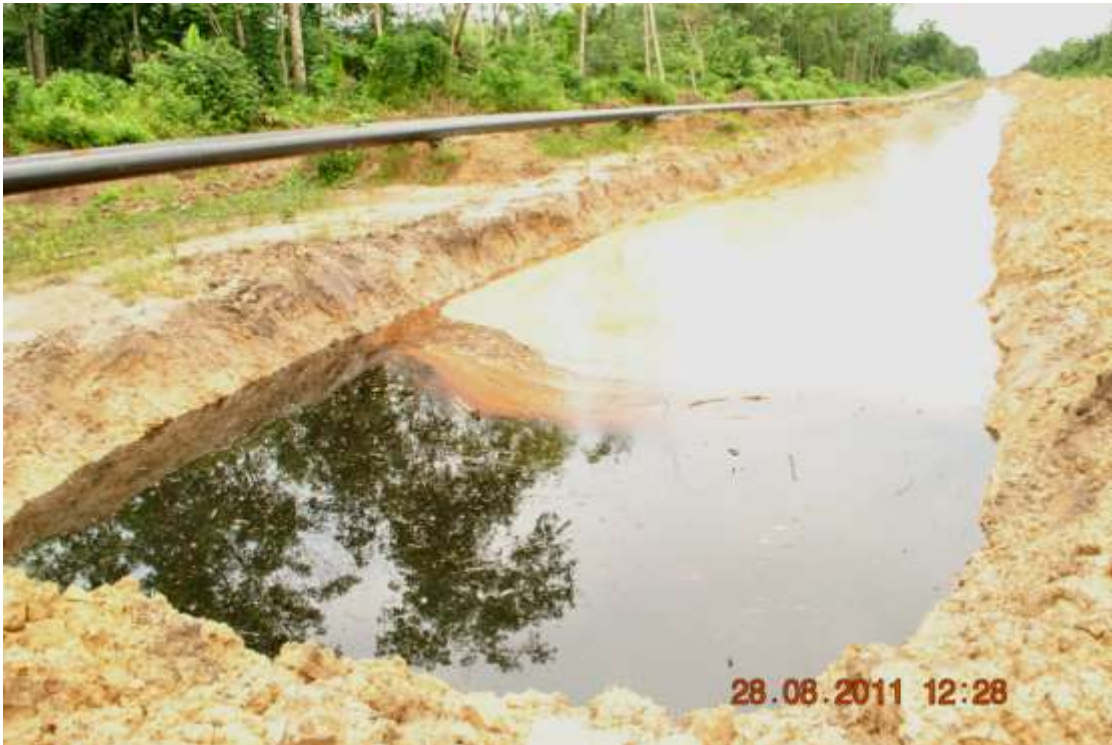
Overview: Part of spill impact on 10" Utorogu-UPS right of way at Ughevwighe. Picture taken during Joint Investigation of 28th August, 2011.

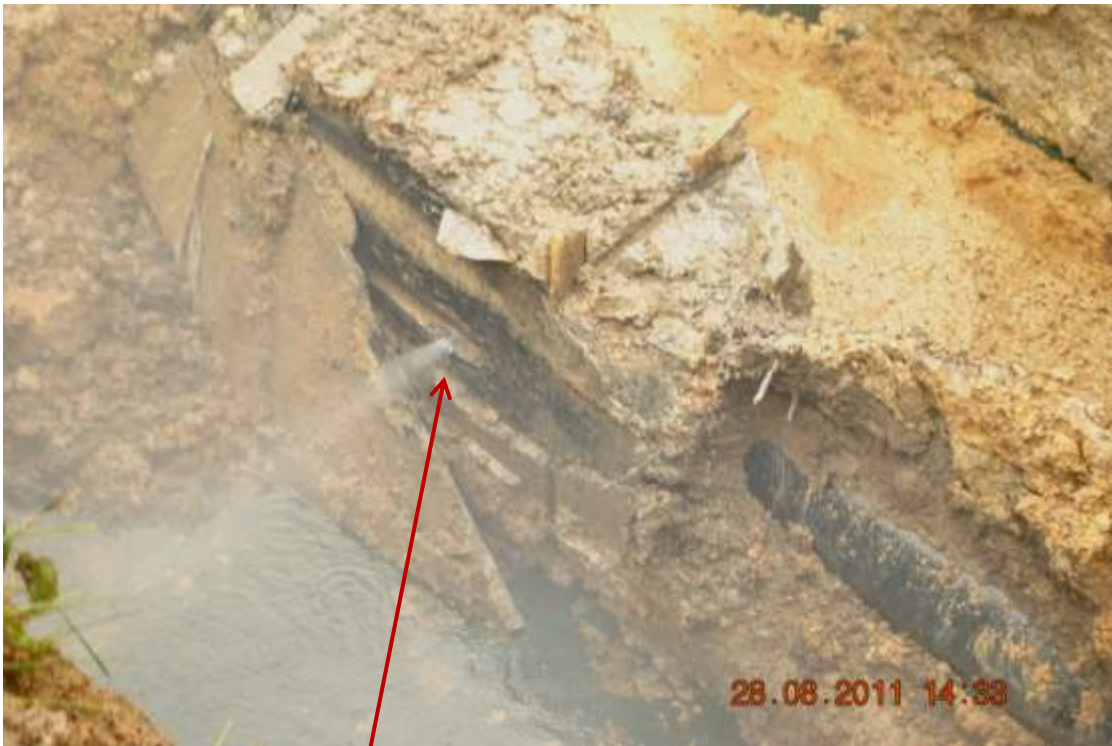
Close-up: Spill due to clamp failure on 10" Utorogu-UPS at Ughevwighe. Picture taken during Joint Investigation of 28th August, 2011.
