Overview: Yokri Well 114S flowline at Yokri/Sokebolou being raised for inspection.  
Picture taken during Joint Investigation of 15<sup>th</sup> August, 2011

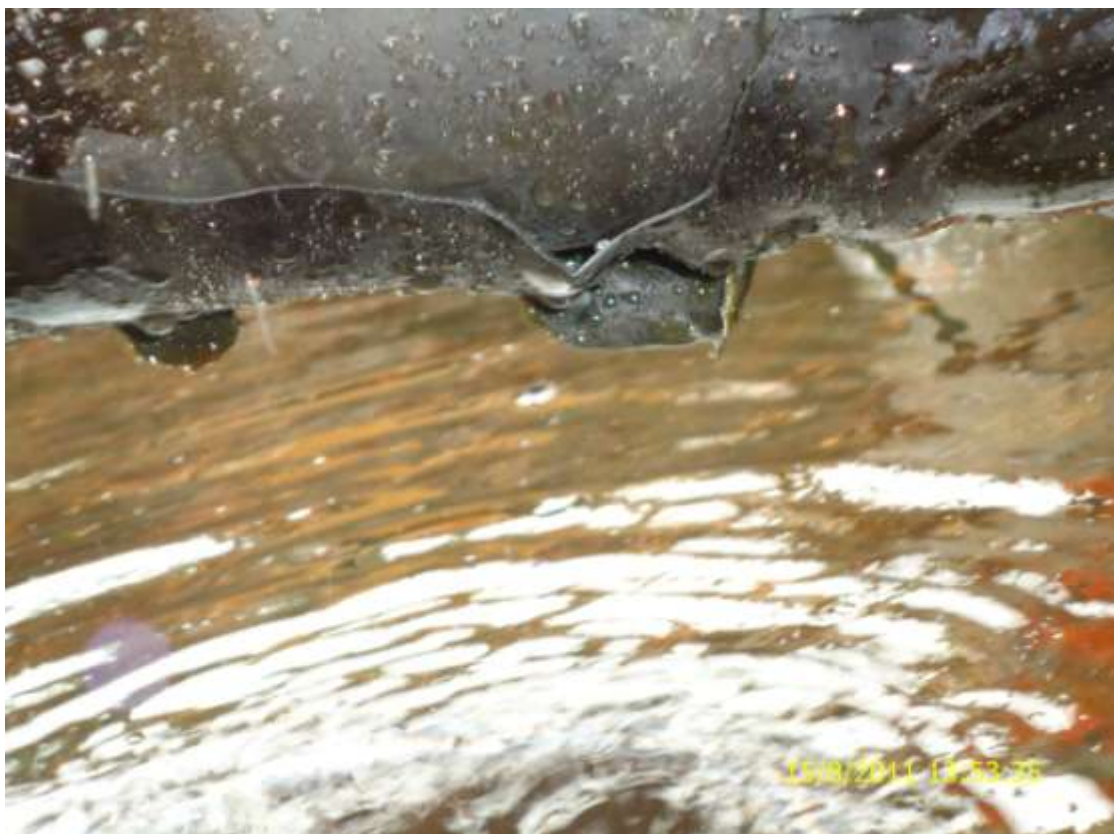
Close-up: Spill due to corrosion on Yokri Well 114S flowline at Yokri/Sokebolou.  
Picture taken during Joint Investigation of 15<sup>th</sup> August, 2011
