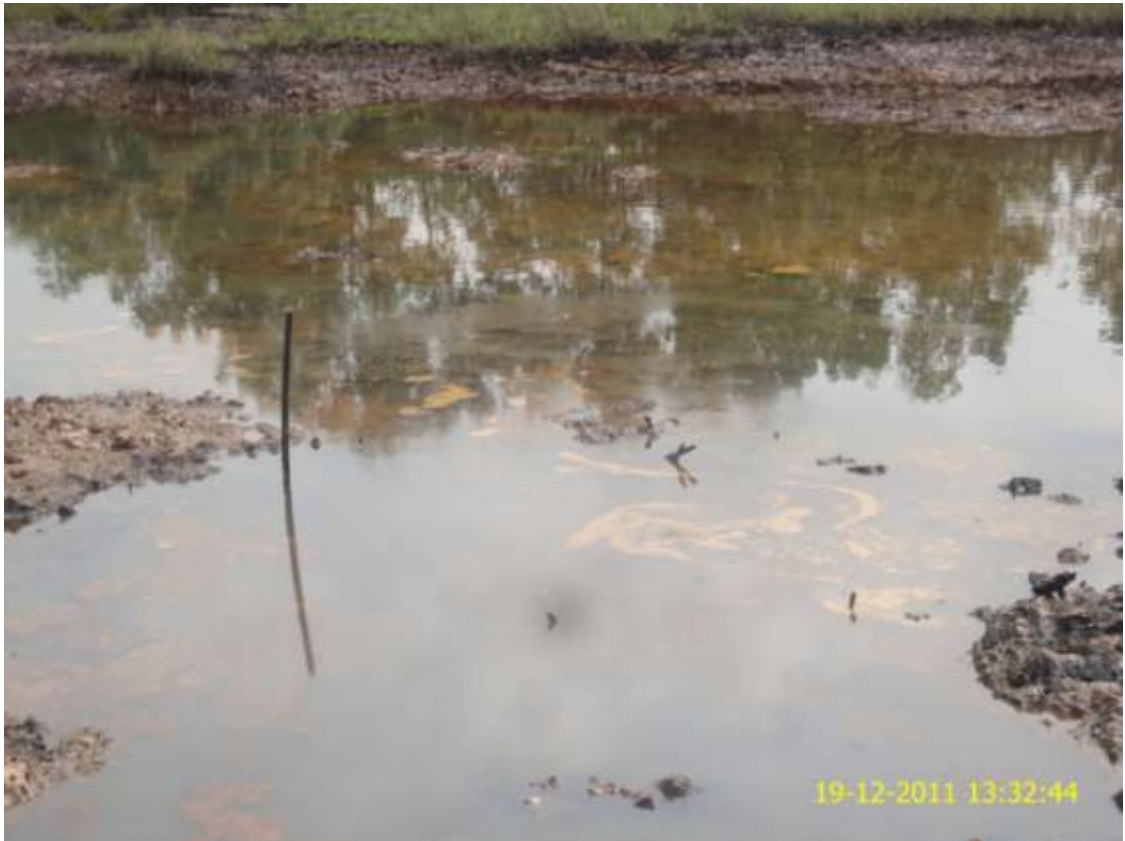
Overview: Part of spill impact on Ekulama1 Well35S flowline right of way at SandSand. Picture was taken during Joint Investigation of 19th December 2011.

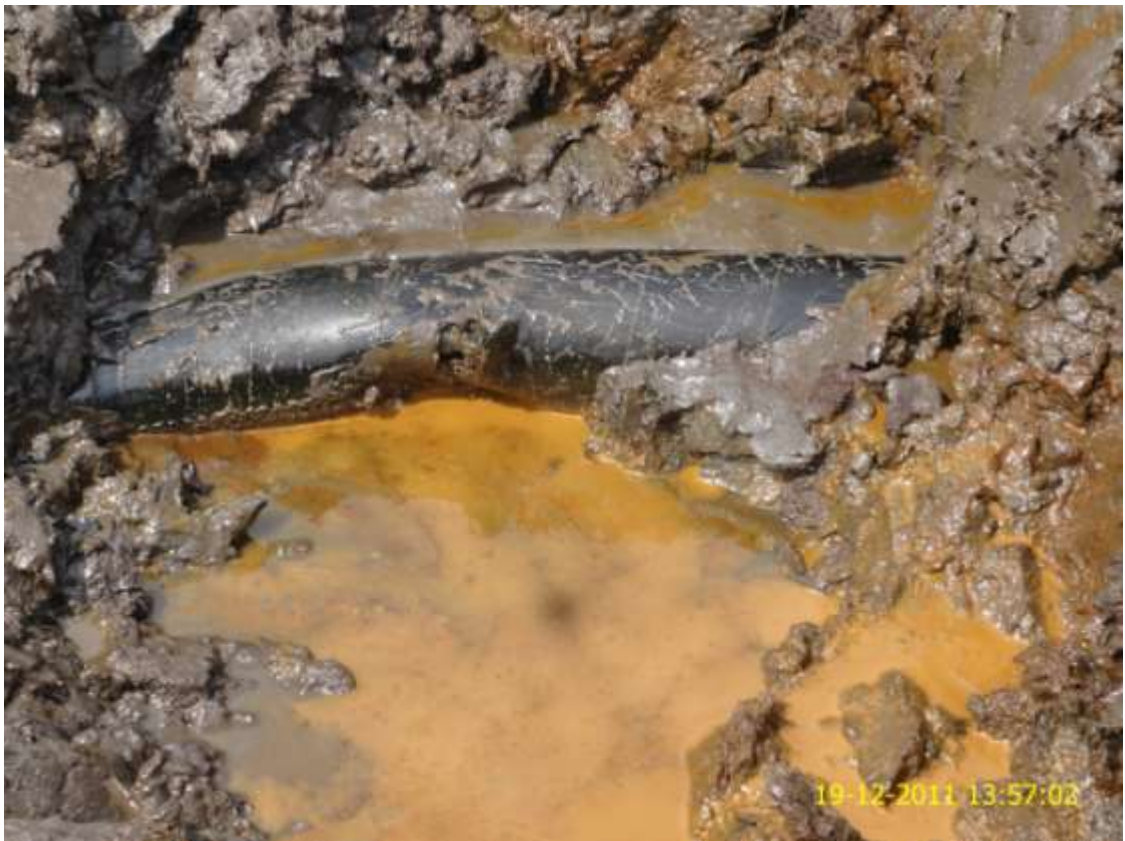
Close-up: Outward dent on Ekulama1 Well35S flowline at SandSand. Picture was taken during Joint Investigation of 19th December 2011.
