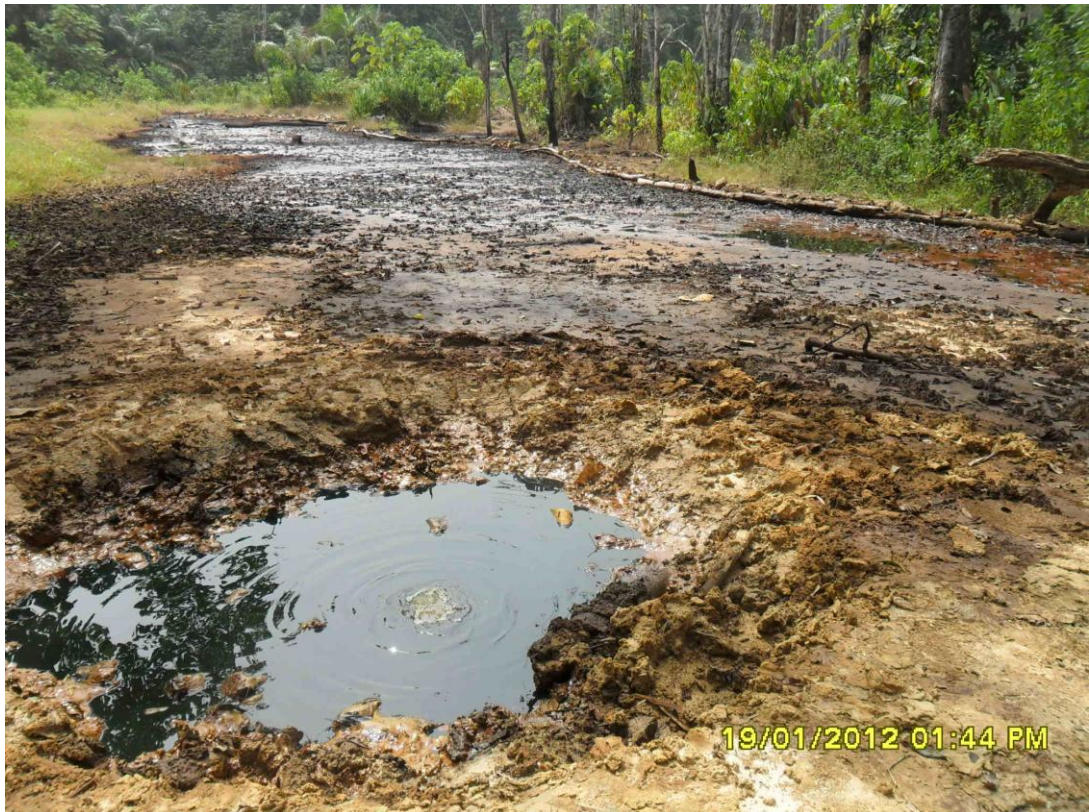
Overview: Part of spill impact on Nun River Well 15S flowline right of way at Onyoma. Picture was taken during Joint Investigation of 19th January 2012.

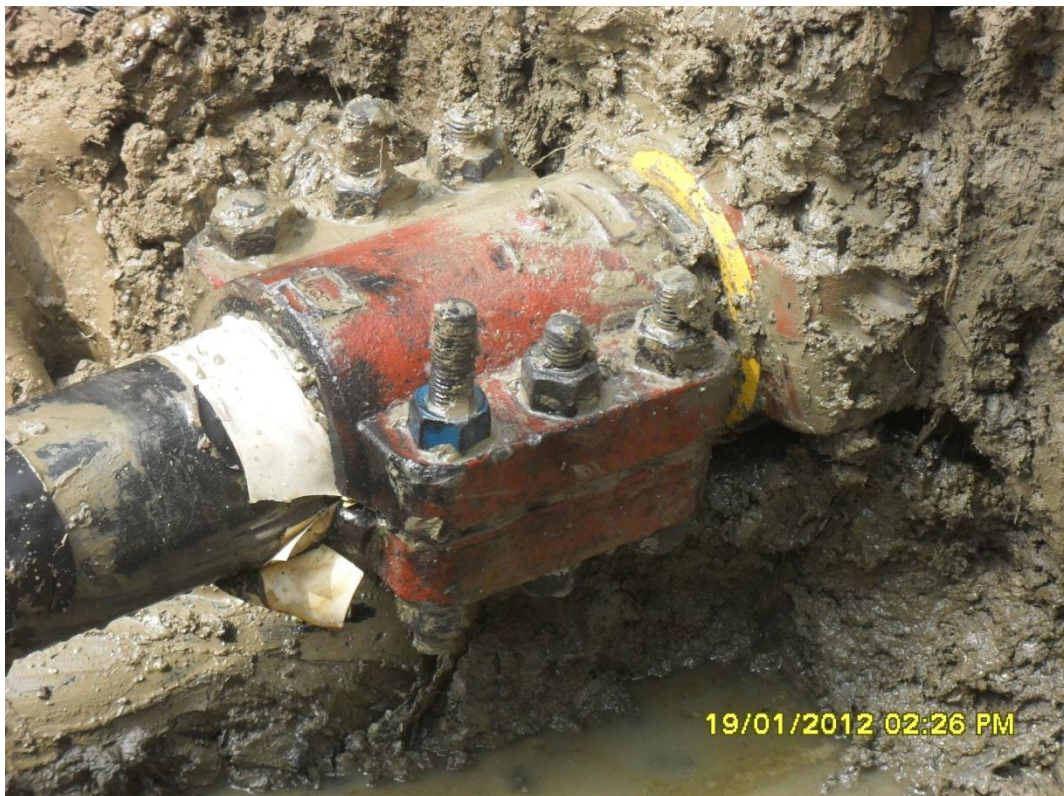
Close-up: Spill due to failed damp on Nun River Well 15S flowline at Onyoma. Picture was taken during Joint Investigation of 19th January 2012.
