Overview: Extent of the spill incident impact on Imo River well 37L flow line at Owaza. Picture taken during Joint Investigation of 14th February, 2011

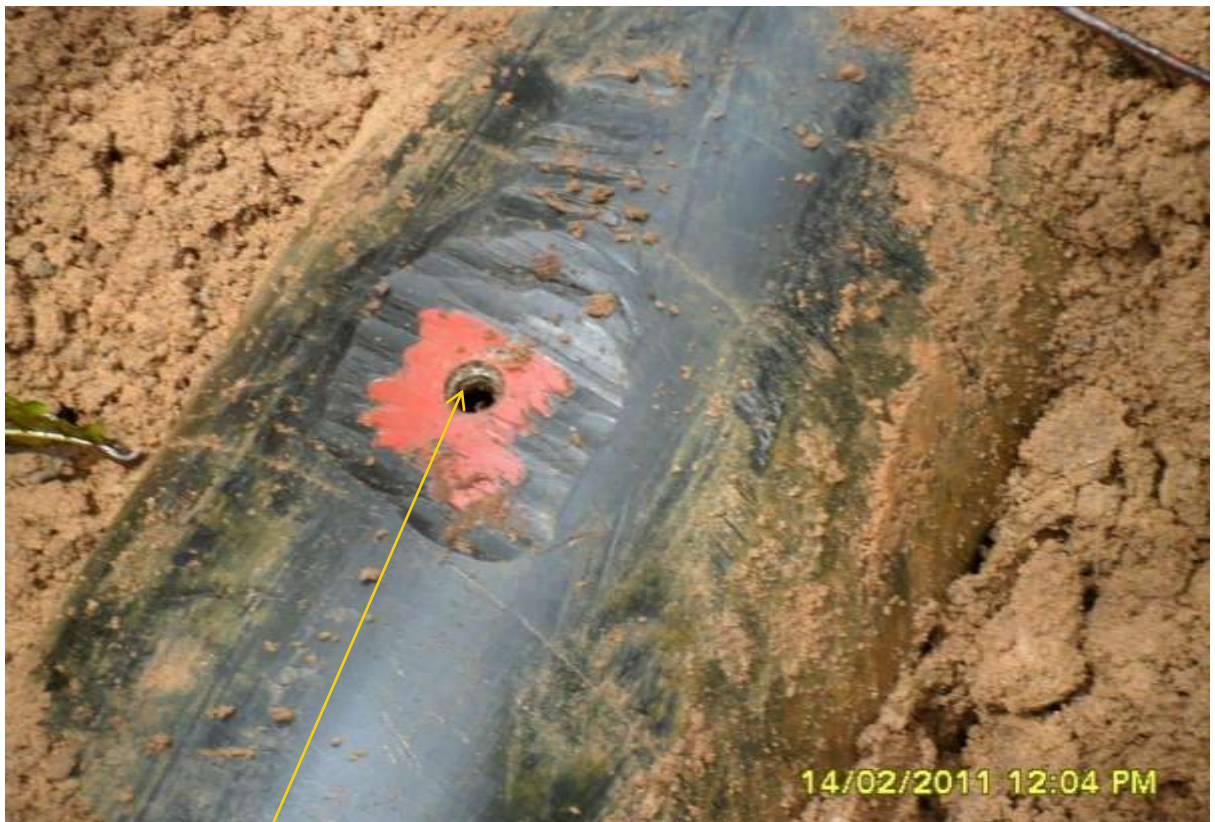
Close-up: Spill due to illegally drilled hole on Imo River well 37L flow line at Owaza. Picture taken during Joint Investigation of 14th February, 2011.
