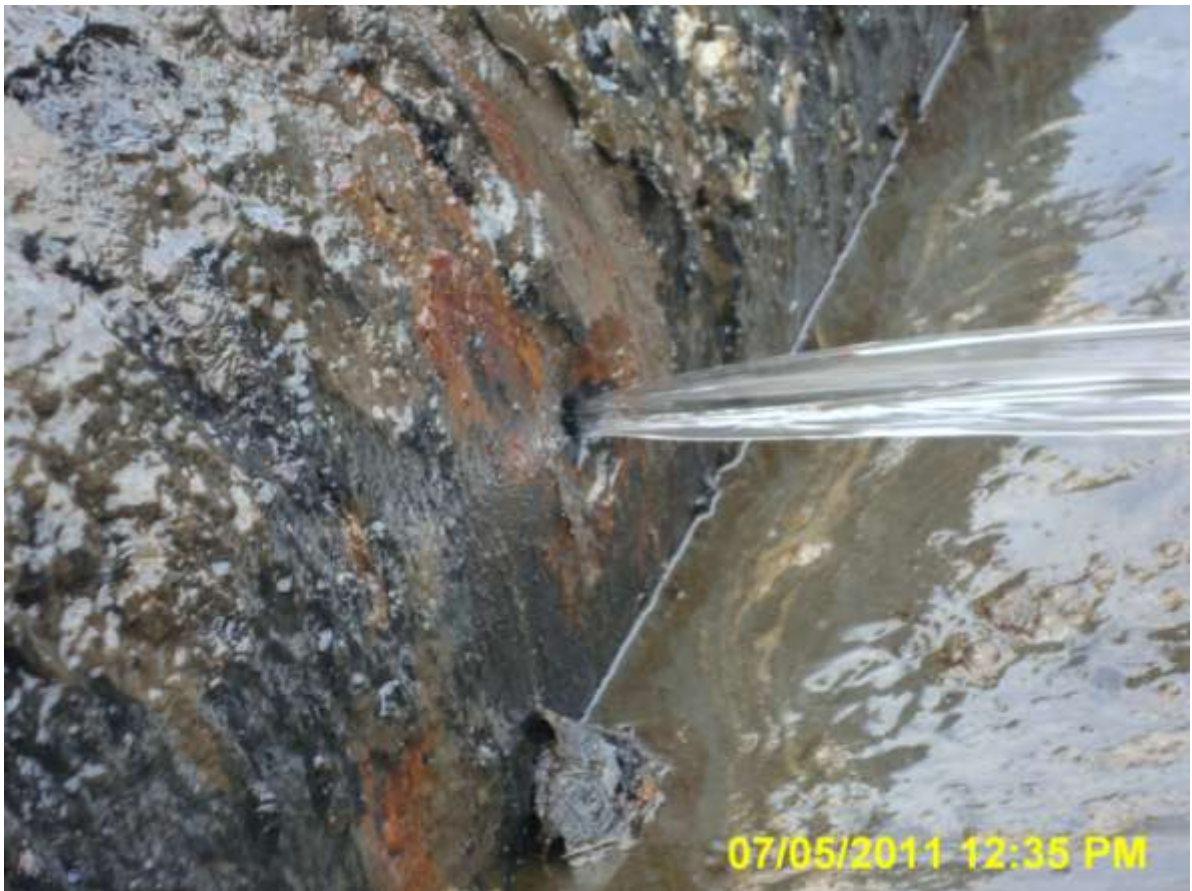
Close-up: Evidence of mechanical grinding on the surface of the 24" Alakiri-Bonny Pipeline in Creek 6. Picture was taken during JIV of 7<sup>th</sup> May 2011

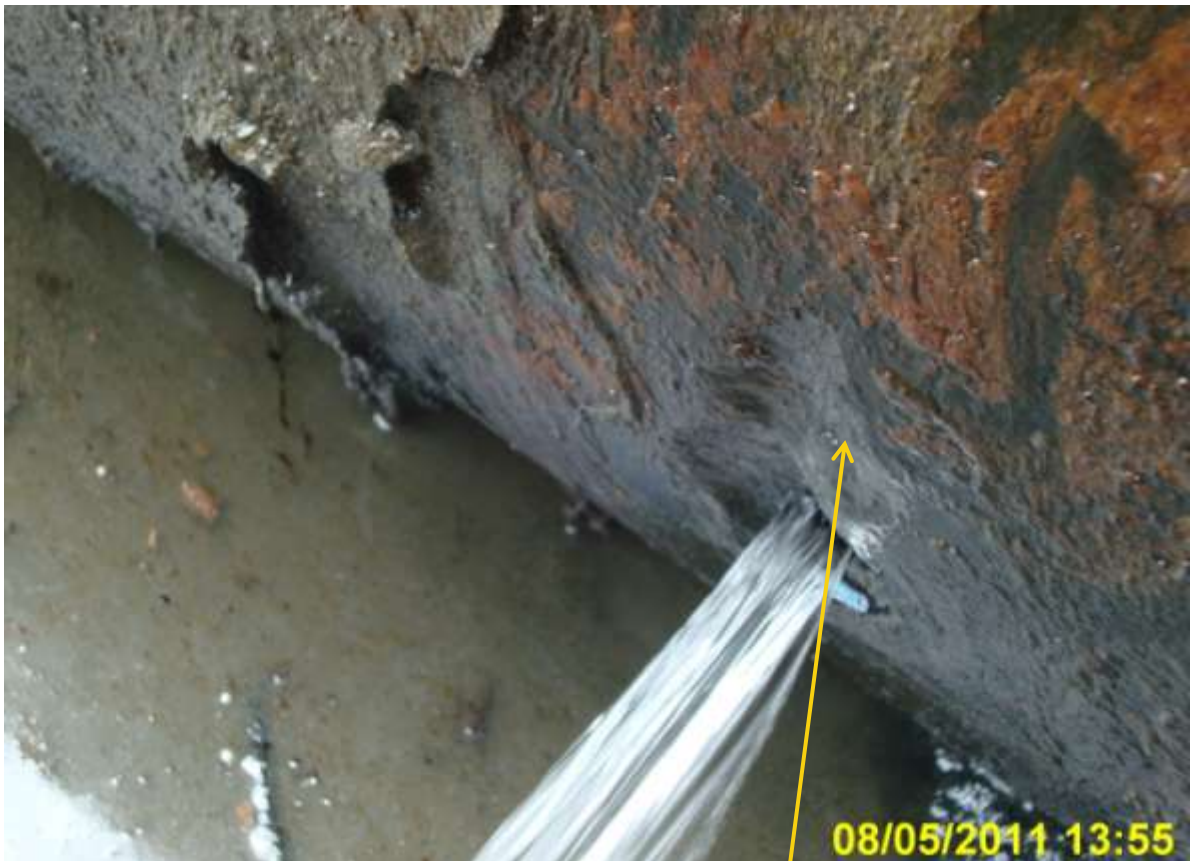
Close-up: Evidence of grinding and drilled hole on 24" Alakiri-Bonny Pipeline at Kalibiama. Picture was taken during JIV of 8<sup>th</sup> May 2011
