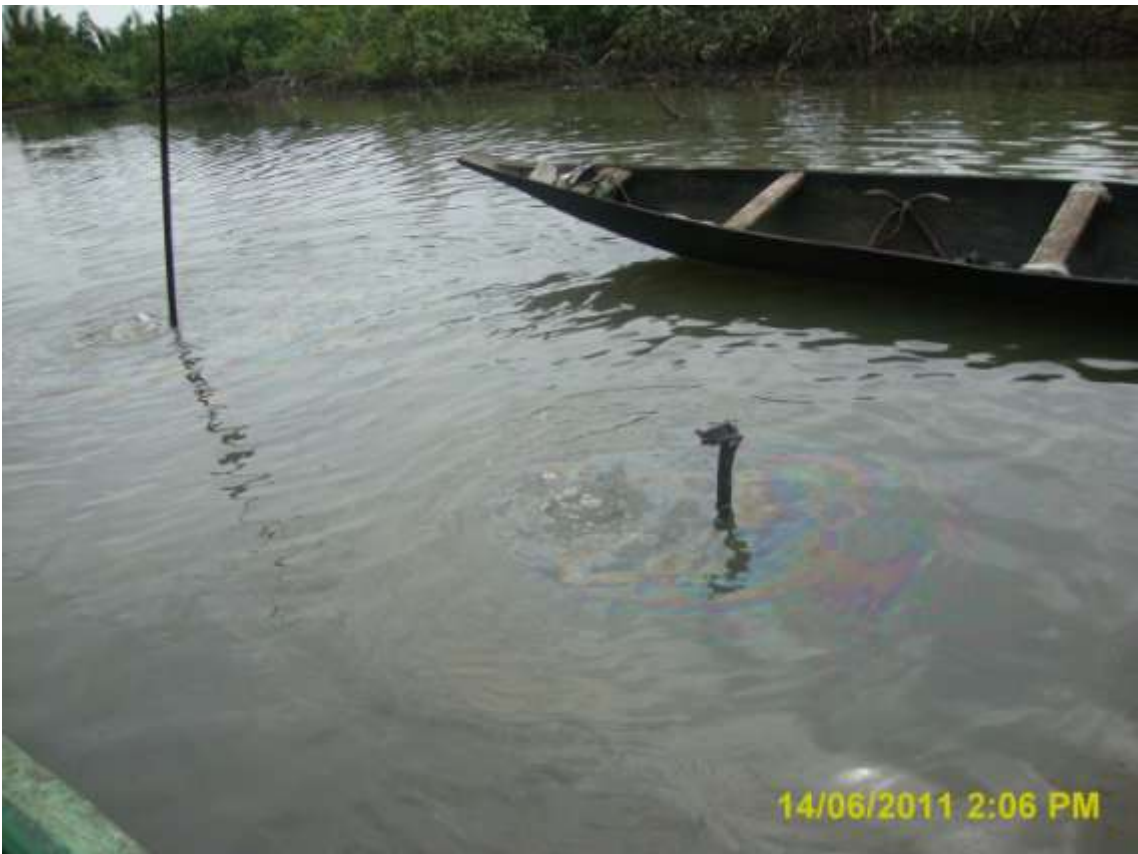
Overview: Bubbles with slight oil sheen along Bonny-Oloma Well 12S flowline Right of Way at Oloma with passing fisherman's canoe in the background.

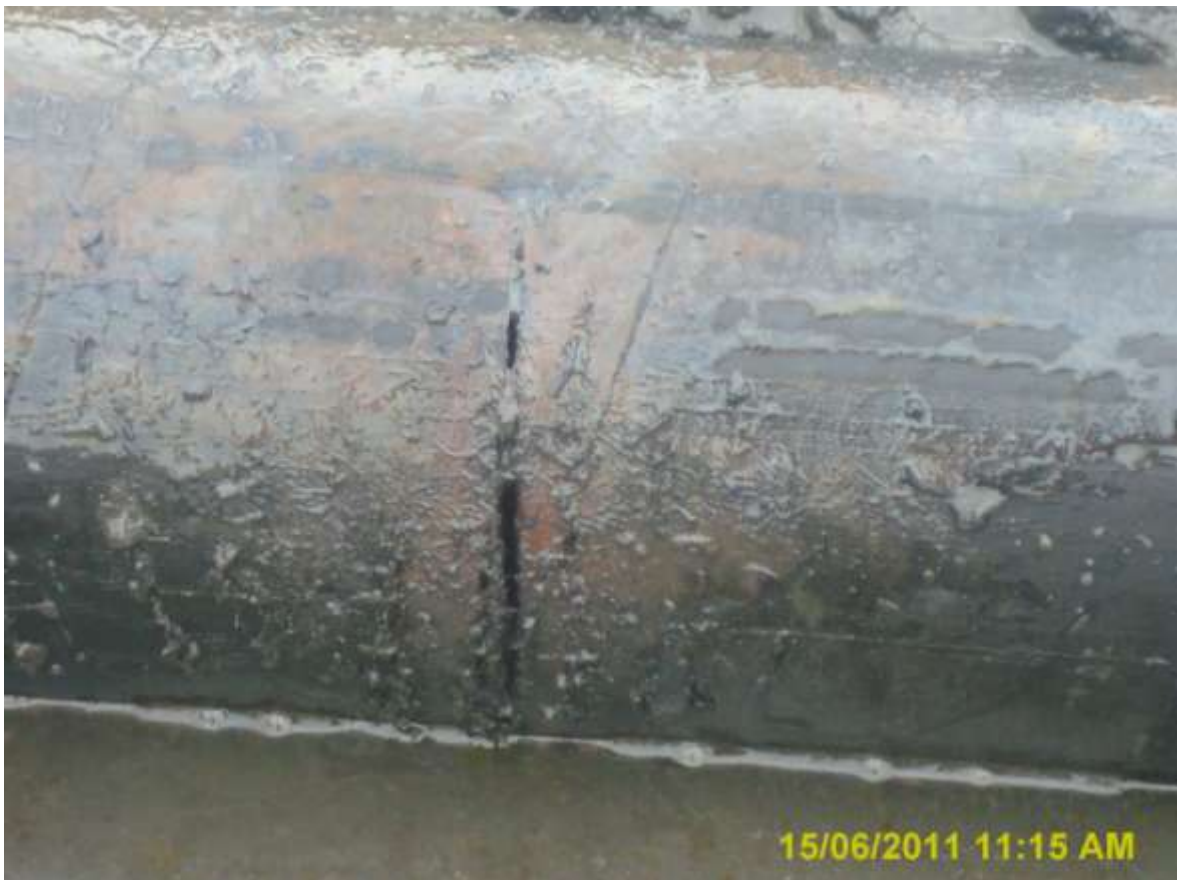
Close-up: Spill due to hacksaw cut on Bonny-Oloma Well 12S flowline at Oloma. Picture taken during Joint Investigation of 15th June, 2011.
