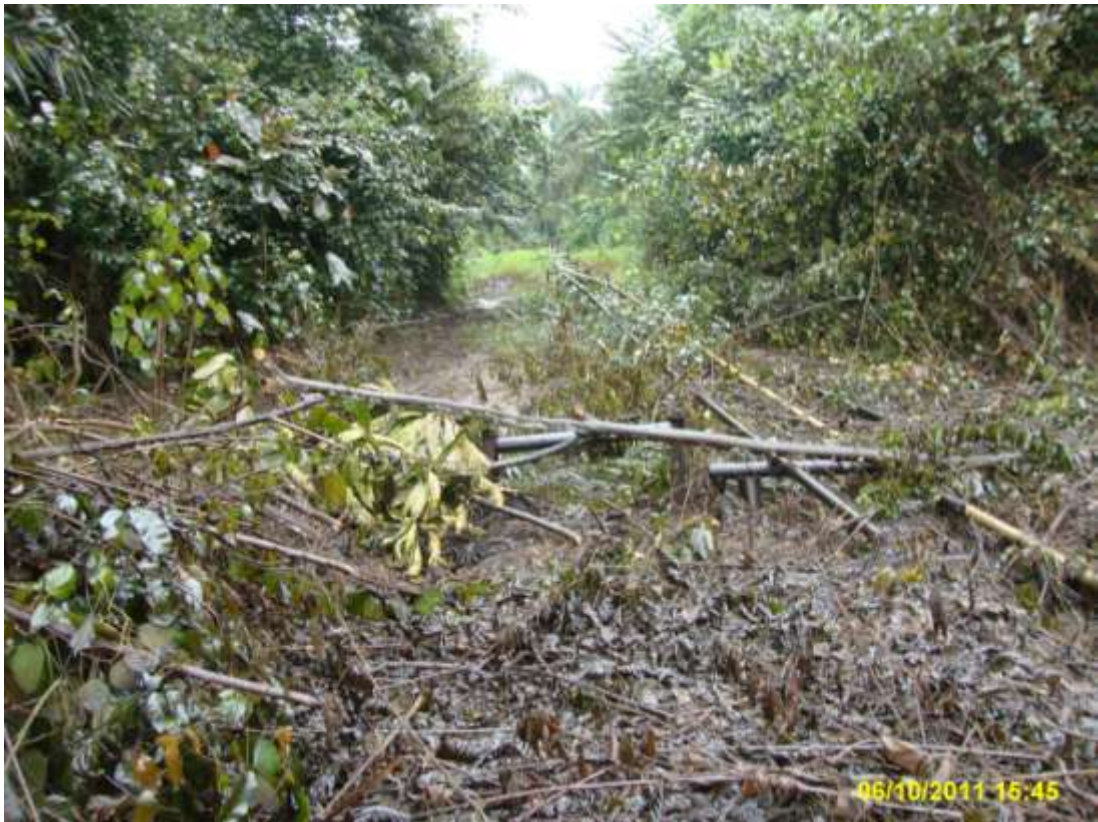
Overview: Part of spill impact on 4" ImoRiver1 Well30S flowline right of way at Igiriukwu. Picture taken during Joint Investigation of 6th October, 2011.

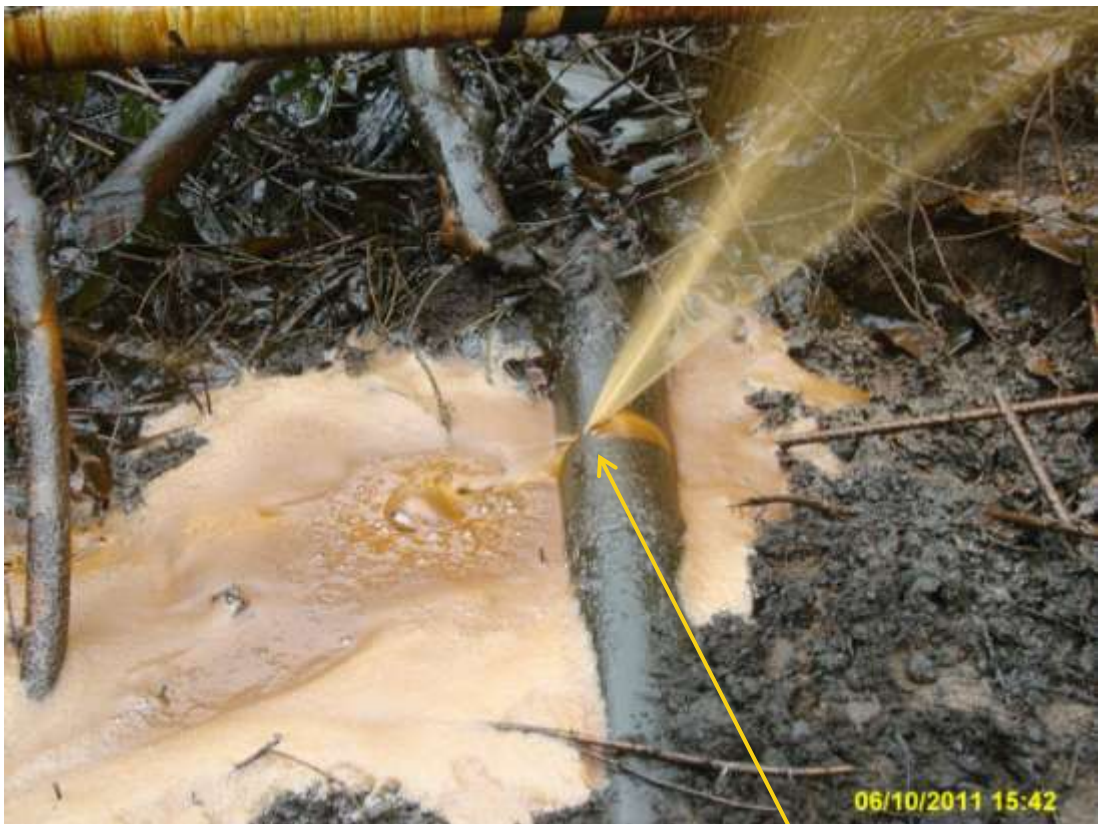
Close-up: Spill due hacksaw cut on 4" ImoRiver1 Well30S flowline at Igiriukwu. Picture taken during Joint Investigation of 6th October, 2011.
