Overview: Bubbling observed on 20" Buguma-Alakiri pipeline right of way at Bakana. Picture was taken during Joint Investigation of 22<sup>nd</sup> October, 2011.

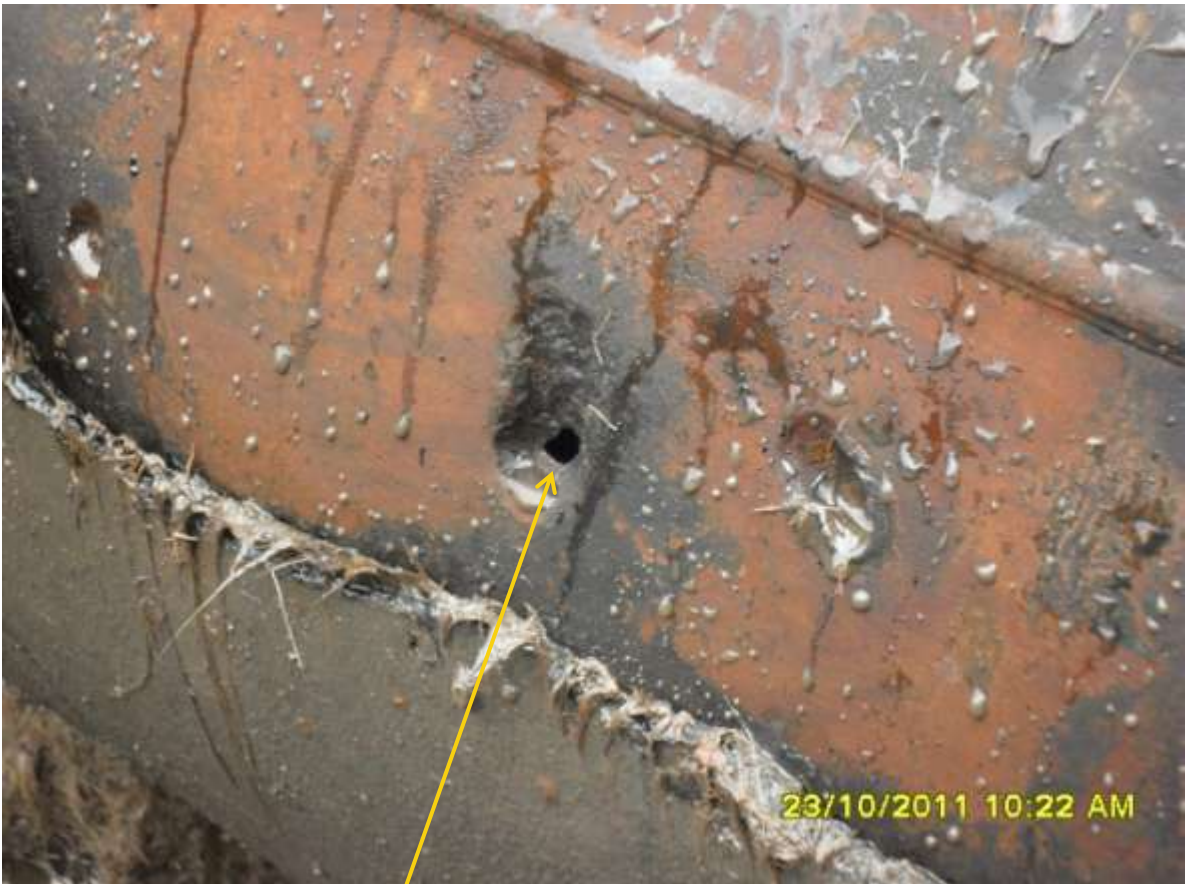
Close-up: Drilled hole on 20" Buguma-Alakiri pipeline at Bakana. Picture was taken during Joint Investigation of 23<sup>rd</sup> October, 2011.

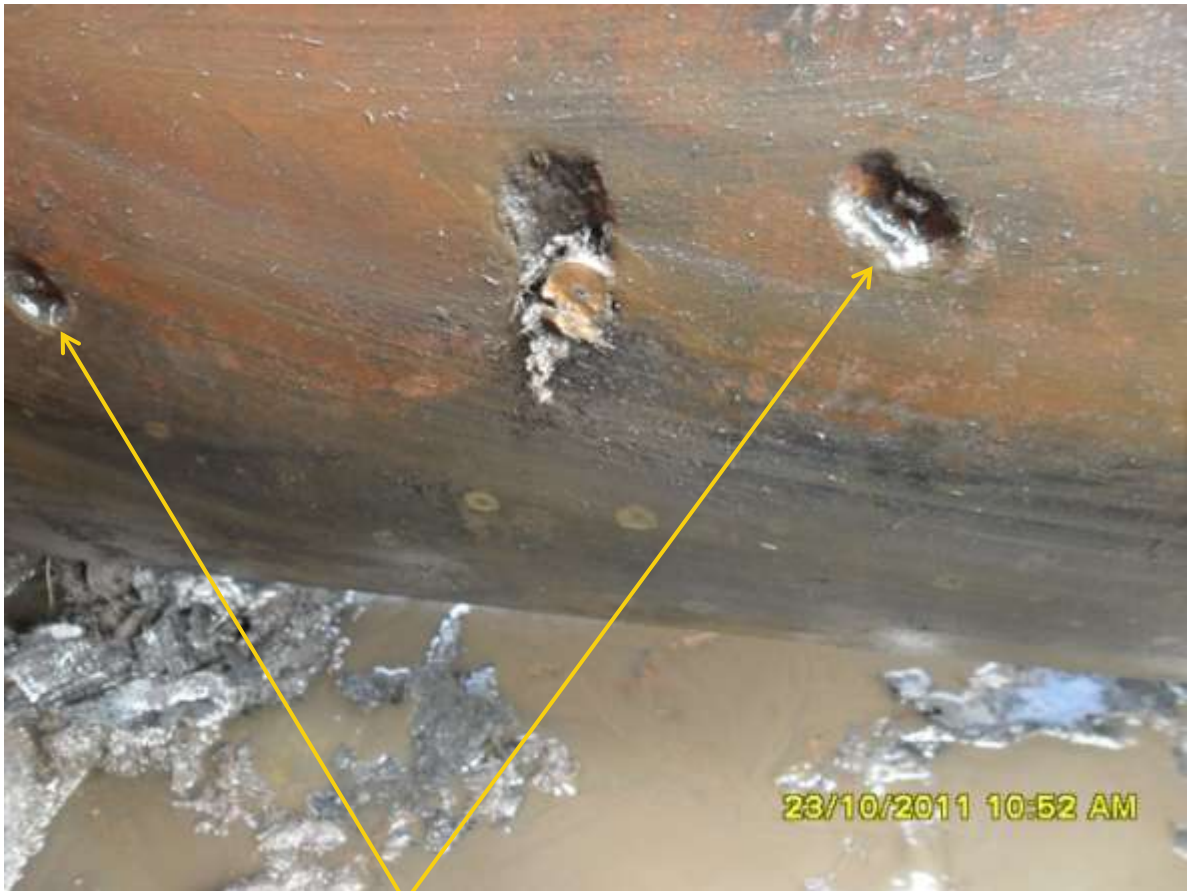
Close-up: Unsuccessful drill attempts can be seen after plugging the Drilled hole on 20" Buguma-Alakiri pipeline at Bakana.
