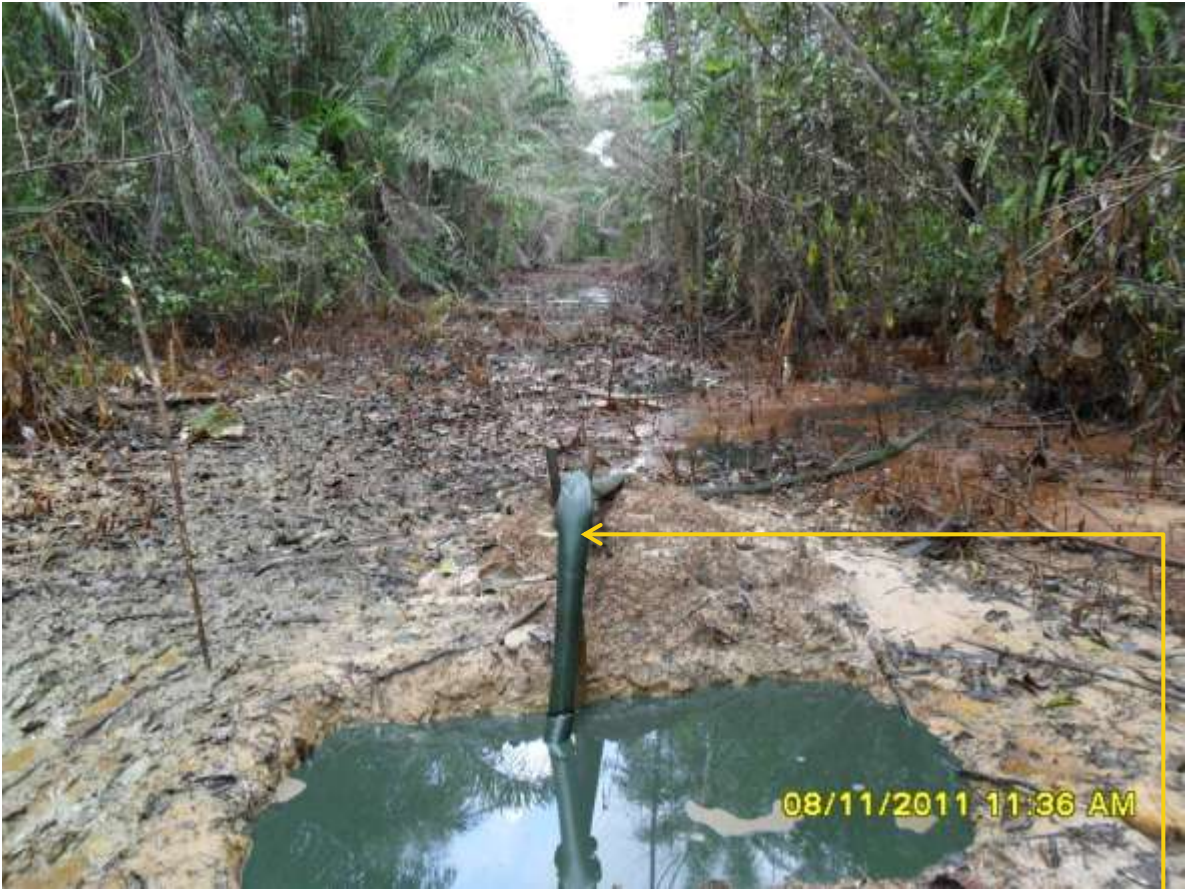
Overview: Part of spill impact on 10" Diebu Creek pipeline at Oporoma right of way. Hose used for bunkering can be seen in the photo.

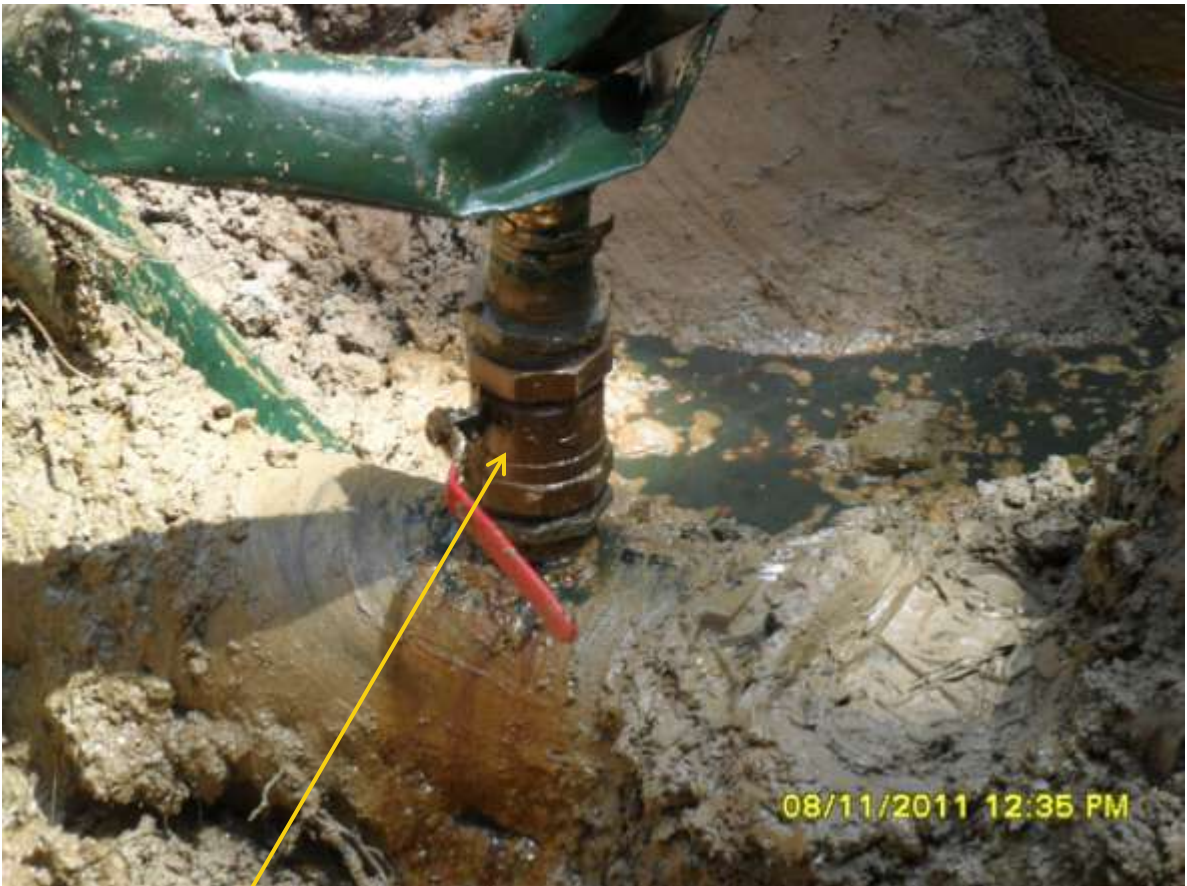
Close-up: One of three illegal fittings on 10" Diebu Creek pipeline at Oporoma. Picture was taken during Joint Investigation of 8th November, 2011.

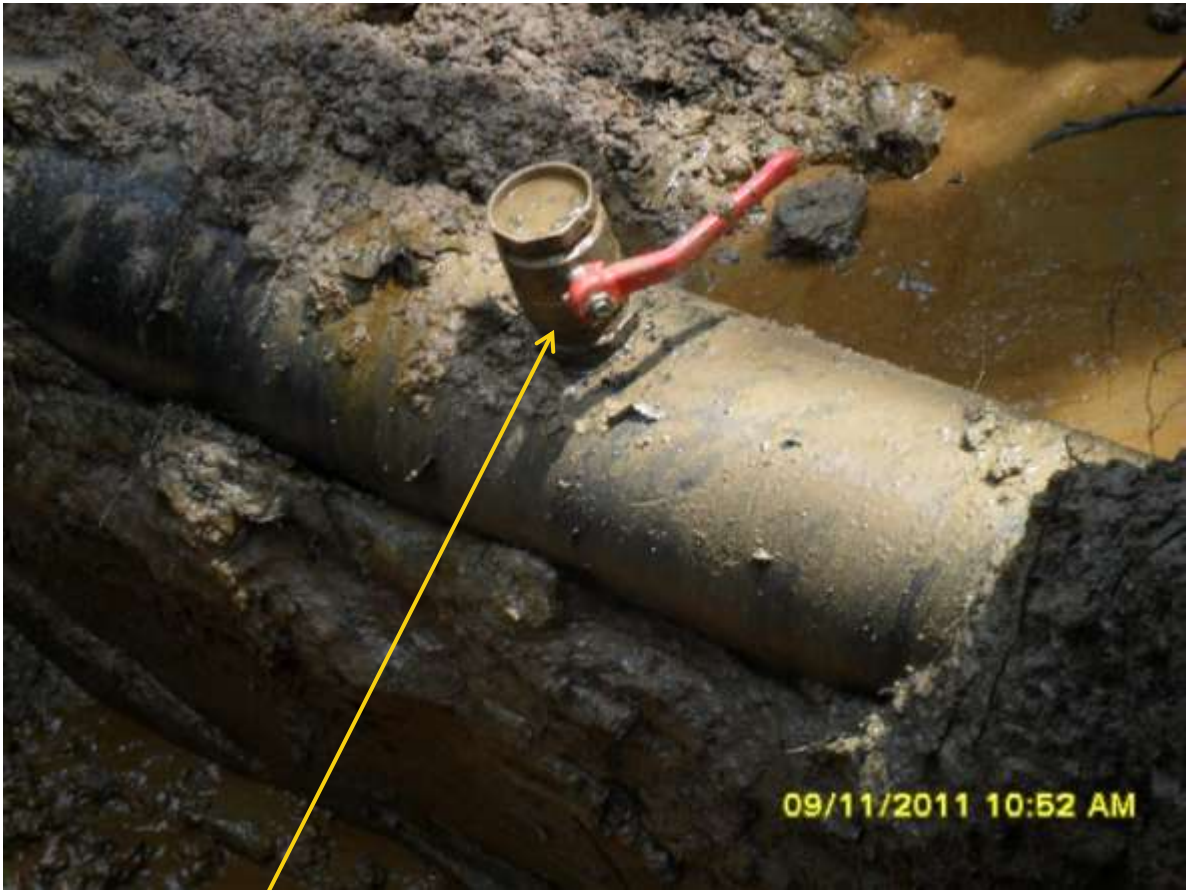
Close-up: One of three illegal fittings on 10" Diebu Creek pipeline at Oporoma. Picture was taken during Joint Investigation of 9th November, 2011.
