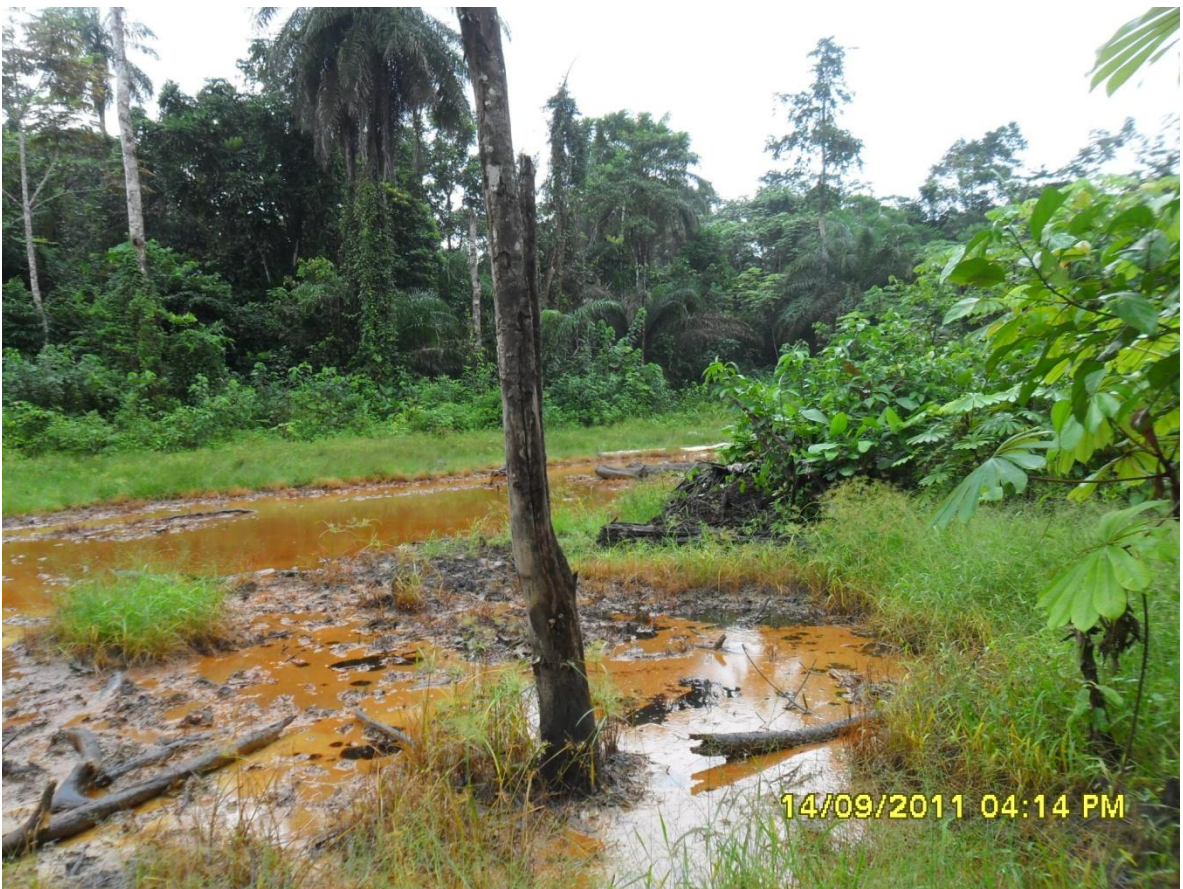
Overview: Part of spill incident impact on NunRiver Well 15 Flowline route at Onyonma. Picture was taken during Joint Investigation of 14th September, 2011.

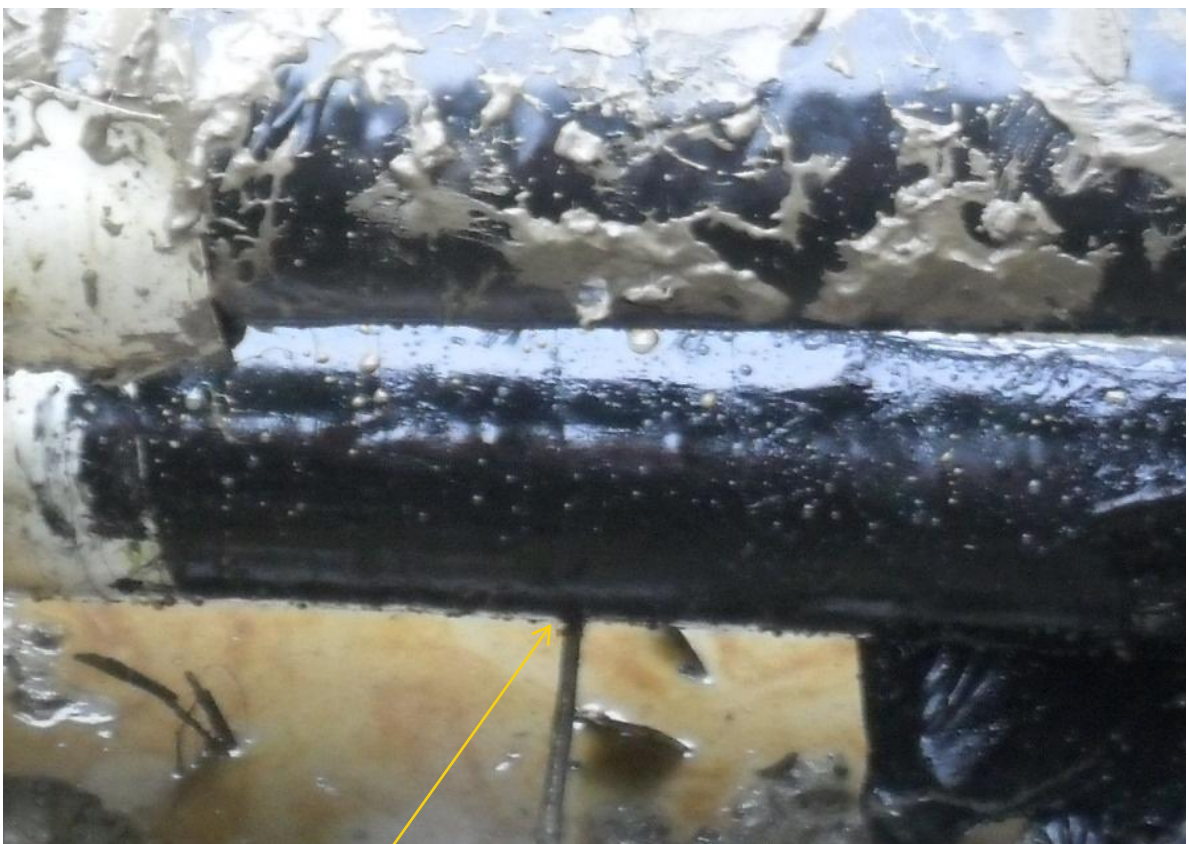
Close-up: Spill due to drilled hole on NunRiver Well 15 Flowline at Onyonma. Stick was inserted into the pipe to show the position of the drilled hole. Picture was taken during Joint Investigation of 14th September, 2011.
