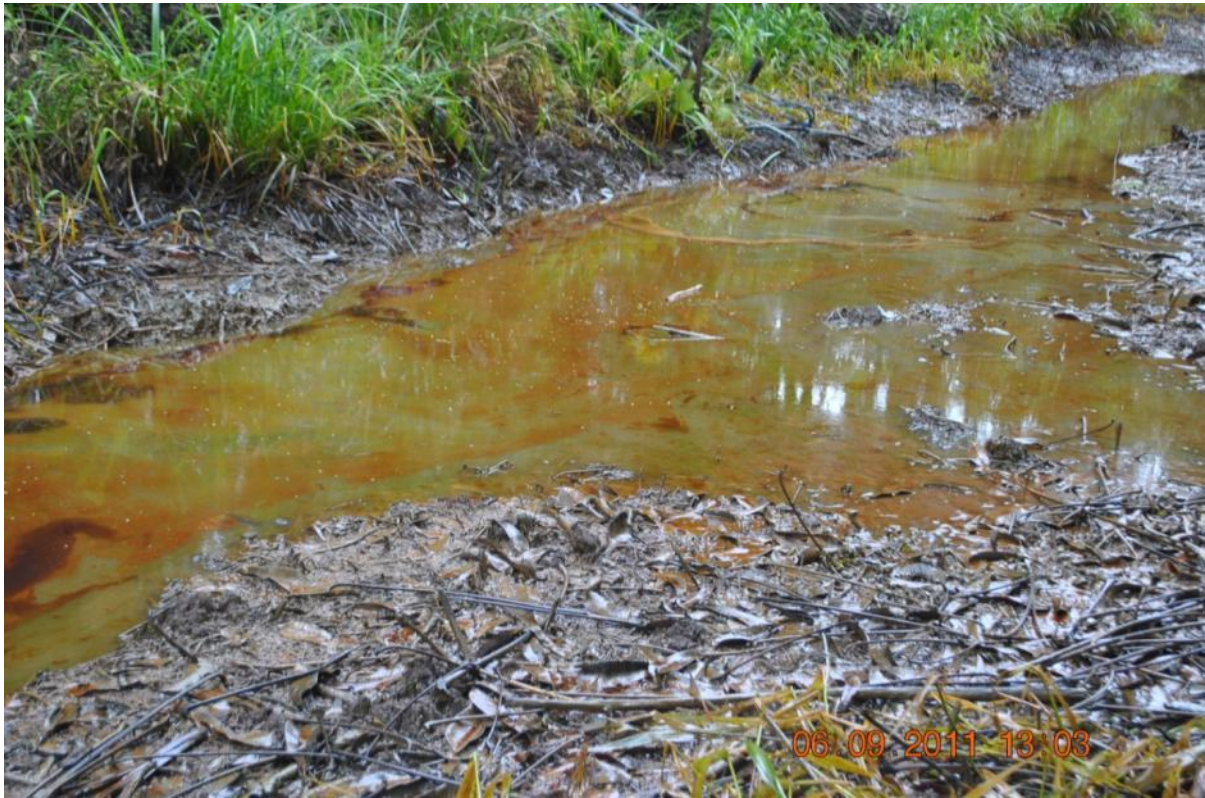
Overview: Part of spill impact on Opukushi Well 34 Flowline at Agbididama & Egbemo_Angalabiri. Picture taken during Joint Investigation of 6th September, 2011

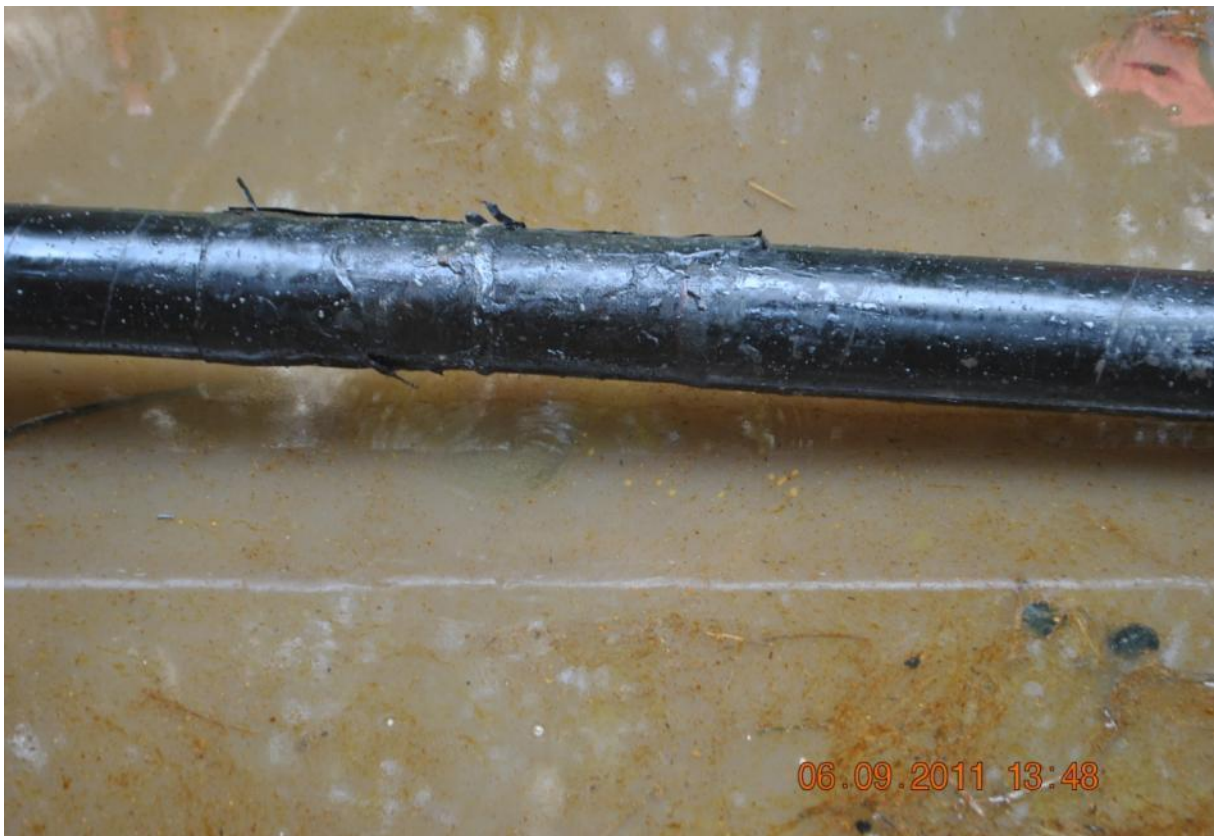
Close-up: Spill due to Internal Corrosion on Opukushi Well 34 Flowline at Agbididama & Egbemo_Angalabiri. Picture taken during Joint Investigation of 6th September, 2011
