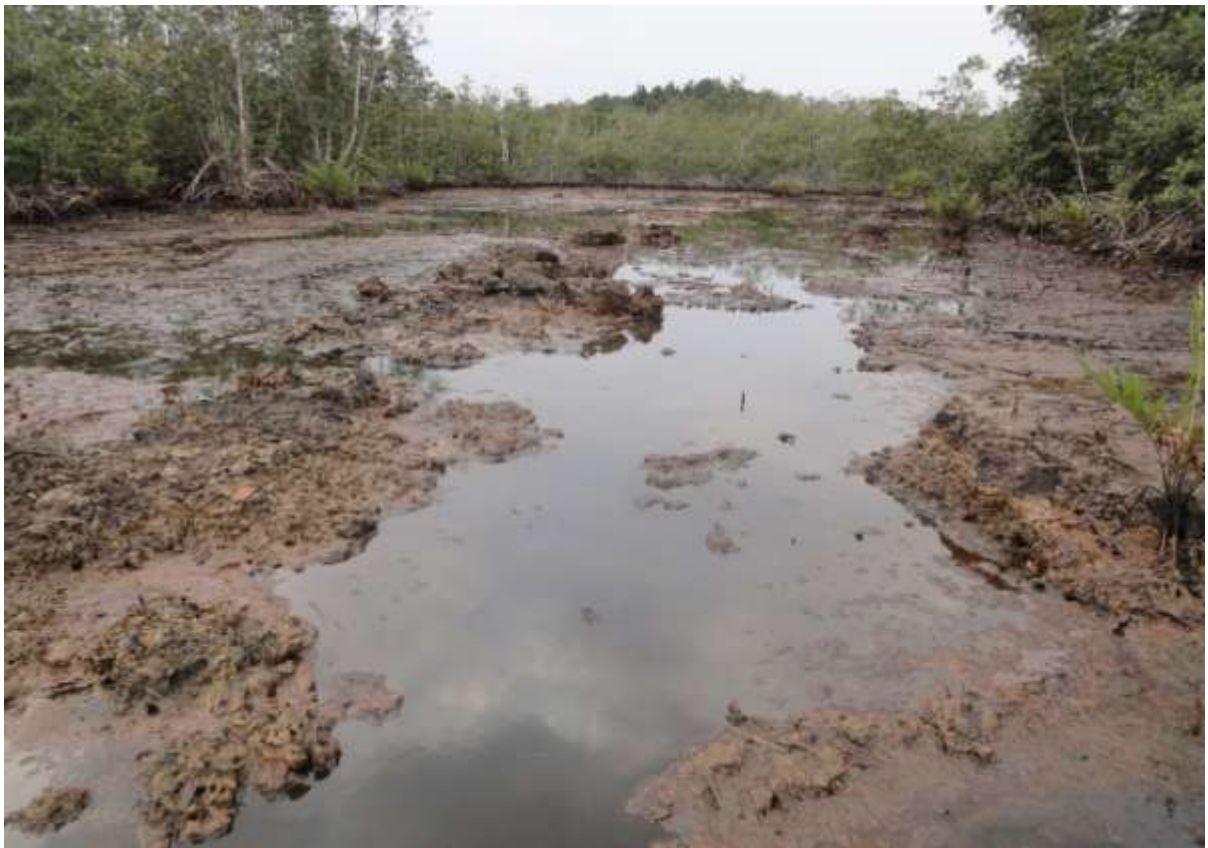
Overview: Part of spill impact on Ekulama 2 Well 38L Flowline at Freetown-Kula. Picture was taken during Joint Investigation of 11th Dec. 2012.

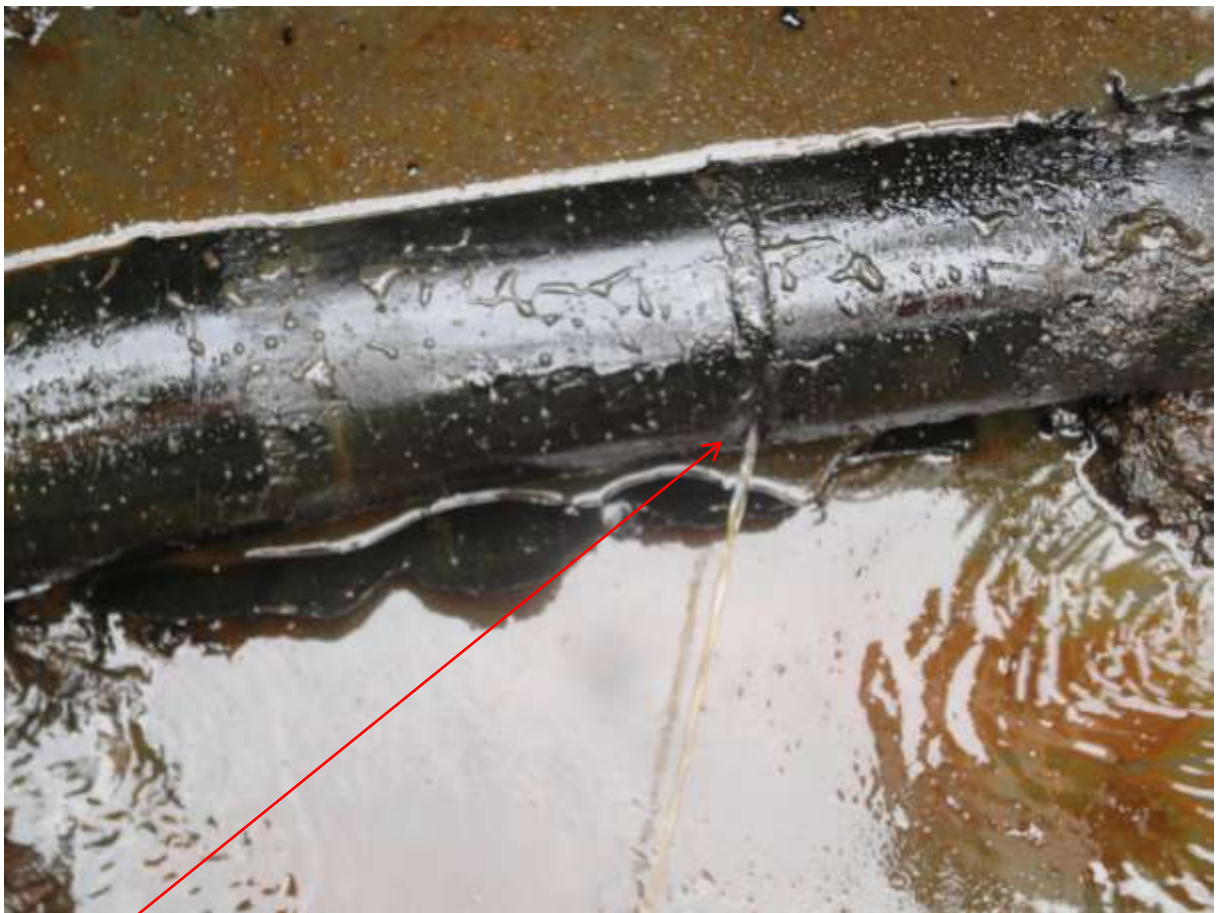
Close-up: Failed weld on Ekulama 2 Well 38L Flowline at Freetown-Kula. Picture was taken during Joint Investigation of 11th Dec. 2012.
