THE SHELL PETROLEUM DEVELOPMENT COMPANY OF NIGERIA LIMITED

JOINT INVESTIGATION REPORT FOR INCIDENT NO: 0199 777742

1. Spill incident Number: 64186 777742 2. Type of incident* OIL SPILL
 3. Name of Location W/15 FILL (DIEBU CREEK)
 4. Name of nearest community PEREMBANI 5. State: BIMOLSA 6. LGA SOUTHERN BAW
 7. Type of Production facility/Installation FLOWLINE 8. Asset owner/District MURR

20. Appendix 1: Overview sketch of the site

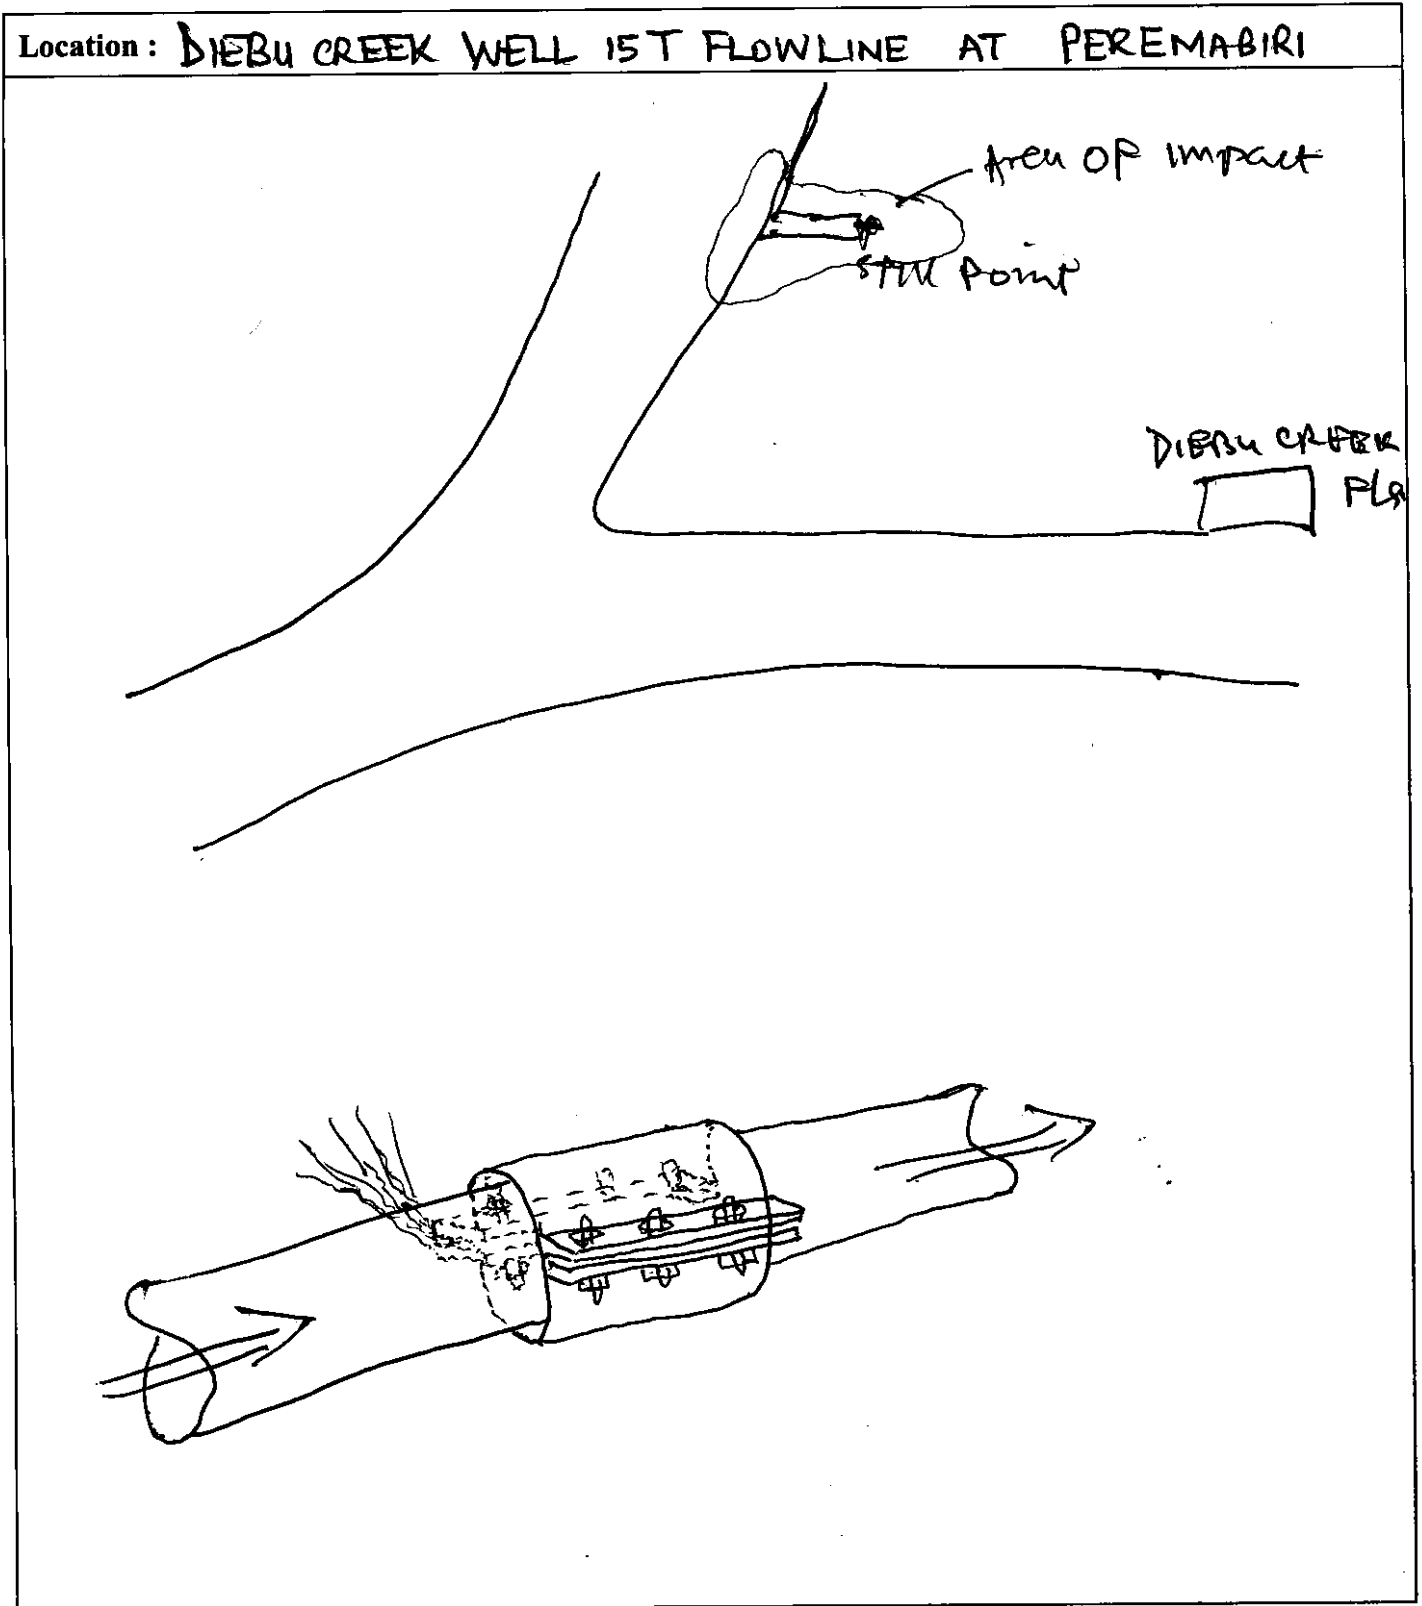
Location: DIEBU CREEK WELL 15T FLOWLINE AT PEREMABIRI

Additional description of cause of incident (if any): The clamp on the flowline where the leak was spilling out from was tampered by unknown persons. The spill occurred as a result of sabotage.

The spill occurred as a result of sabotage (tampered plug). Clean-up of the impacted area should be carried out promptly. Surveillance activities should be stepped-up to prevent a re-occurrence.
