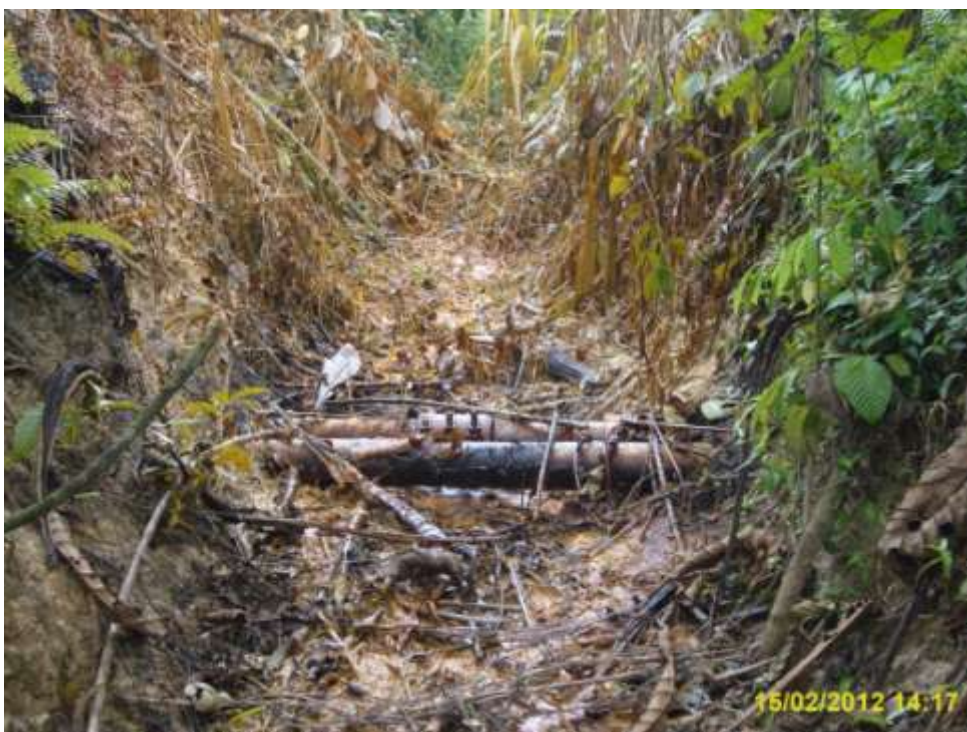
Overview: Part of spill impact on Well15 flowline right of way at Peremabiri. Picture was taken during Joint Investigation of 15th February 2012.

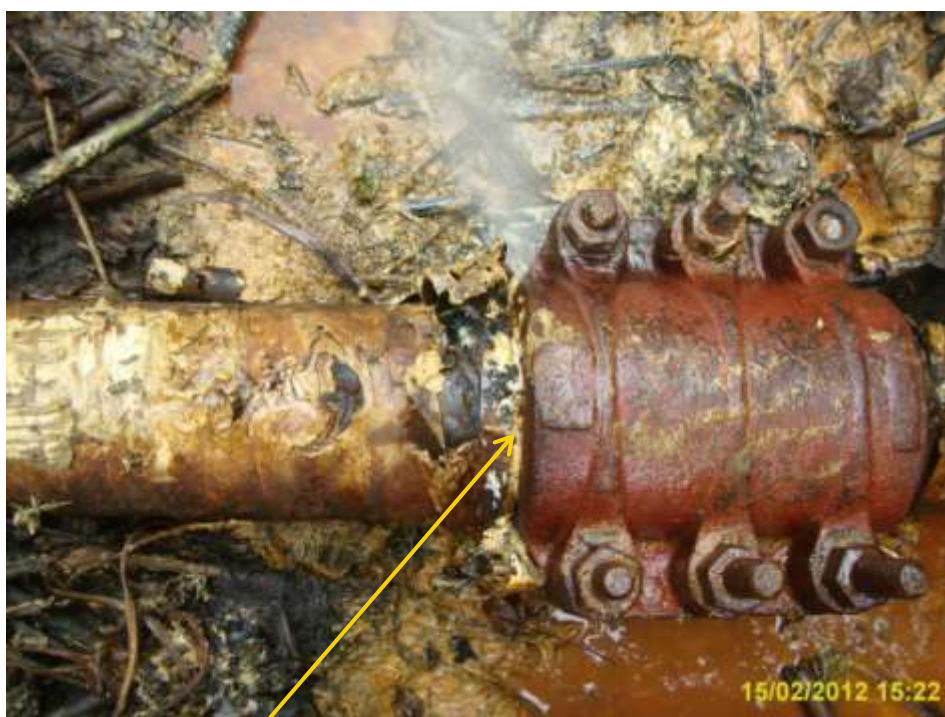
Close-up: Tampered clamp on Well15 flowline at Peremabiri. Picture was taken during Joint Investigation of 15th February 2012.
