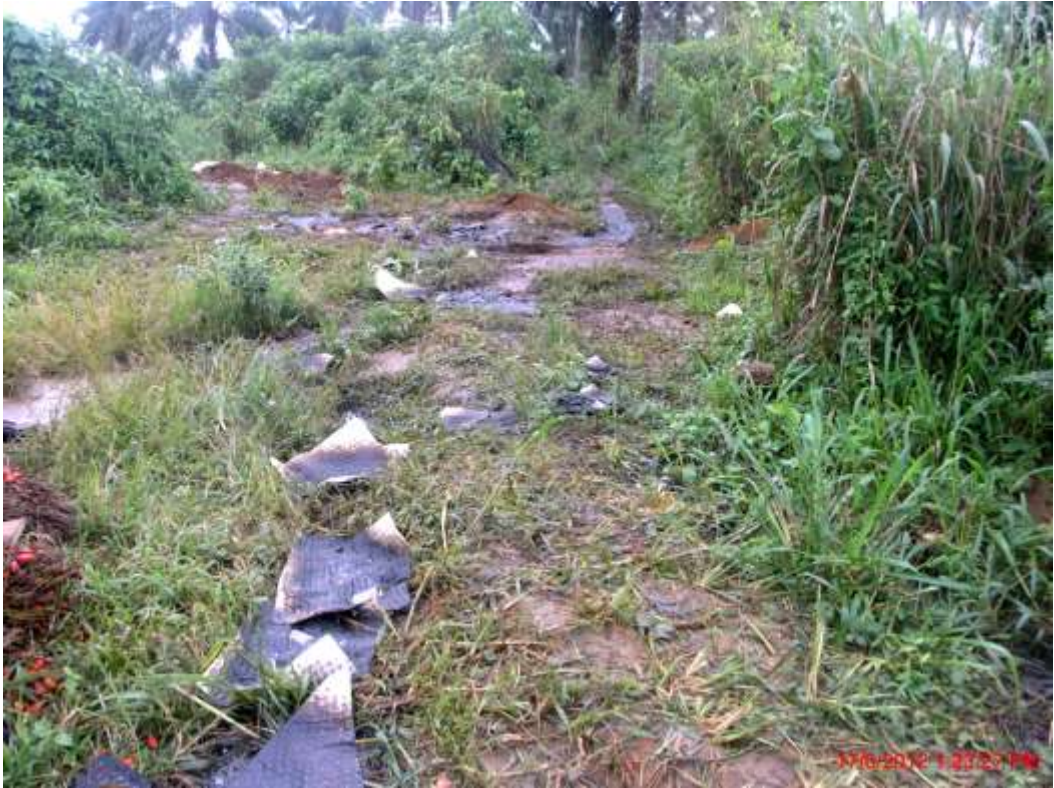
Overview: Part of spill impact on Agbada2 Well69S flowline right of way at Umuokwa. Picture was taken during Joint Investigation of 17th June 2012.

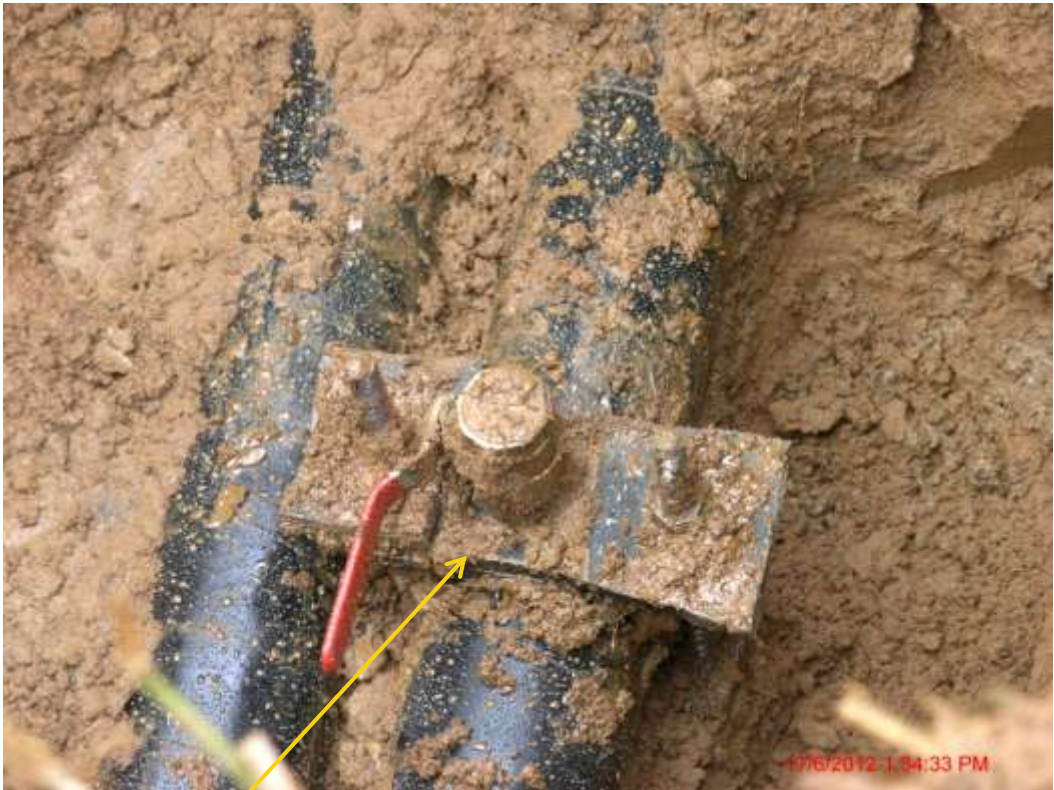
Close up: Illegal fitting on Agbada2 Well69S flowline at Umuokwa. Picture was taken during Joint Investigation of 17th June 2012.
