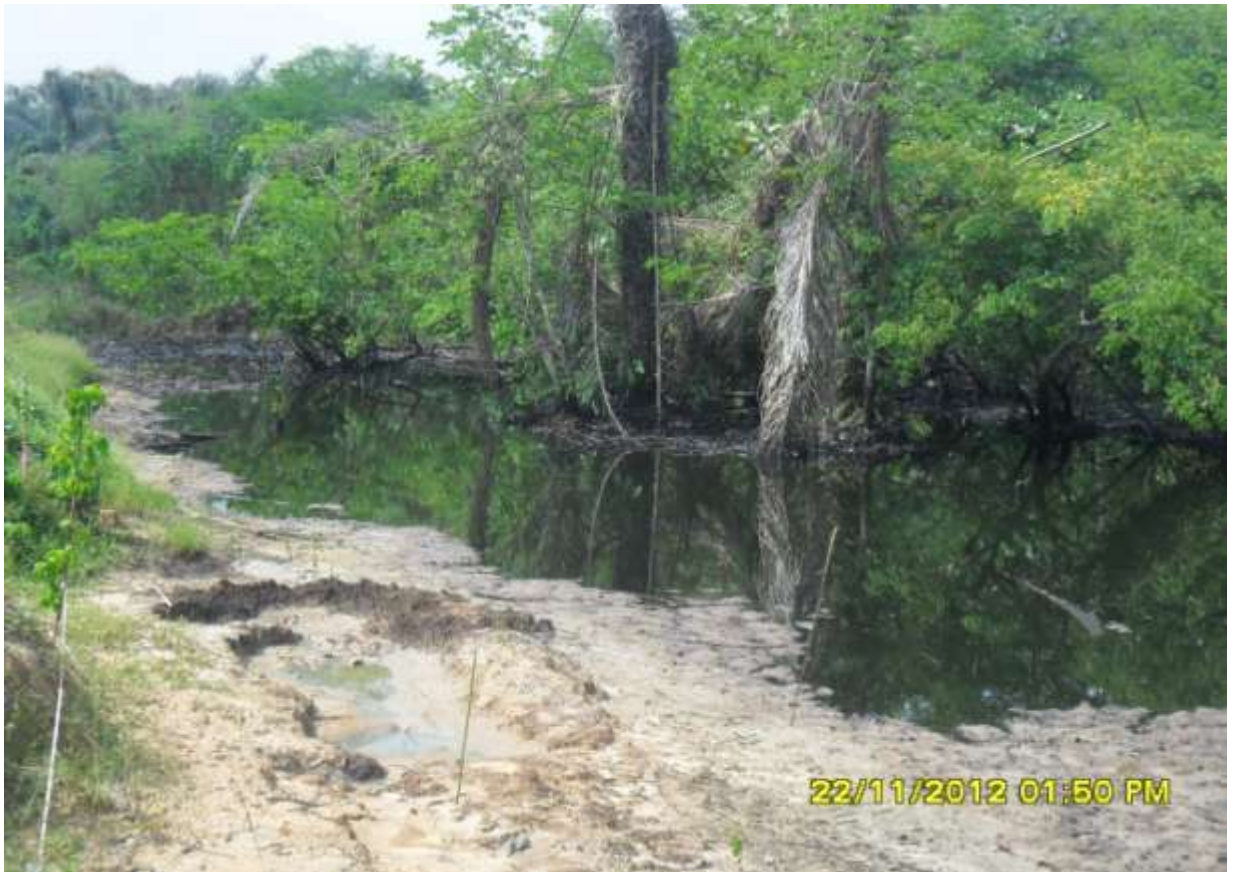
Overview: Part of spill impact on Imo River Well 64S/L Flowline at Owaza. Picture was taken during Joint Investigation of 22nd Nov. 2012.

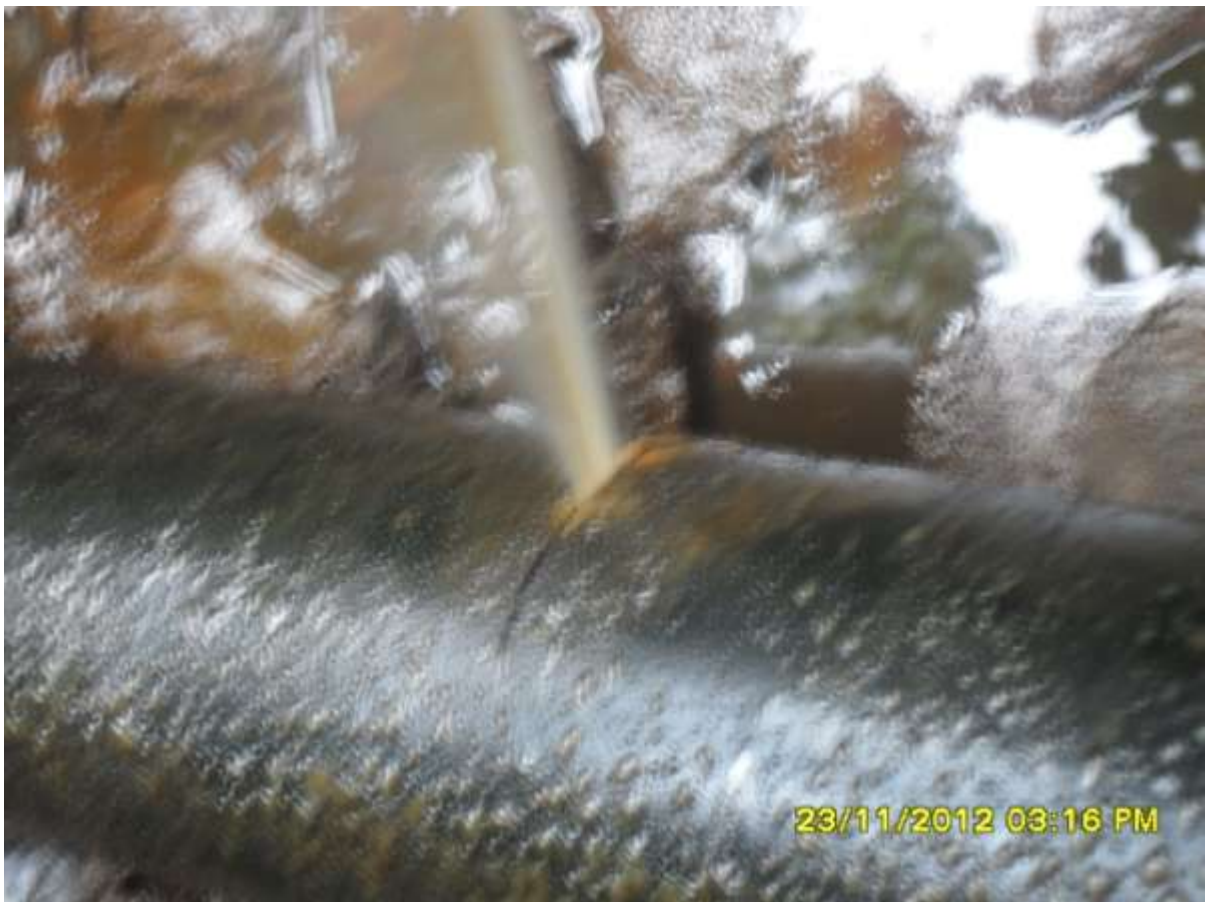
Close-up: Hacksaw cut on Imo River Well 64S/L Flowline at Owaza. Picture was taken during Joint Investigation of 23rd Nov. 2012.

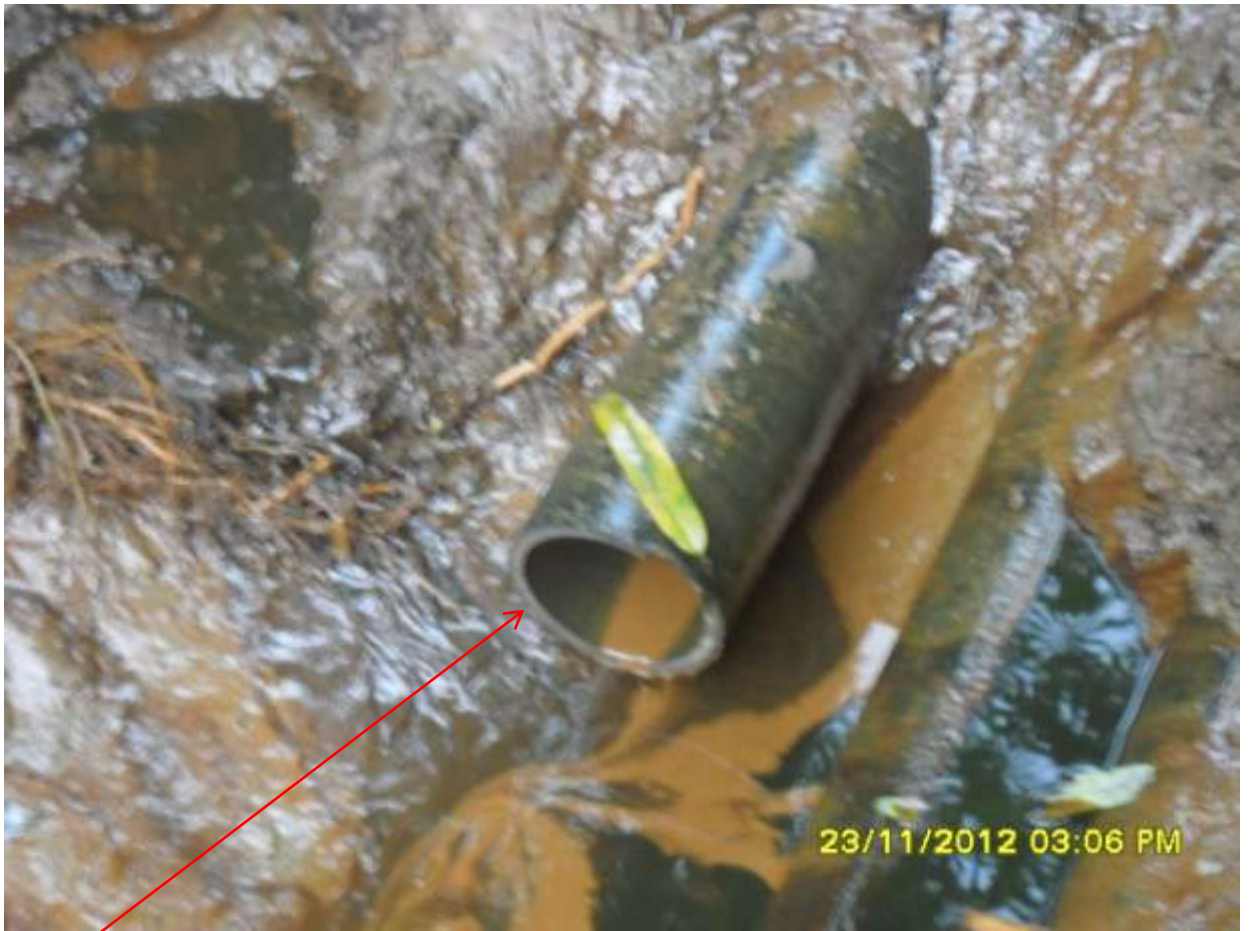
Close-up: Missing Flowline on Imo River Well 64S/L Flowline at Owaza. Picture was taken during Joint Investigation of 23rd Nov. 2012.
