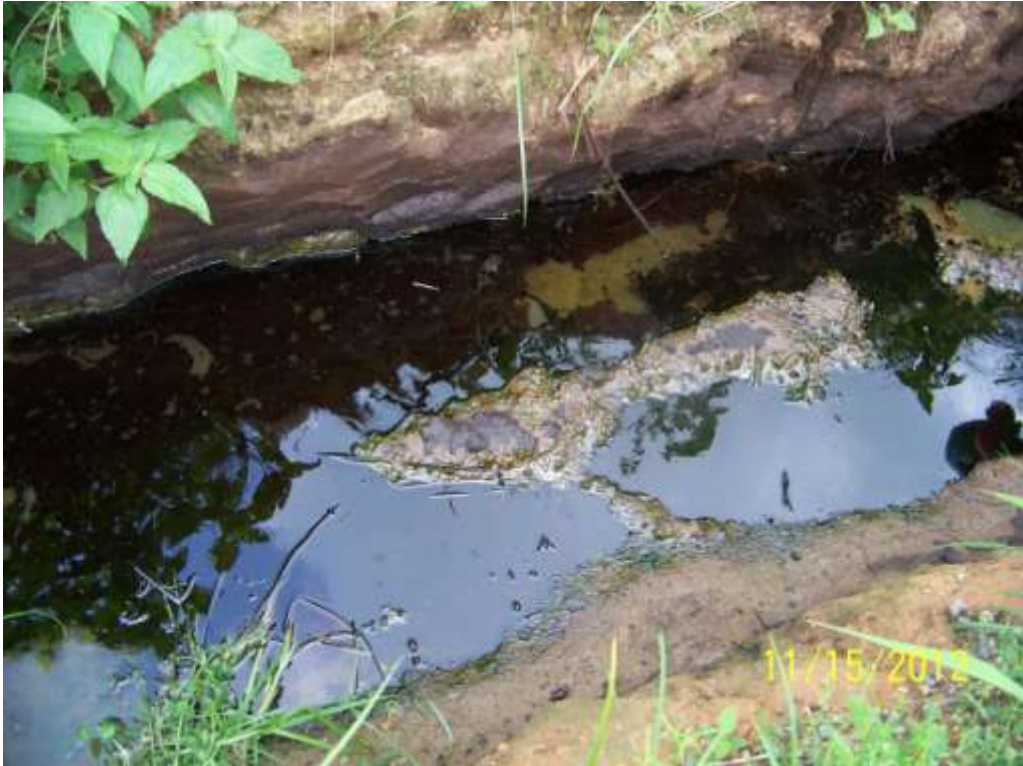
Close up: Part of spill impact on Obigbo Well28LS flowline right of way at Umuebulu. Picture was taken during Joint Investigation of 15th November 2012.

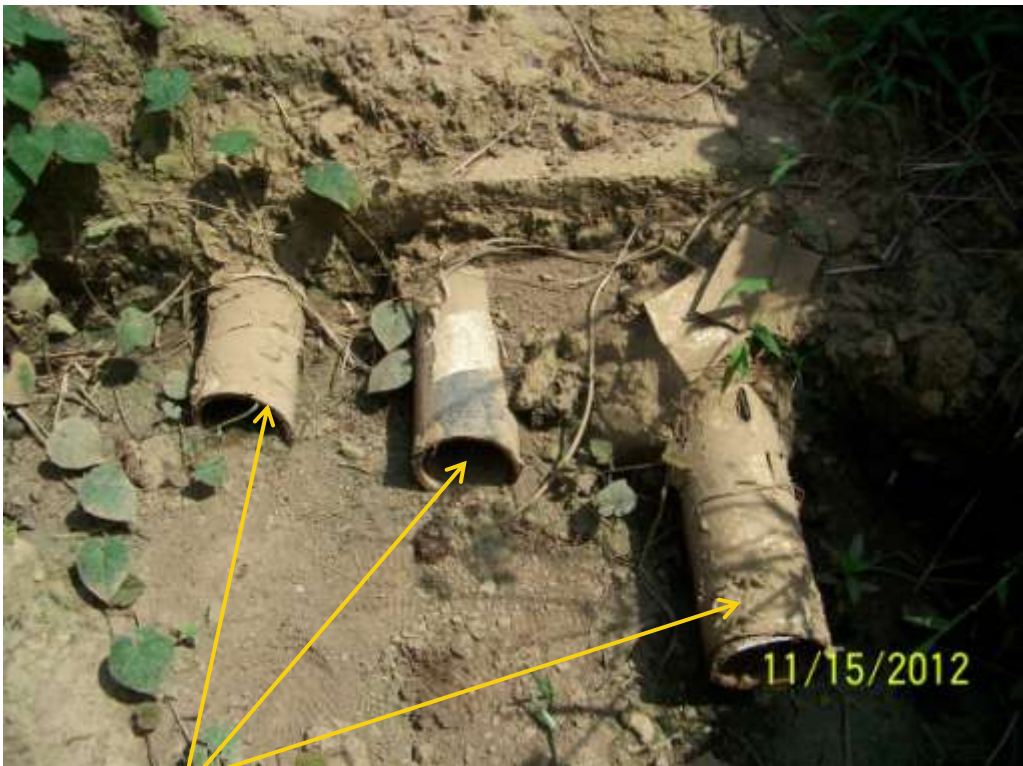
Close up: Cut sections on Obigbo Well28LS flowline at Umuebulu. Picture was taken during Joint Investigation of 15th November 2012.
