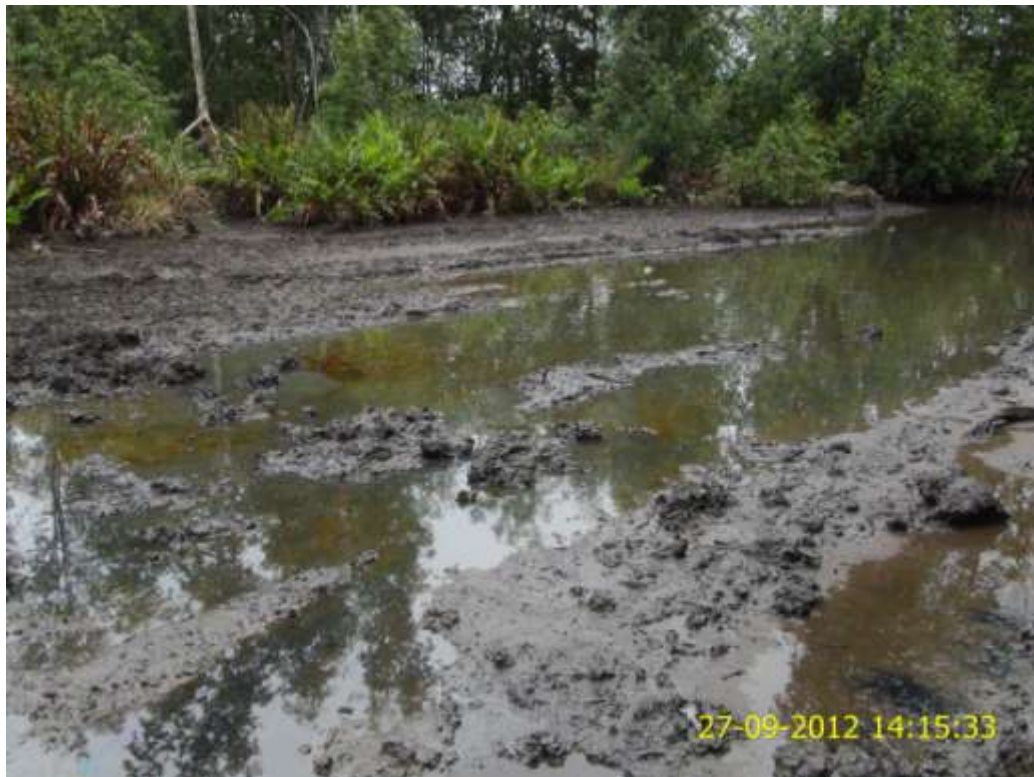
Overview: Part of spill impact on 4" Santa Barbara Well 11T flowline right of way at Ikegimakiri. Picture was taken during Joint Investigation of 27th September 2012.

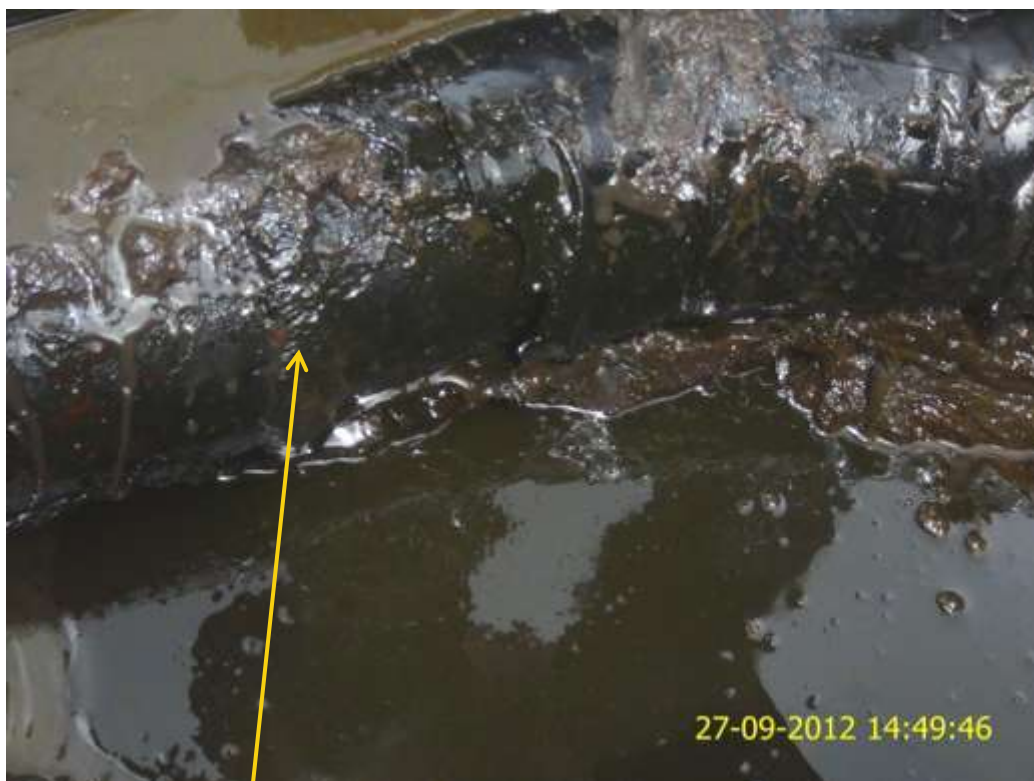
Close up: Failed weld on 4" Santa Barbara Well 11T flowline at Ikegimakiri. Picture was taken during Joint Investigation of 27th September 2012.
