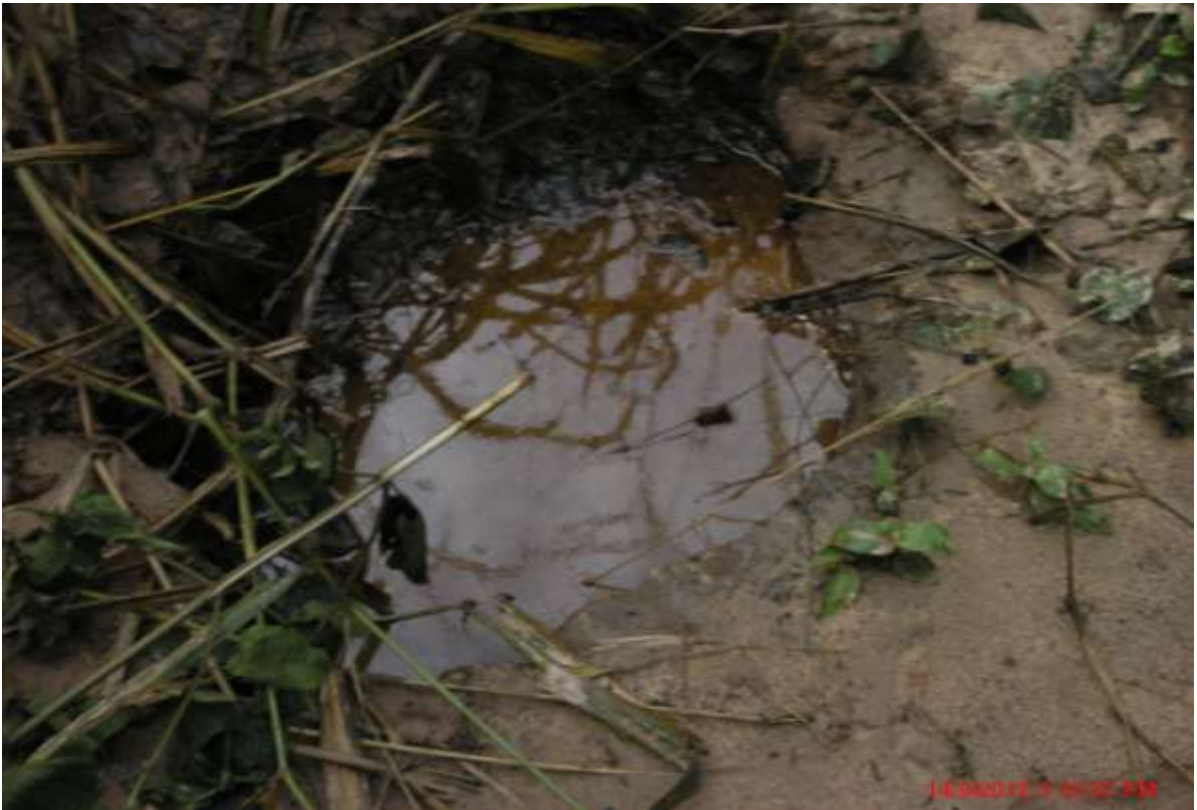
Overview: Part of spill impact on Imo River Well 33L Flowline at Owaza. Picture was taken during Joint Investigation of 14th Sept. 2012.

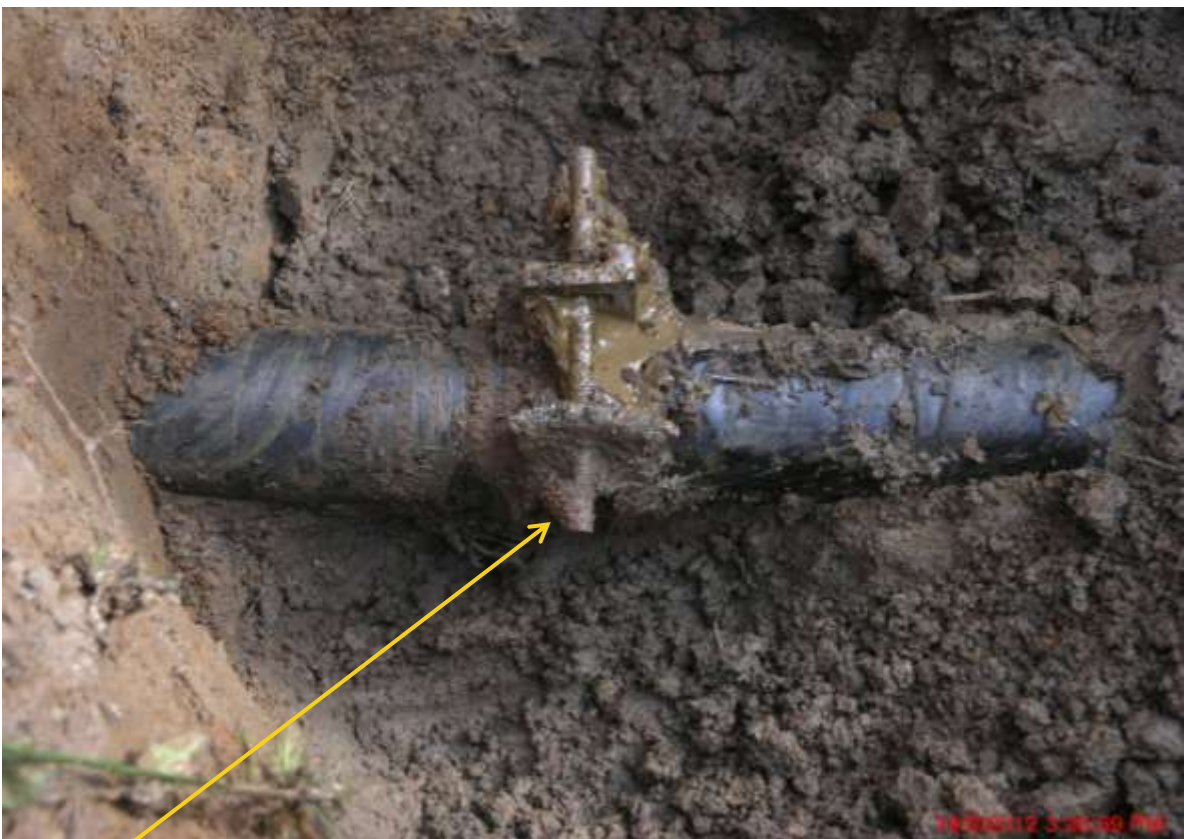
Close-up: Illegal fitting on Imo River Well 33L Flowline at Owaza. Picture was taken during Joint Investigation of 14th Sept. 2012.
