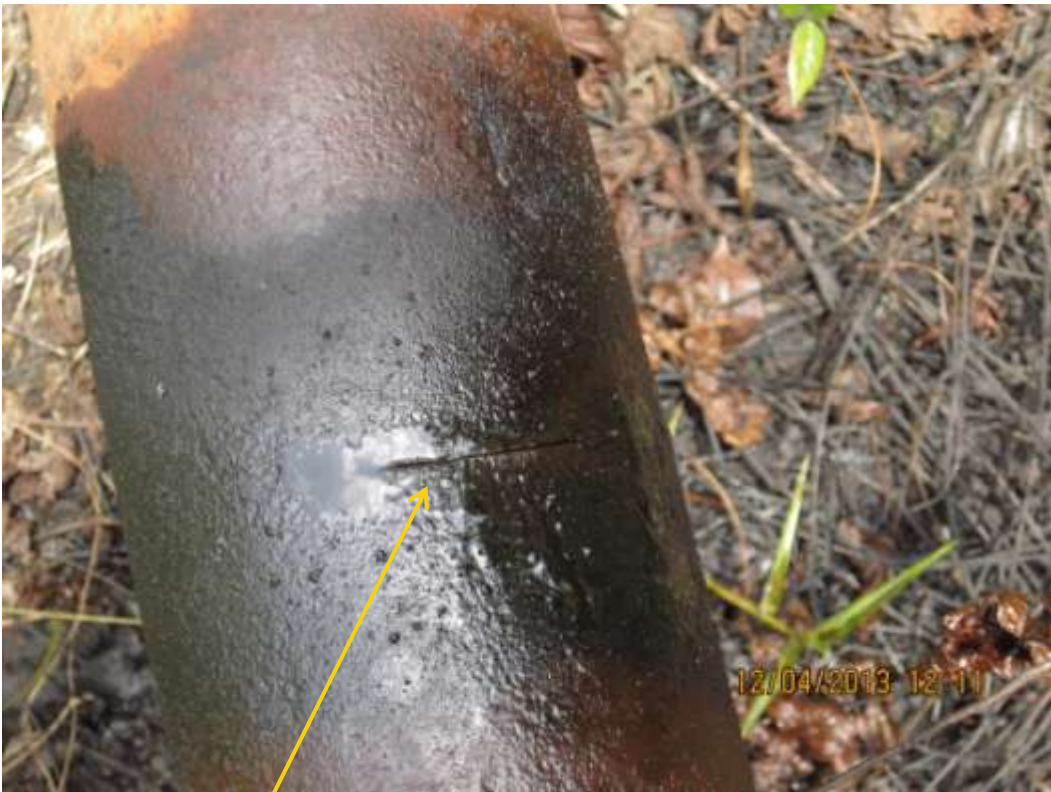
Close up: Hacksaw cut on 4" Adibawa Well8S flowline at Edagberi. Picture was taken during Joint Investigation of 12th April 2013.

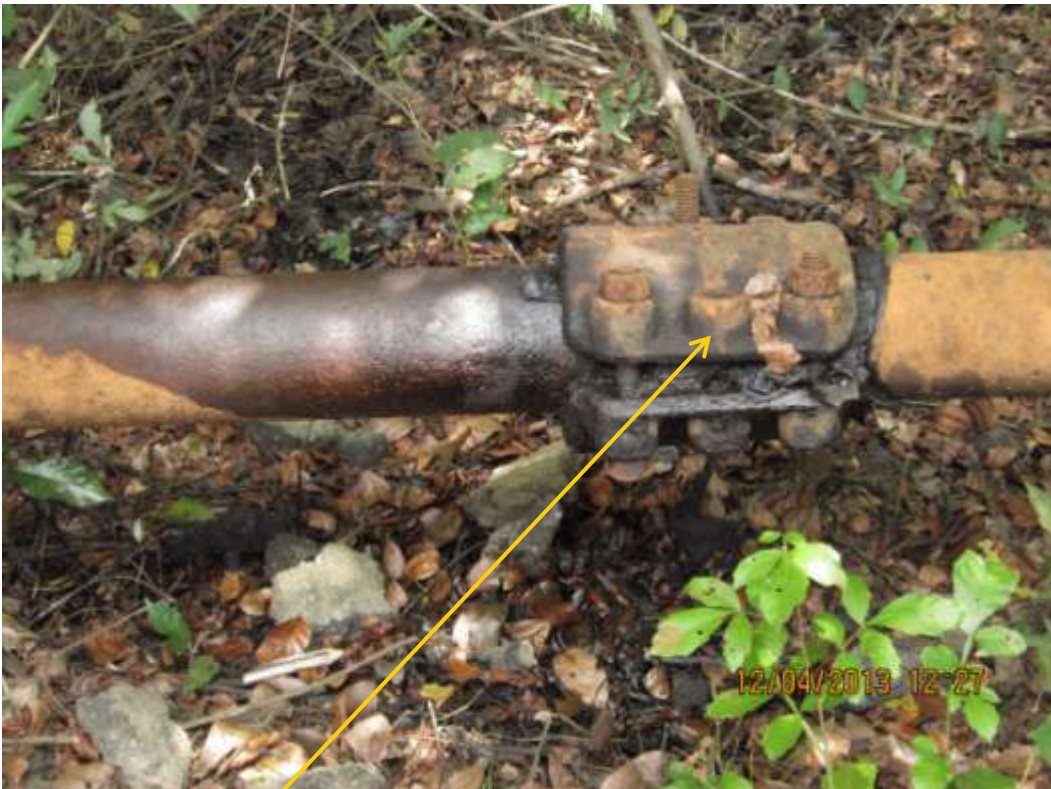
Close up: Location of missing bolt and nut on 4" Adibawa Well8S flowline at Edagberi. Picture was taken during Joint Investigation of 12th April 2013.
