Close up: Hacksaw cut on 4" Adibawa Well10S flowline at Edagberi. Picture was taken during Joint Investigation of 10th April 2013.

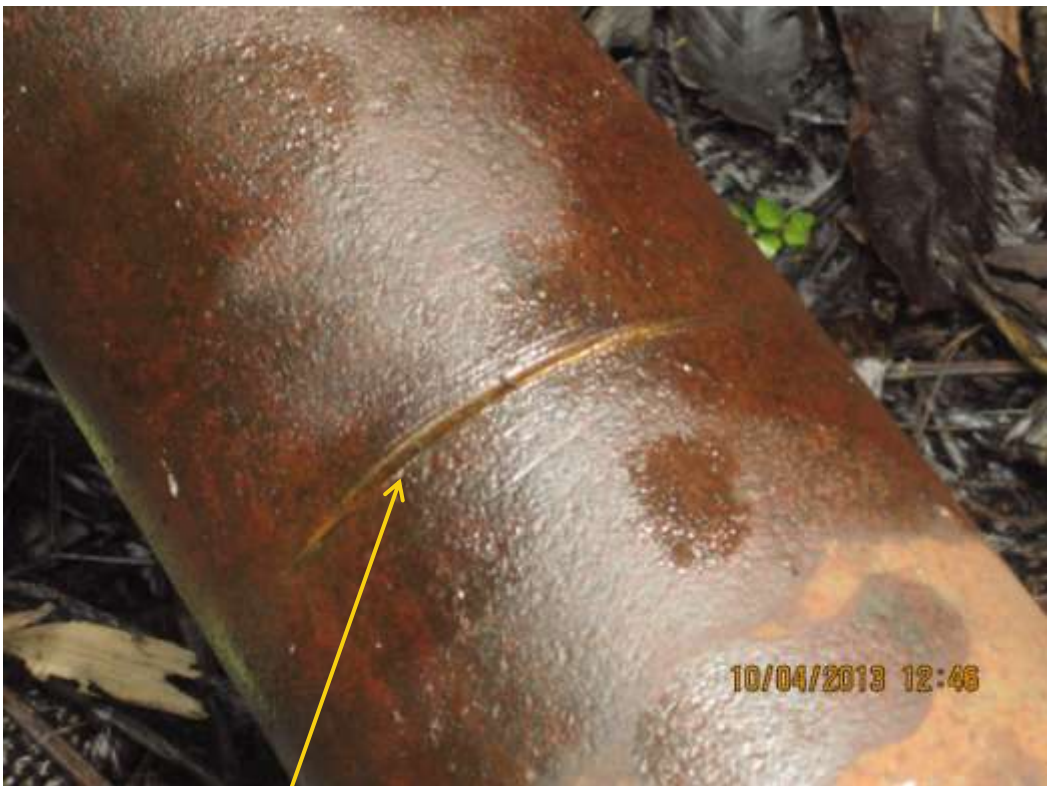
Closeup: Hacksaw cut on 4" Adibawa Well10S flowline at Edagberi. Picture was taken during Joint Investigation of 10th April 2013.

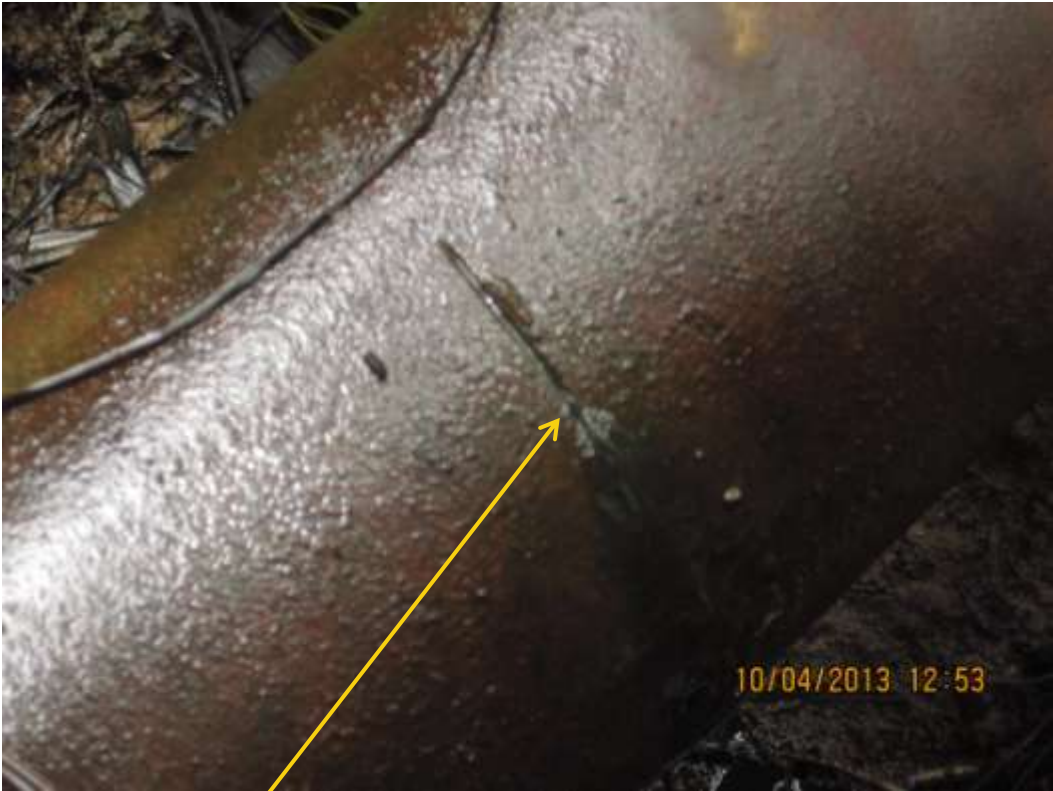
Close up: Hacksaw cut on 4" Adibawa Well10S flowline at Edagberi. Picture was taken during Joint Investigation of 10th April 2013.

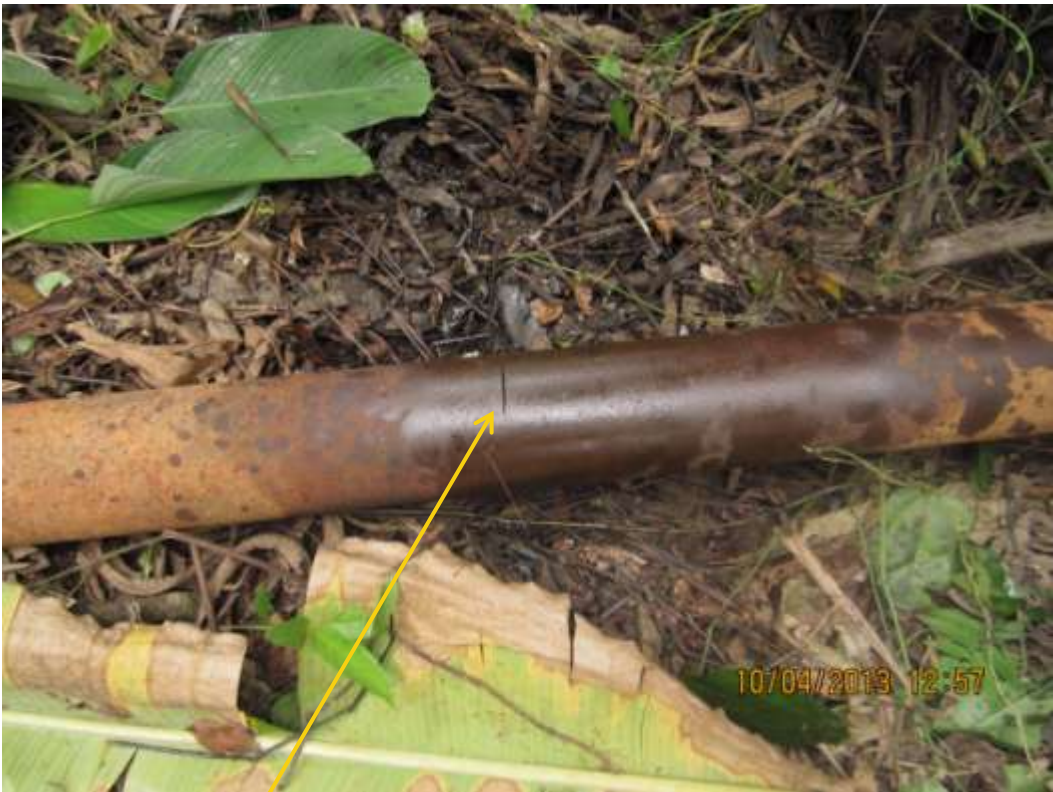
Close up: Hacksaw cut on 4" Adibawa Well10S flowline at Edagberi. Picture was taken during Joint Investigation of 10th April 2013.
