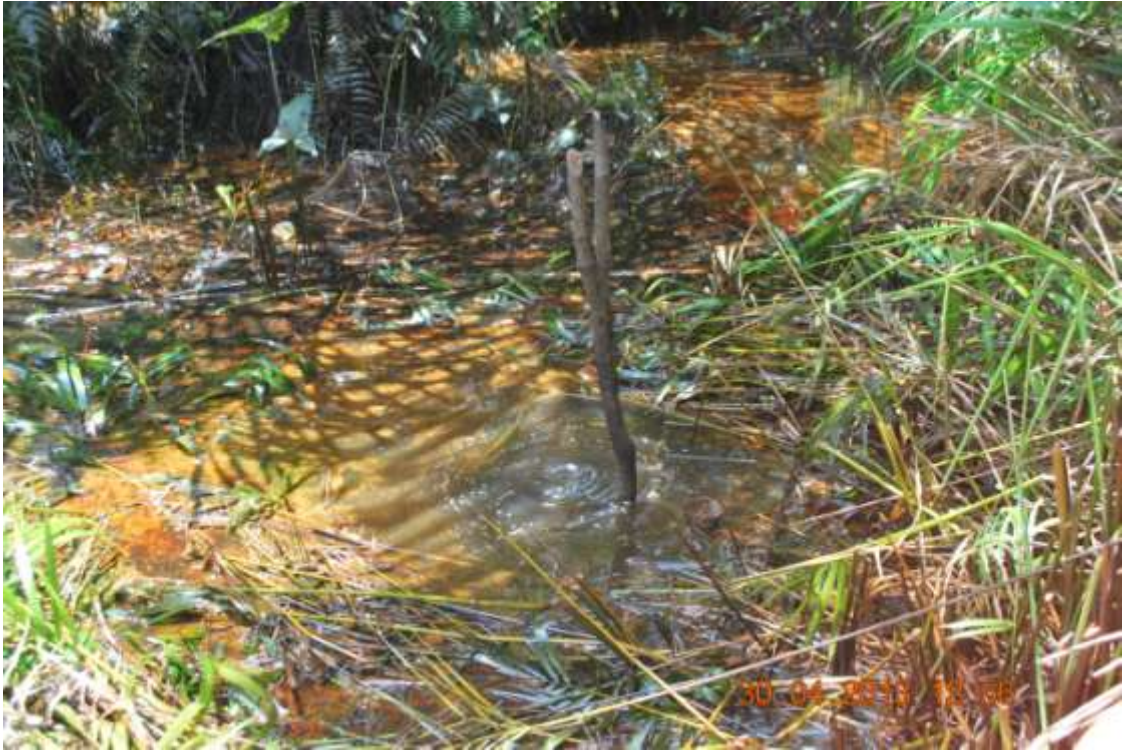
Overview: Part of spill impact on Adibawa Well2S flowline right of way at Edagberi. Picture was taken during Joint Investigation of 30<sup>th</sup> April 2013.

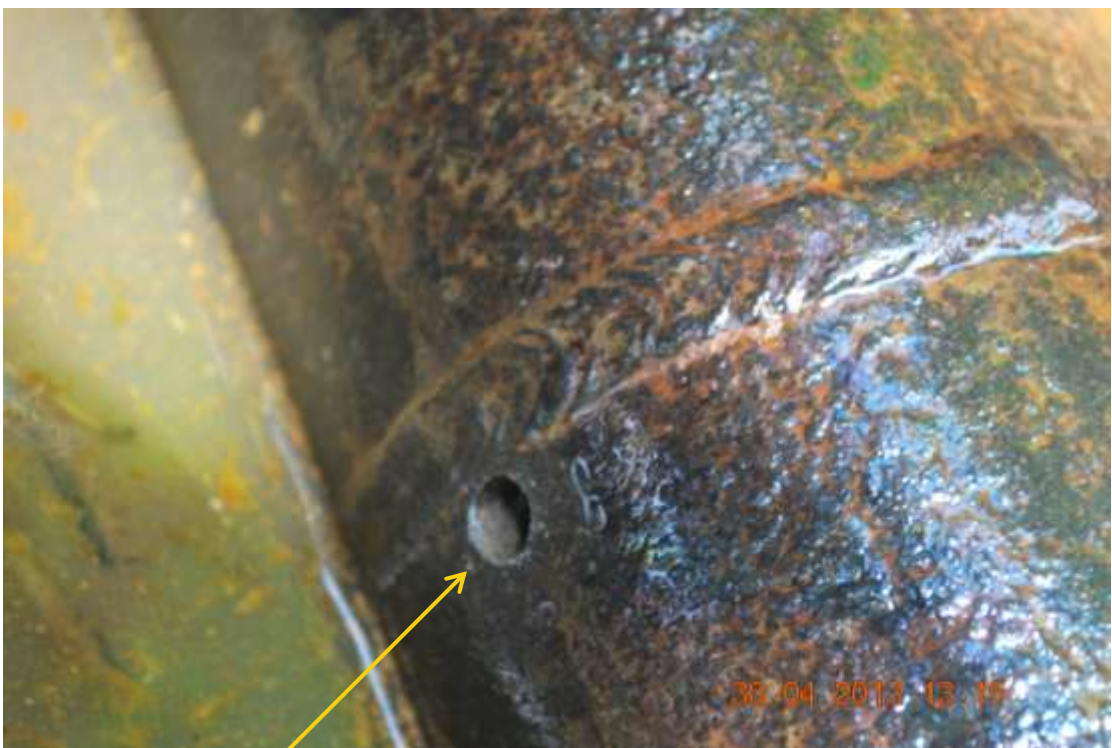
Close up: Drilled hole on Adibawa Well2S flowline at Edagberi. Picture was taken during Joint Investigation of 30<sup>th</sup> April 2013.
