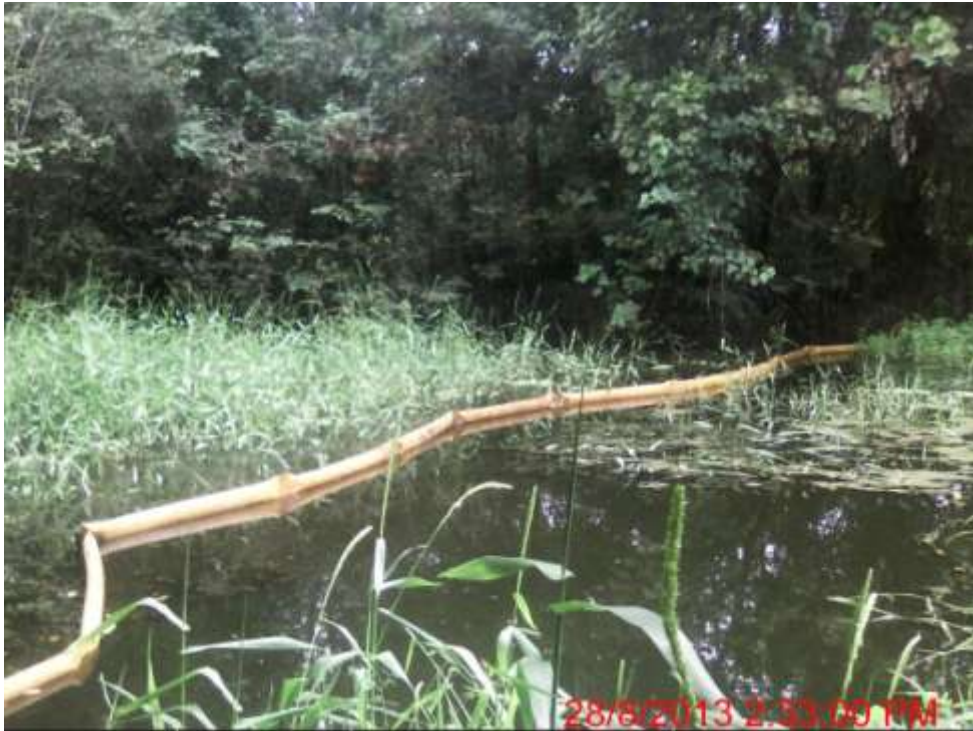
Overview: Part of spill impact on 4in Adibawa North East flowline right of way at Biseni. Picture was taken during Joint Investigation of 28th August 2013.

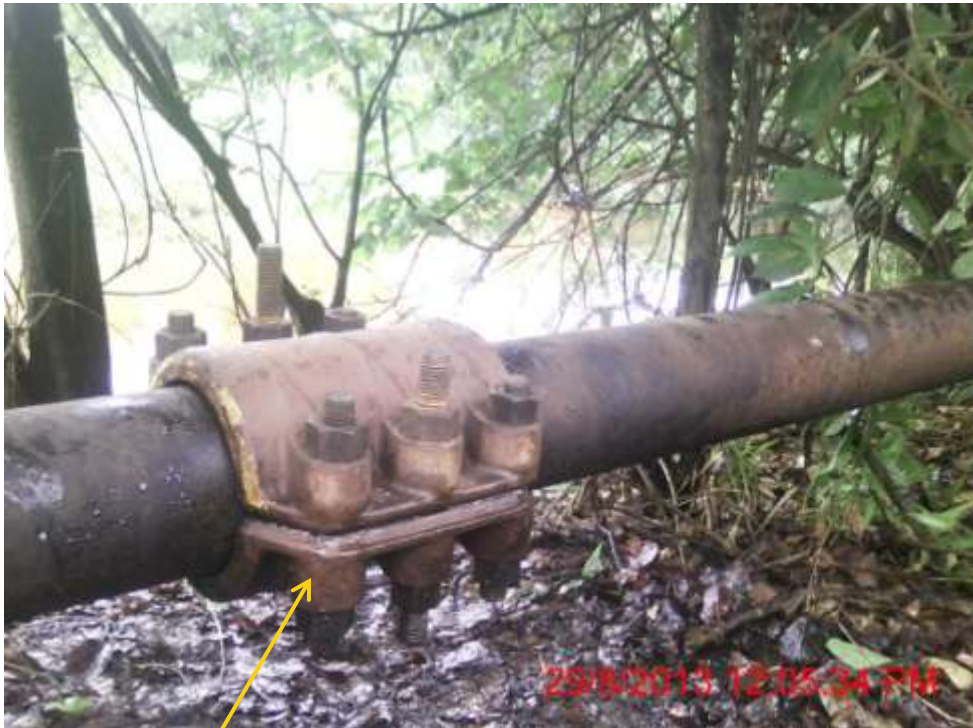
Close up: Tampered clamp on 4in Adibawa North East flowline at Biseni. Picture was taken during Joint Investigation of 29th August 2013.
